Chattanooga Home Inspector

Property Inspection Report

123 Inspection Way, Chattanooga, TN 37421
Inspection prepared for: Mrs. Buyer & Mr. Buyer
Date of Inspection: 1/5/2021 Time: 8:00 AM
Age of Home: 2007 Size: 3100
Weather: 30 degrees and sunny
Order ID: 11652

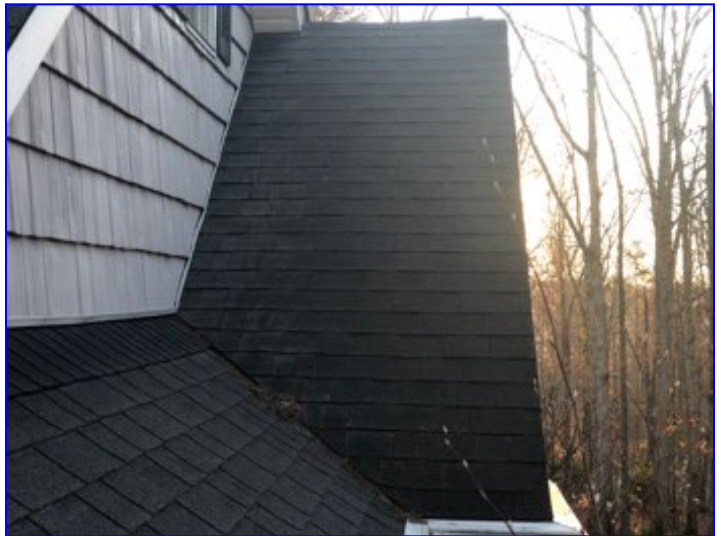
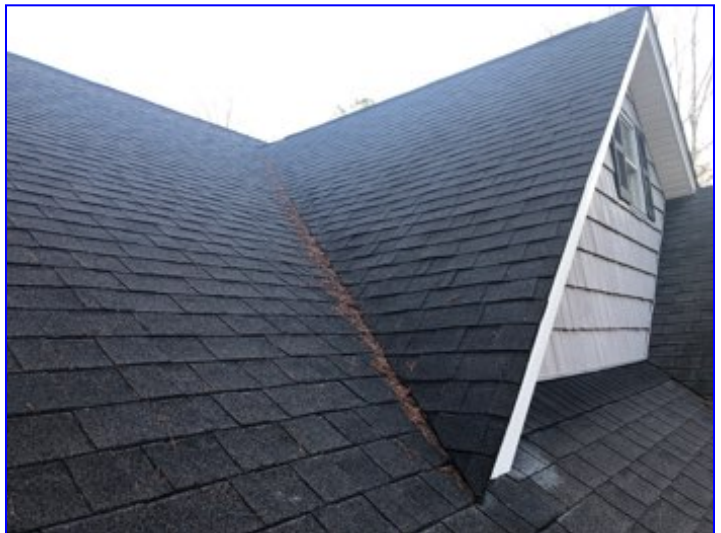
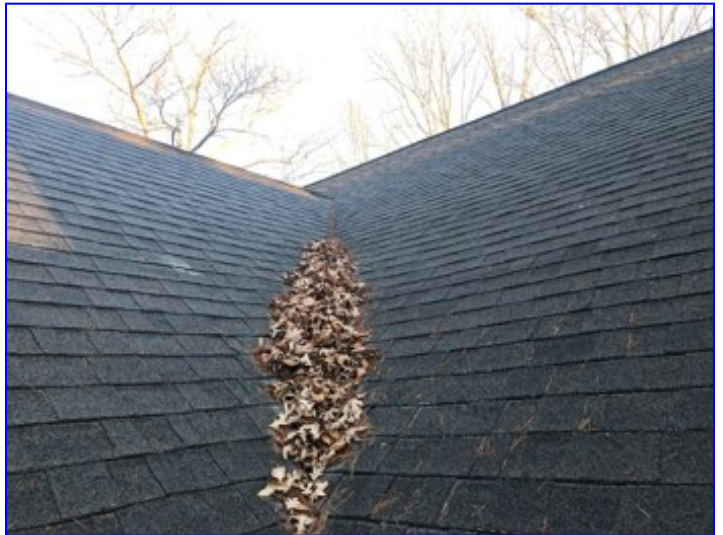
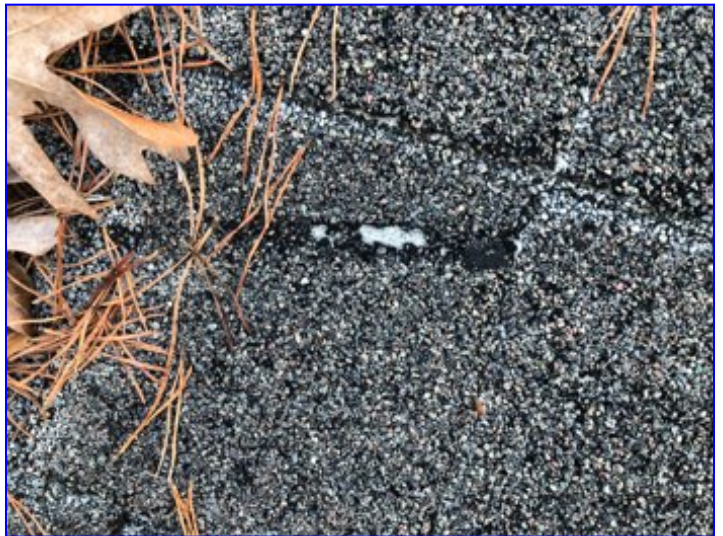
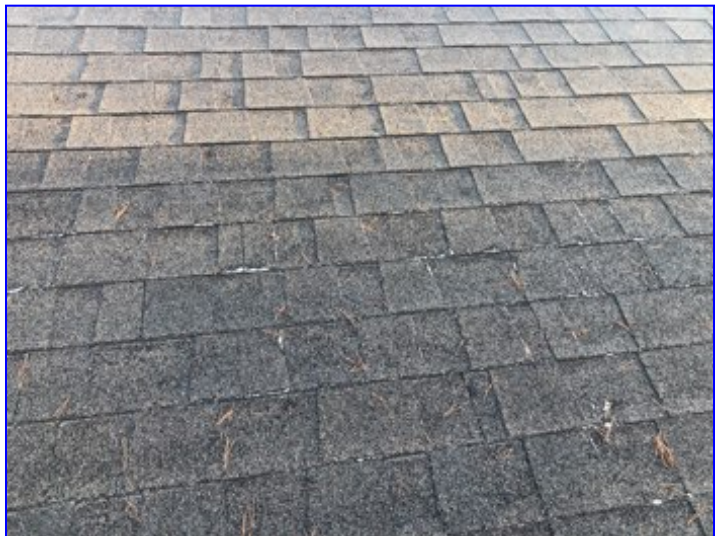
- Granules on asphalt shingles are deteriorated and appear to be nearing the end of their service life, especially on the south slope. Recommend licensed roofer review roof and repair / replace as needed.
- Various roof shingles are damaged. Recommend licensed roofer review roofing system and repairing / replacing damaged areas as needed.
- Exposed nails noted in areas of roof. Recommend adding roof grade silicone to exposed nails to prevent water entry.
- No **drip edge** flashing noted. Recommend adding drip edge flashing as needed.

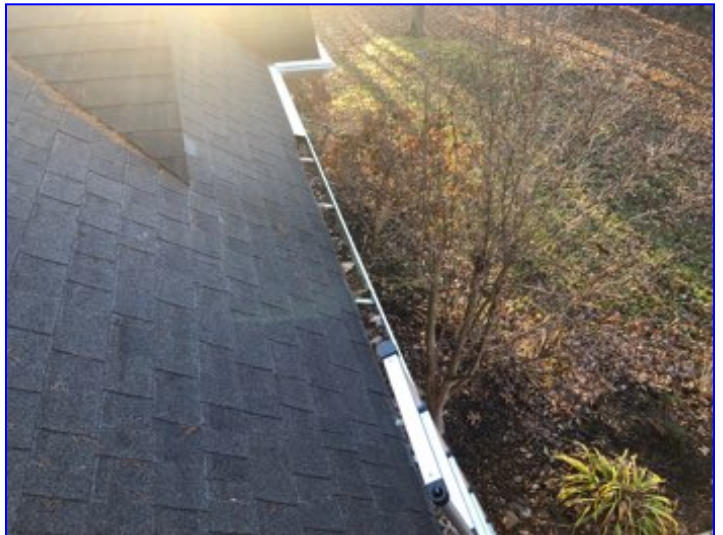
- Gutters not attached in some areas. Recommend repairing gutters to flow correctly.
- Excessive debris noted in gutters. Recommend cleaning gutters as a part of regular home maintenance.

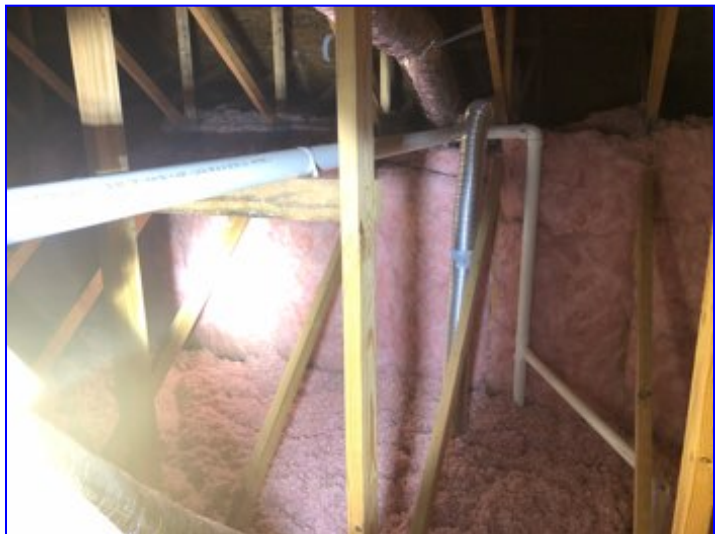
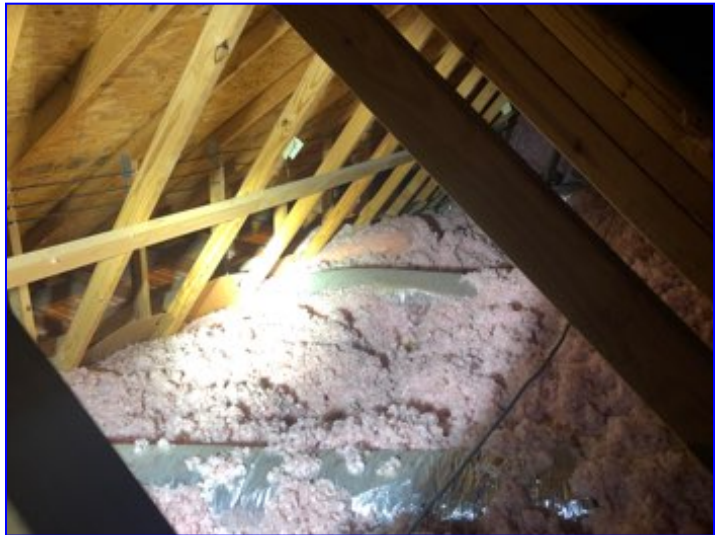
- "Tunneling" noted in attic insulation. This indicates current or past presence of pests in attic. No structural damage is visible at this time.

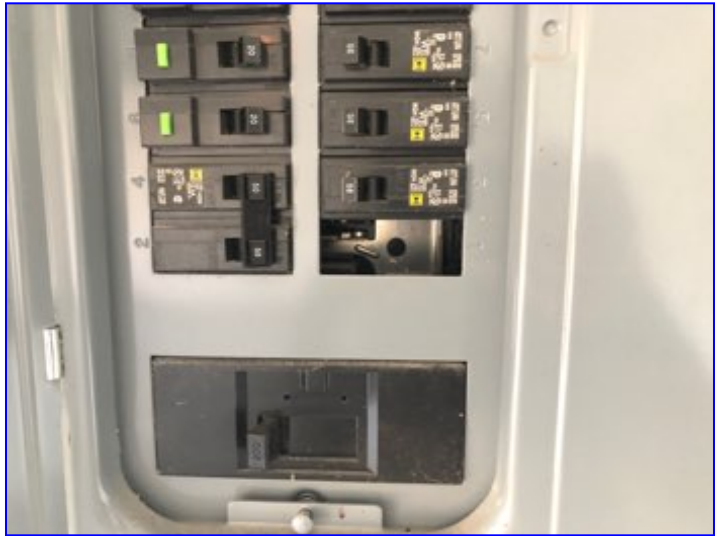
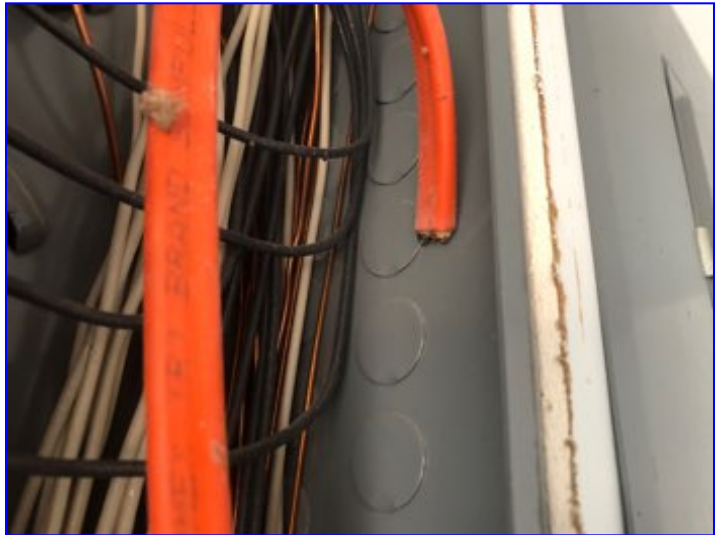
- Service panel missing screws. (Quantity 3) Recommend adding blunt tip screws as needed.
- Service panel is missing "knock-outs" where breakers could be installed. Recommend installing covers where breakers are missing.
- Abandoned exposed wires noted in electrical panel. Recommend removing or properly terminating wires by adding wire nuts over exposed wires.

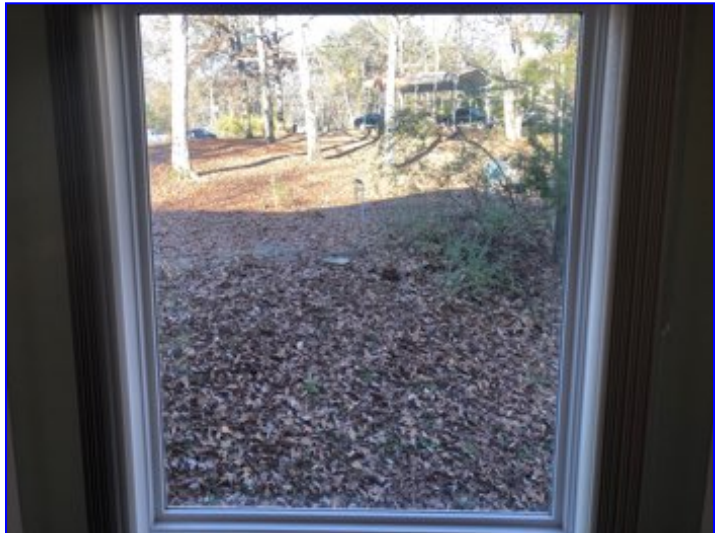
- Broken window pane noted. Recommend replacing damaged window pane. (Total Quantity 2)

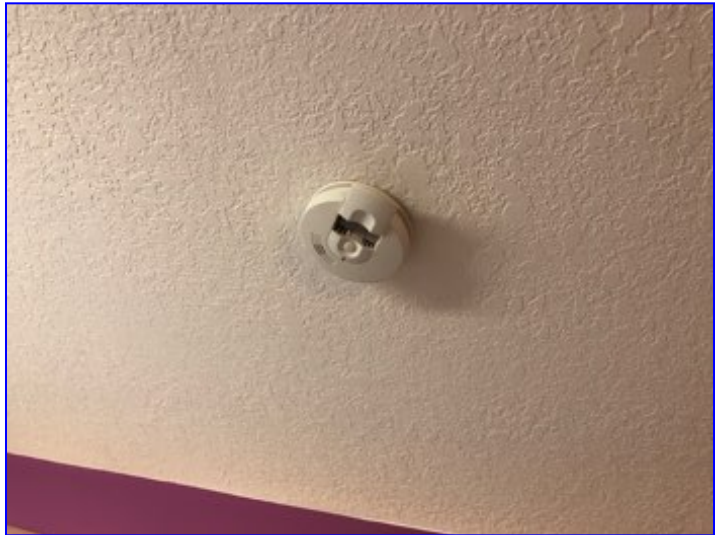
- Smoke detectors have been removed throughout home. Recommend reinstalling smoke detectors.

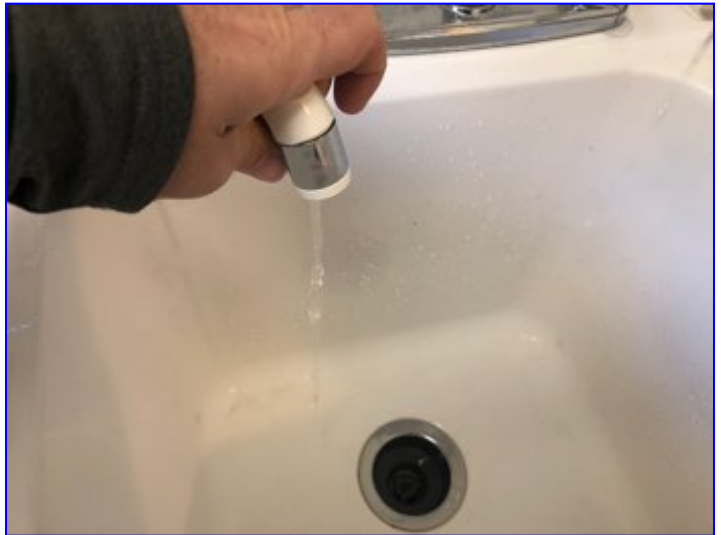
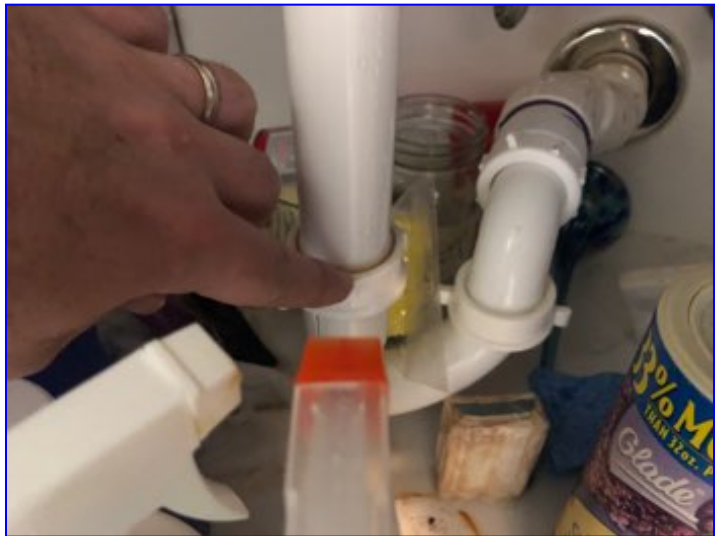
- Drain line leaks under sink. Recommend repairing leak.

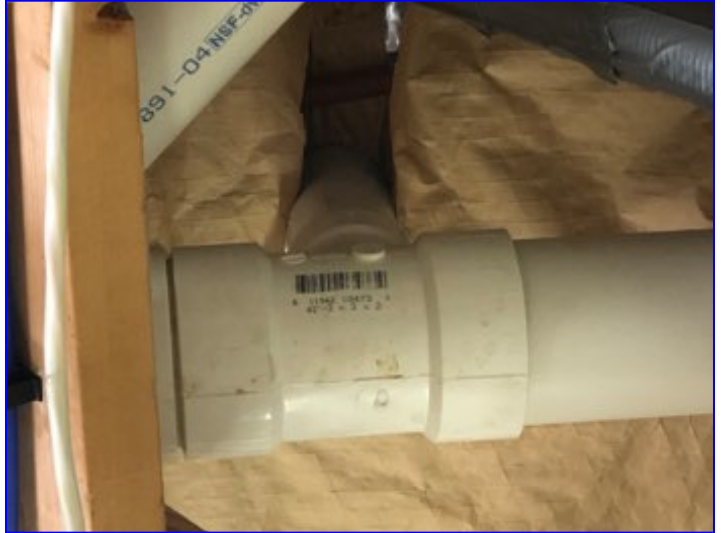
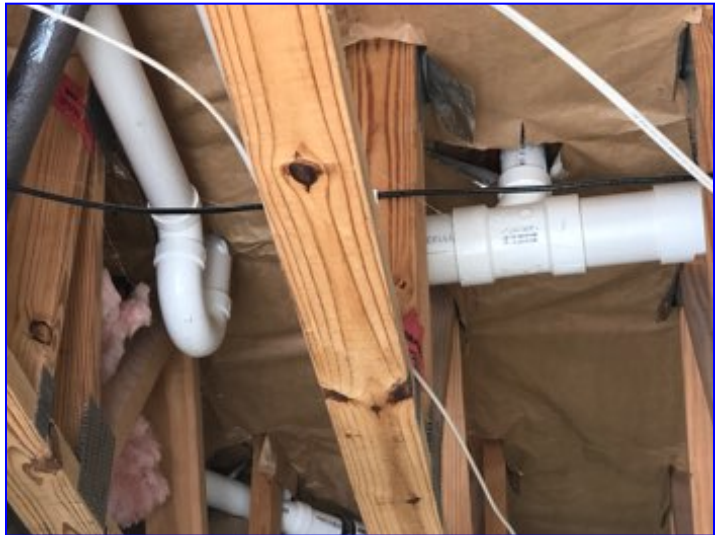
- Active leak noted in basement, which appears to be under the master bathroom. Unable to view subfloor to determine if damaged. Recommend repairing leak and replacing damaged areas due to leak.

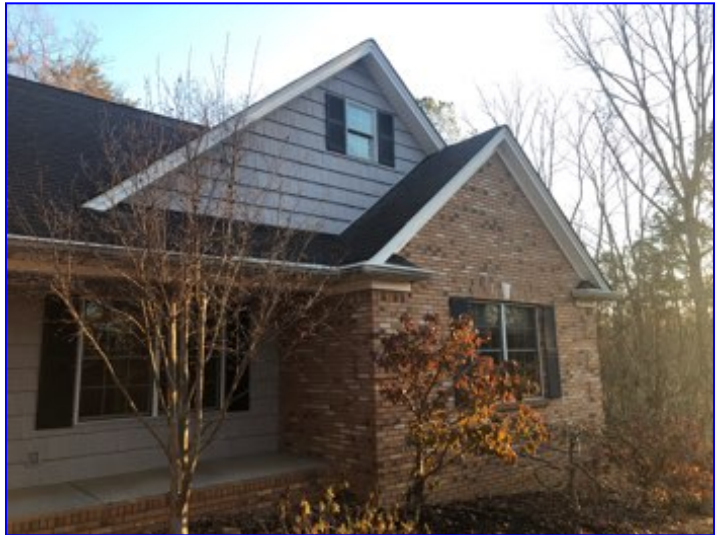
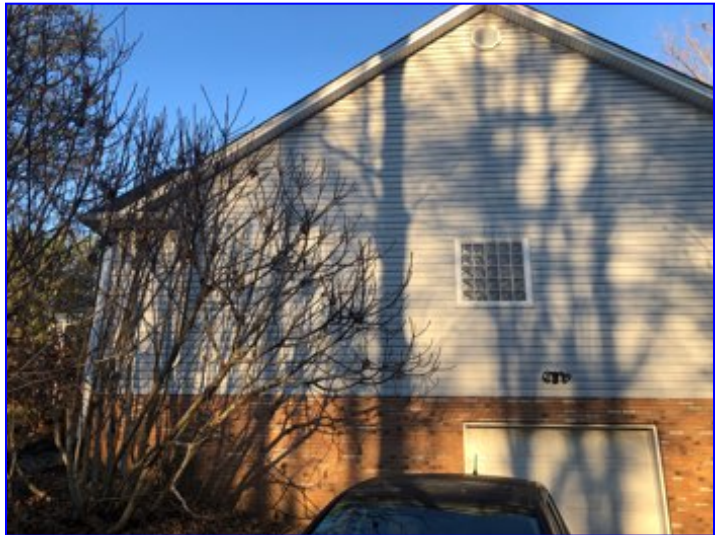
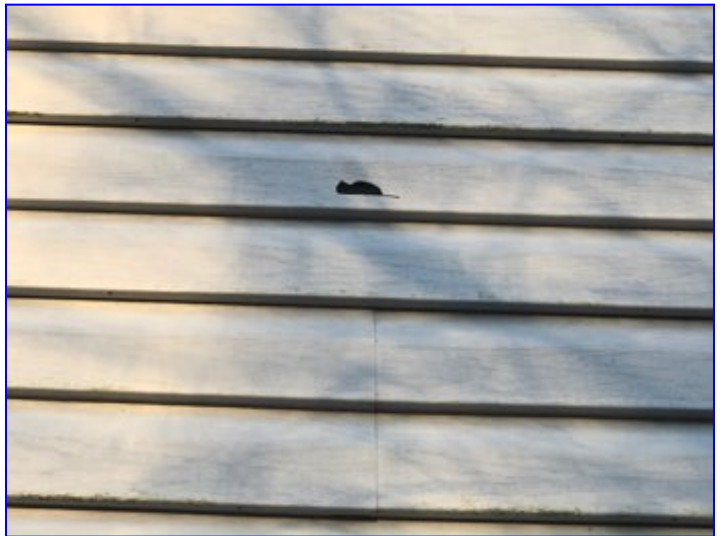
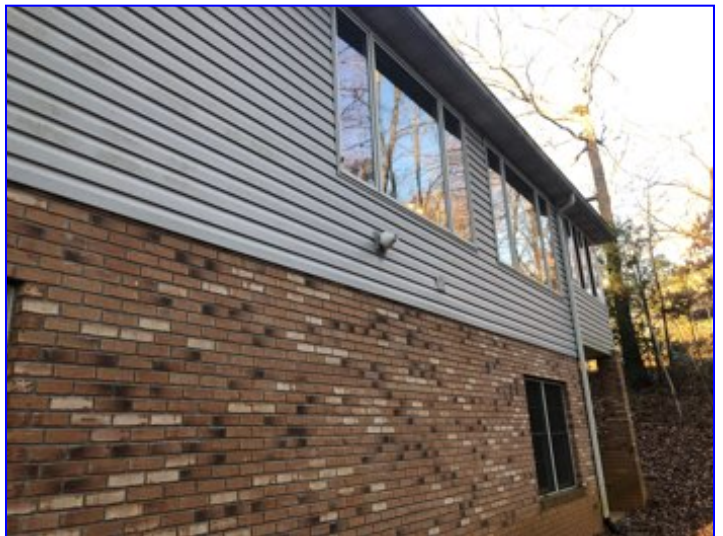
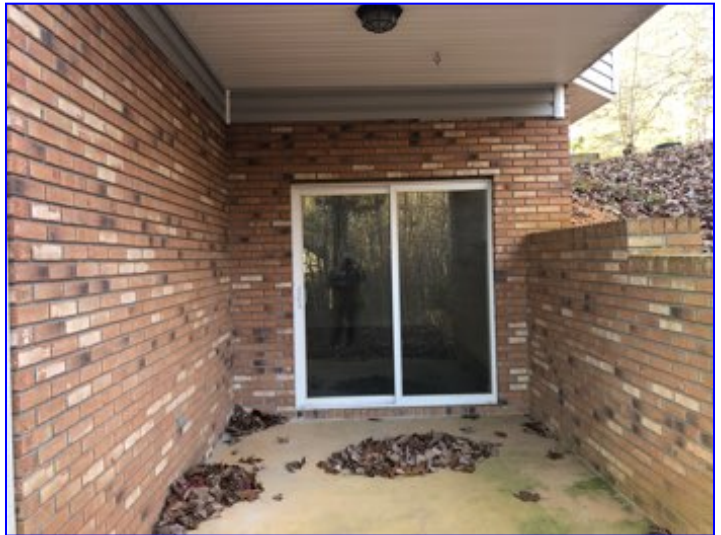
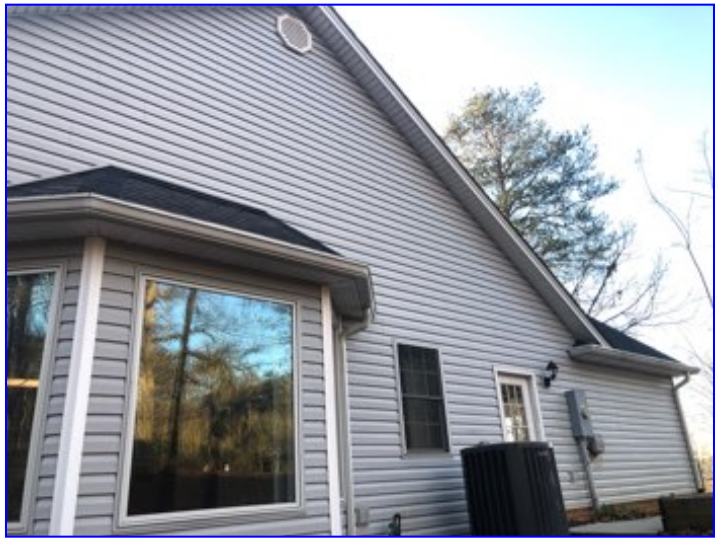
- Small holes or damaged area noted in siding. Recommend sealing these areas to prevent water entry.
- Pictures and arrows may not represent all exterior damaged surfaces. Recommend a professional that can repair damaged exterior surfaces ensure all damaged or rotten areas be repaired properly.

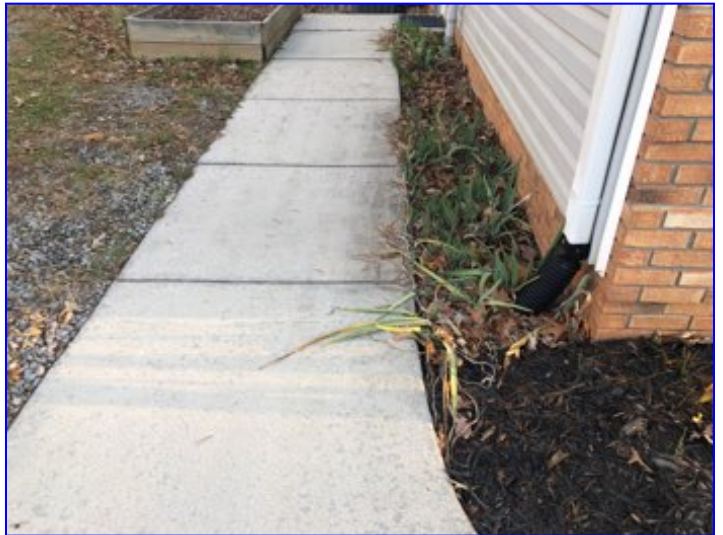
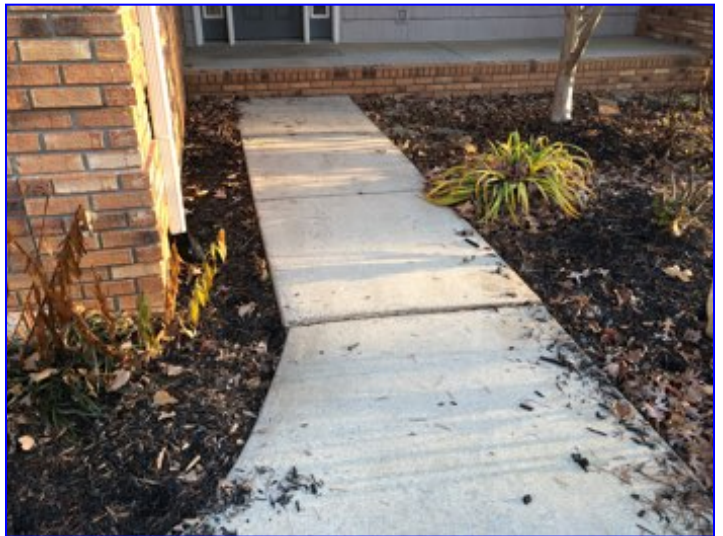
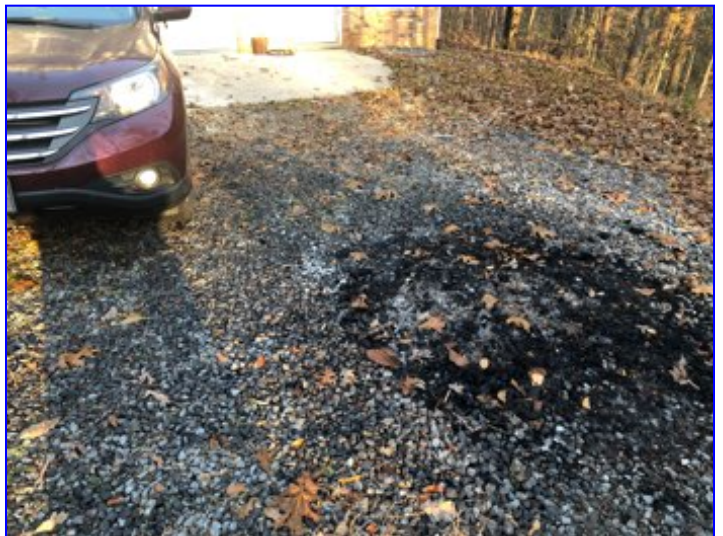
- Typical cracks noted.
- Loose sidewalk material noted. Recommend securing sidewalk material to prevent trip hazard.
- Washed out area noted on northwest sidewalk. Recommend monitoring concrete for cracking/settling and repairing as needed.

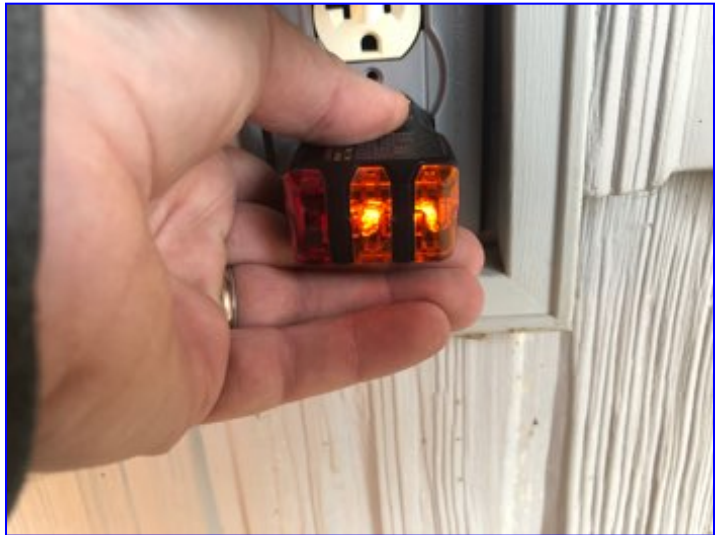
- Exterior outlets not **GFCI** protected. Consider replacing outlets with Ground Fault Circuit protection.

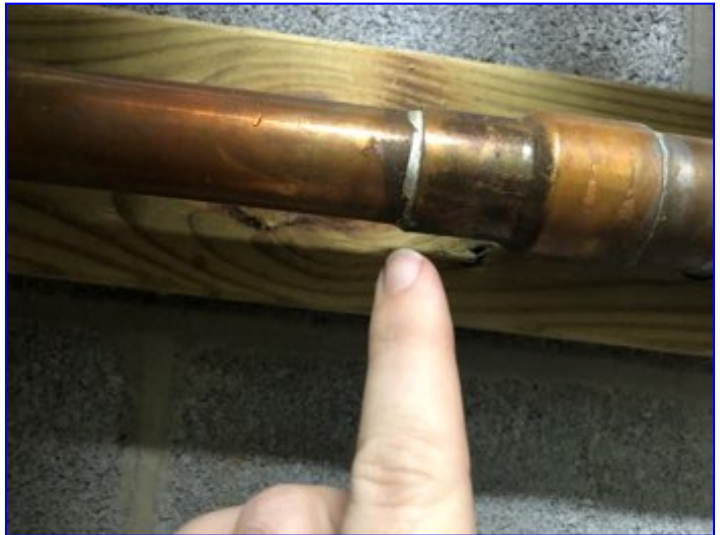
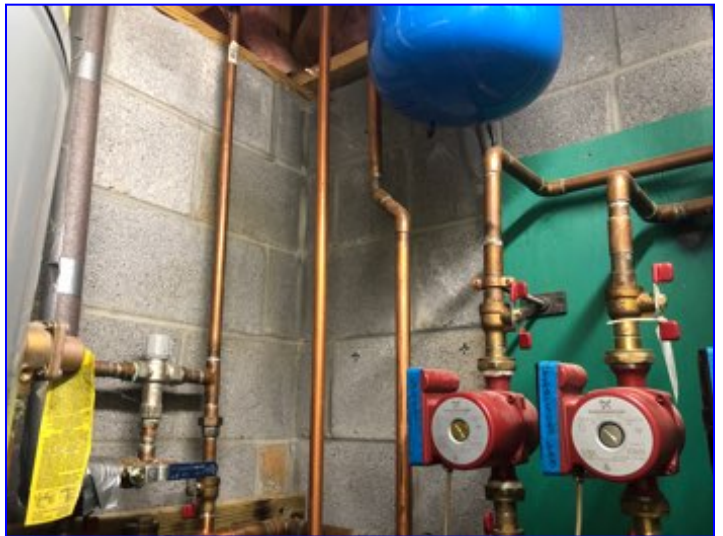
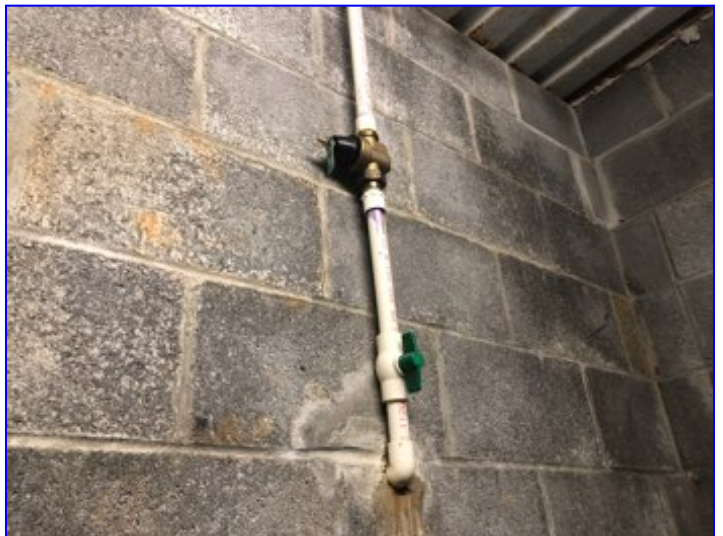
- Sewer system not visible, unable to inspect.
- Septic system not visible, unable to inspect.
- **PVC** piping noted for waste drain and vent lines.
- Unable to locate public water meter.
- Water line behind water heater is leaking. Recommend repairing copper line as needed.

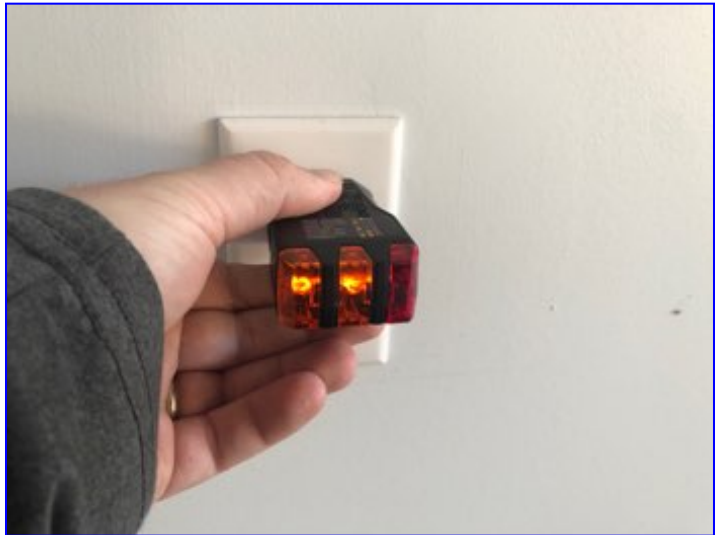
- No GFCI protection in garage. It is recommended that outlets in garage are GFCI protected, however many homes have dedicated outlets in garage that are not GFCI protected to power items such as deep freezers.

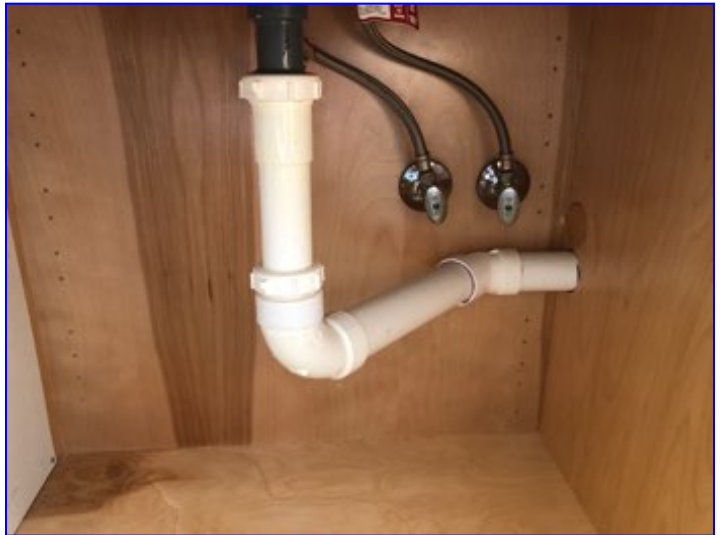
- Drain line leaks under sink on left side. Recommend repairing leak.

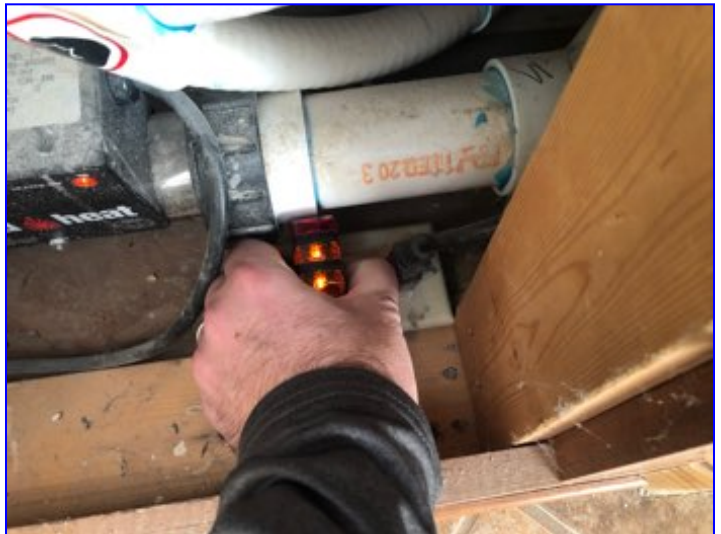
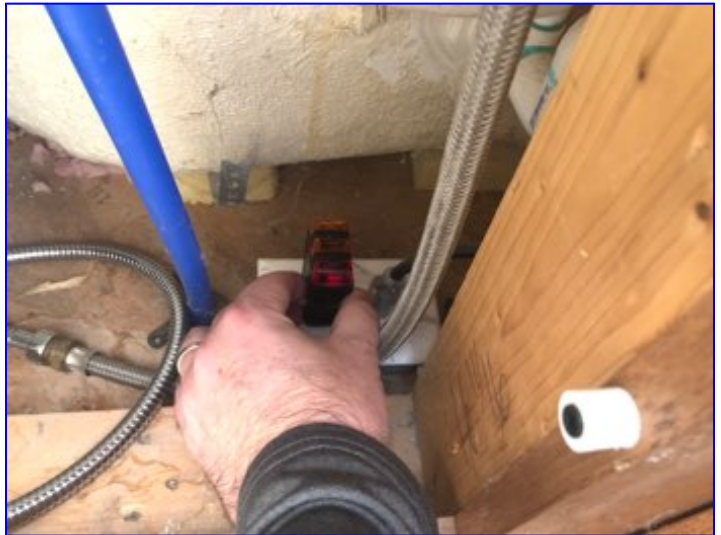
- Whirlpool
- Whirlpool tub observed. Tub was filled to a level above the water jets and operated to check intake and jets. The tub was then drained to check for leaks and/or damage. Pump and supply lines were not completely visible or accessible. GFCI was present and was tested. The items tested appeared to be in good condition. If a more detailed report is desired, the client is advised to consult a licensed plumber for a complete review.
- GFCI outlet powering the heat unit is not operating properly and will not trip when tested. Recommend repairing or replacing outlet.

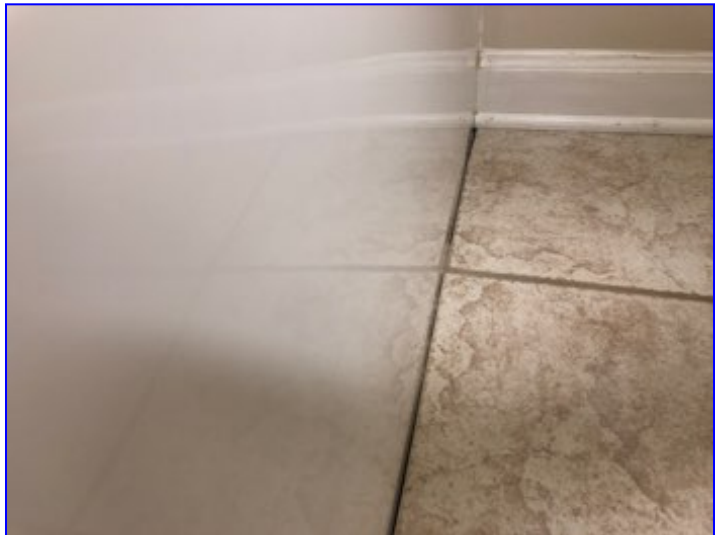
- Areas of tile floor in this bathroom are missing grout. Recommend adding grout to prevent further damage of tile.

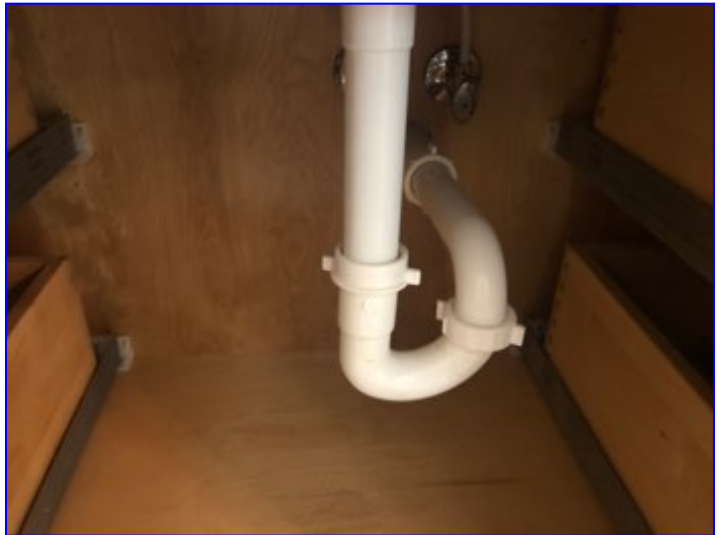
- Drain line leaks under sink. Recommend repairing leak.
