PROPERTY INSPECTION **REPORT**

2404 Cave Springs Rd, Rising Fawn, GA 30738

DATE OF INSPECTION: 10/8/2024

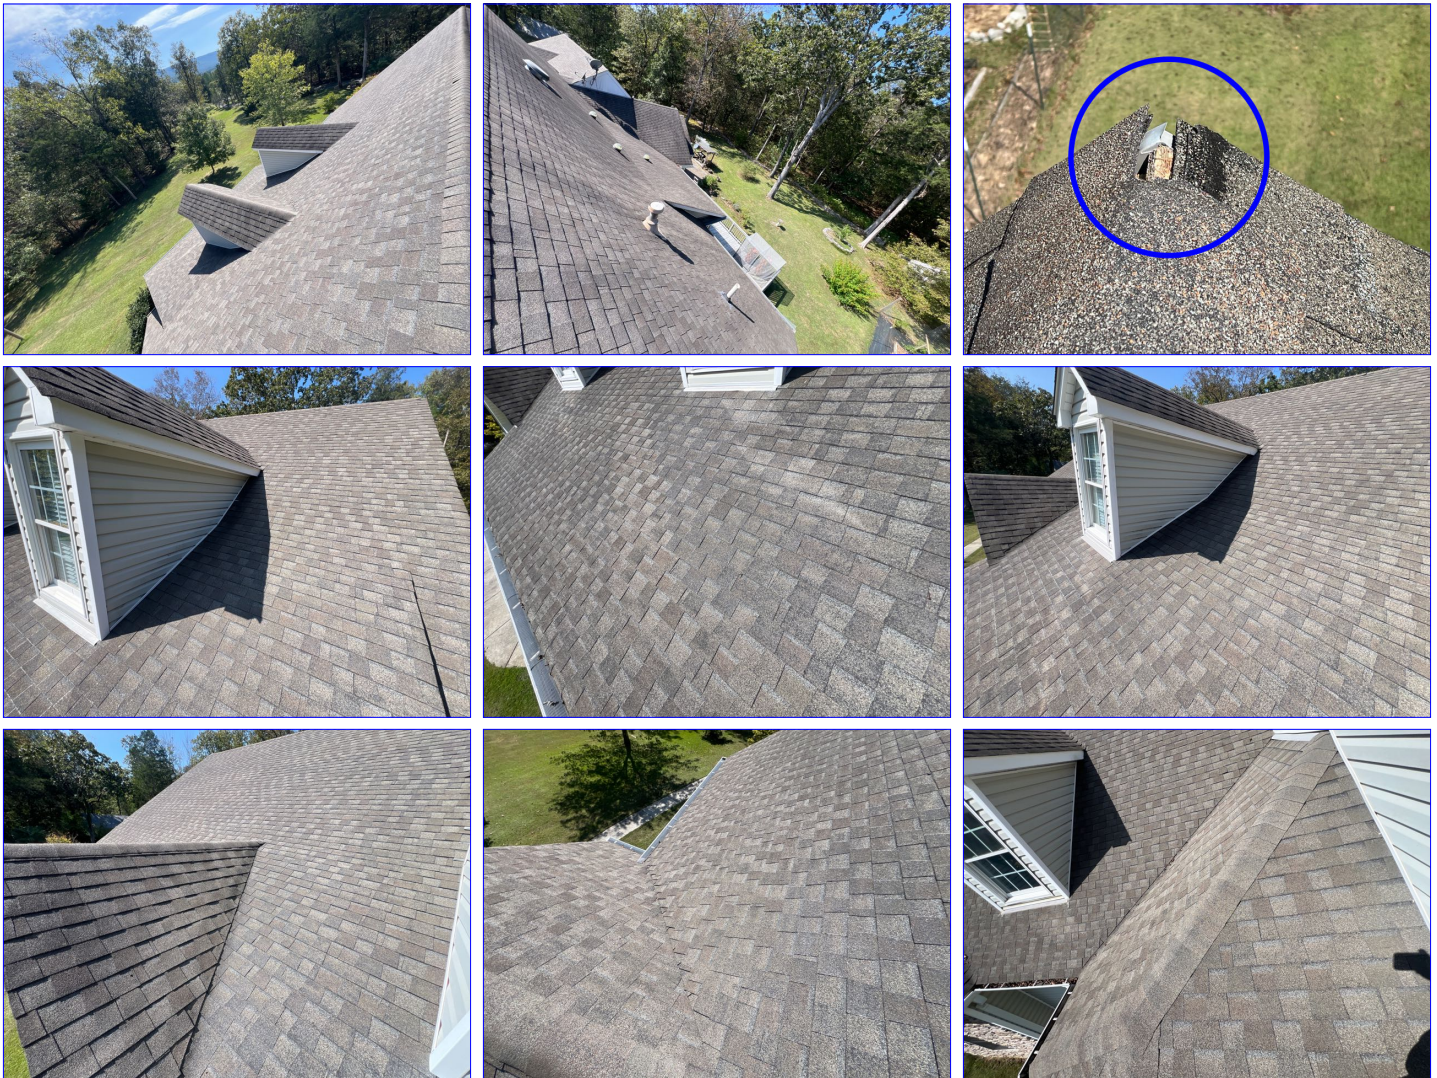
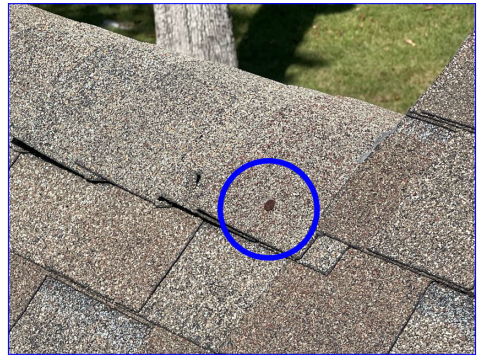
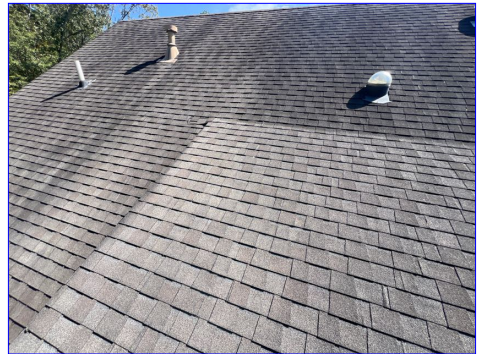
- Pictures and arrows may not represent all damaged surfaces. Recommend a licensed professional ensure all damaged areas be repaired properly.
- Loose shingles noted on roof. Recommend to properly reattach or replace shingles.
- No kick-out flashing noted at areas where the roof meets the structure. Recommend adding kick-out flashing as needed.
- Granule loss, damaged shingles, and/or exposed nails noted on roof. Recommend repairing as needed.

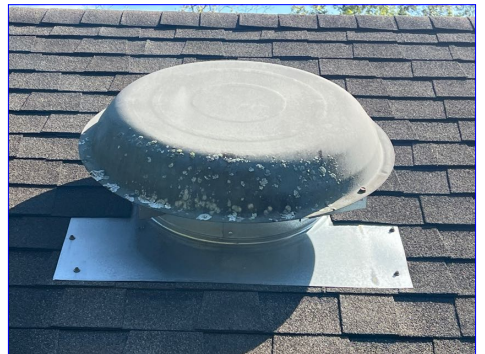
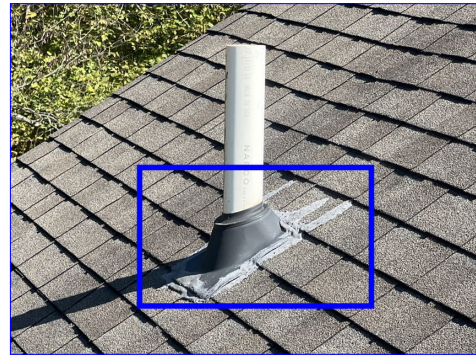
- Improperly installed vent boots noted. Recommend properly installing boots.
- Exposed nails noted on vent boot. Recommend adding roofing grade sealant.

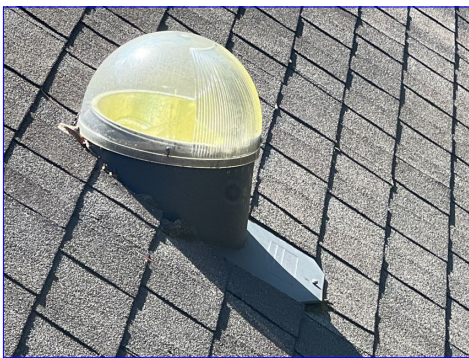
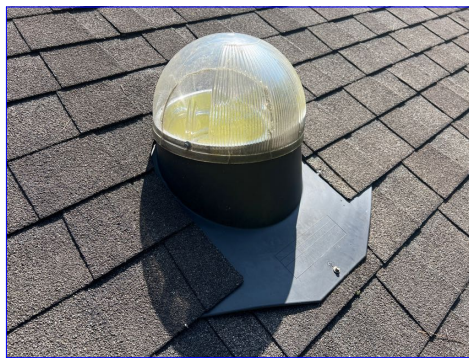
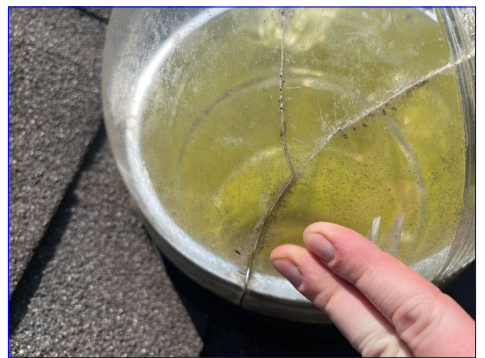
- Damaged/cracked skylight noted. Recommend repair/replacement as needed to prevent moisture intrusion into attic.

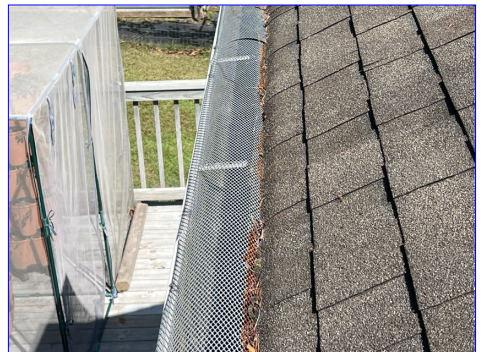
- Buried gutter drains noted.
- Drain extensions and/or splash blocks are disconnected or improperly installed. Recommend correction as needed.

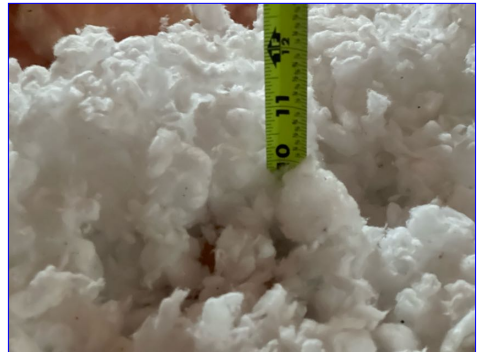
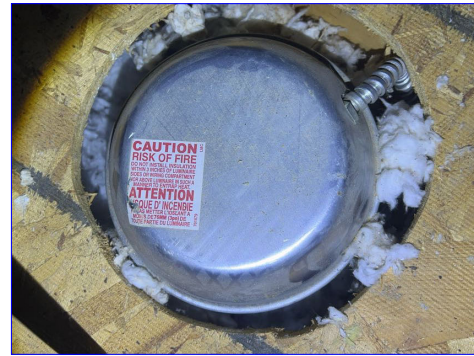
- "Tunneling" noted in attic insulation. This indicates current or past presence of pests in attic. No structural damage is visible at this time.
- Insulation is missing in various areas of attic. Recommend adding insulation where needed.
- Insulation in close proximity to older incandescent can lights in attic. Recommend proper clearance per manufacturer requirements.

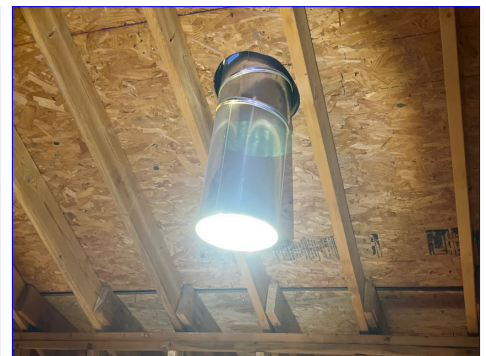
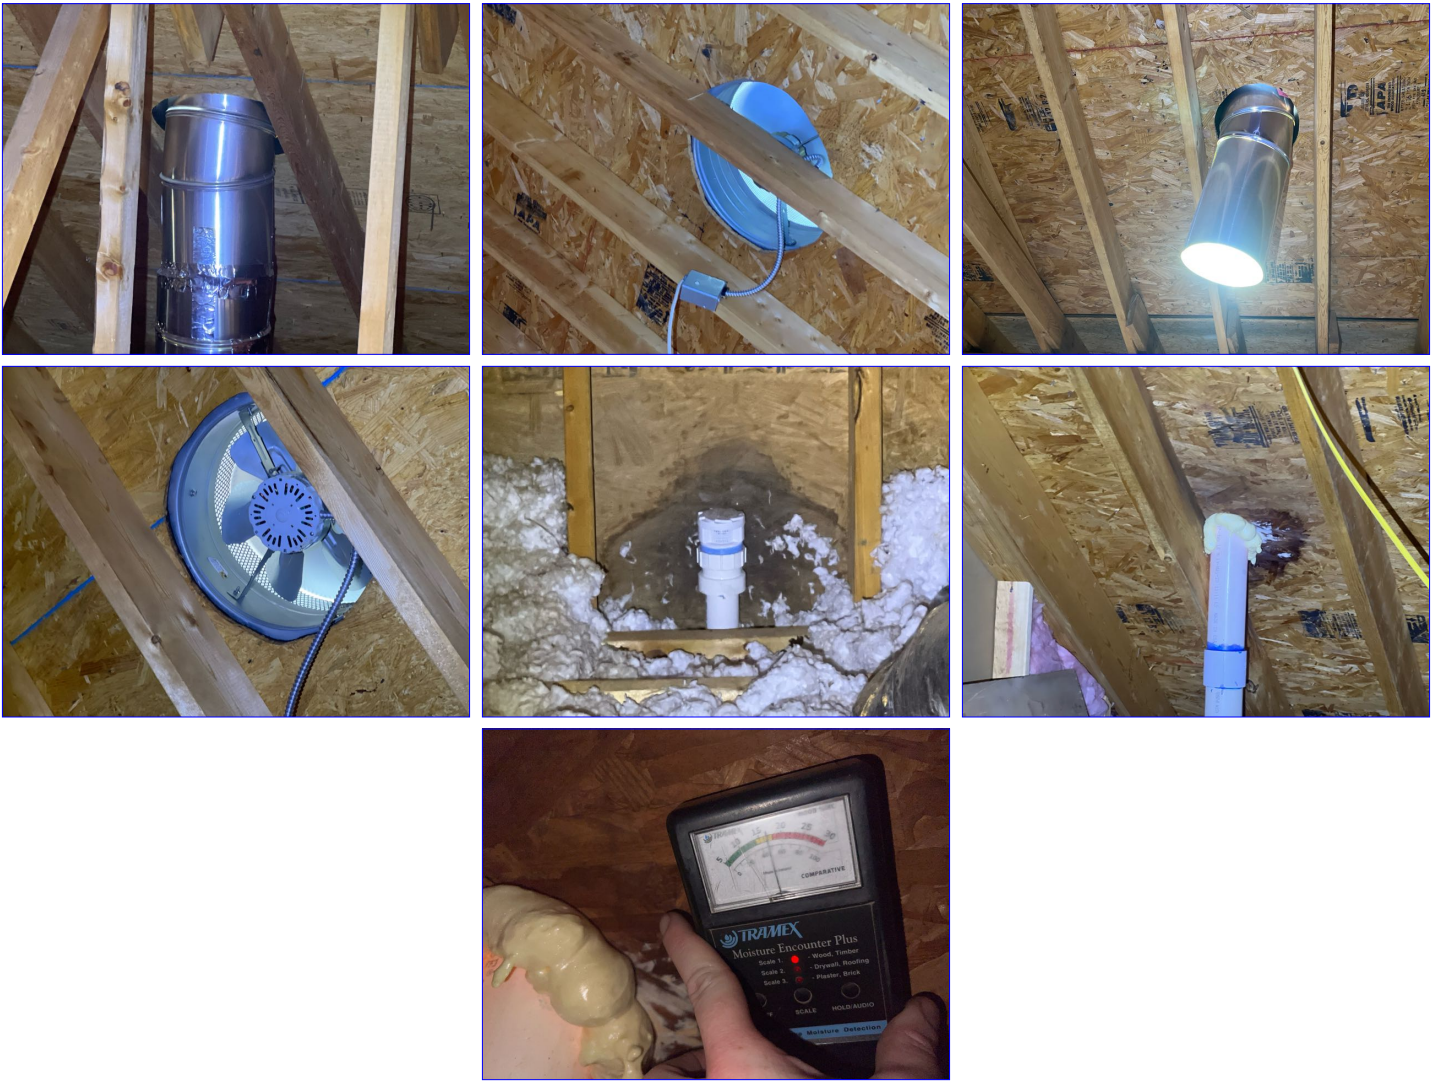
Observations:
 • Plumbing vent pipes terminate in the attic with Studer valve that appears to be leaking. Recommend venting plumbing vent lines through roof to exterior of structure to prevent possible gas backup into attic.
 • High moisture noted around plumbing vents in attic. Recommend repairing or reinstalling plumbing boots as needed.

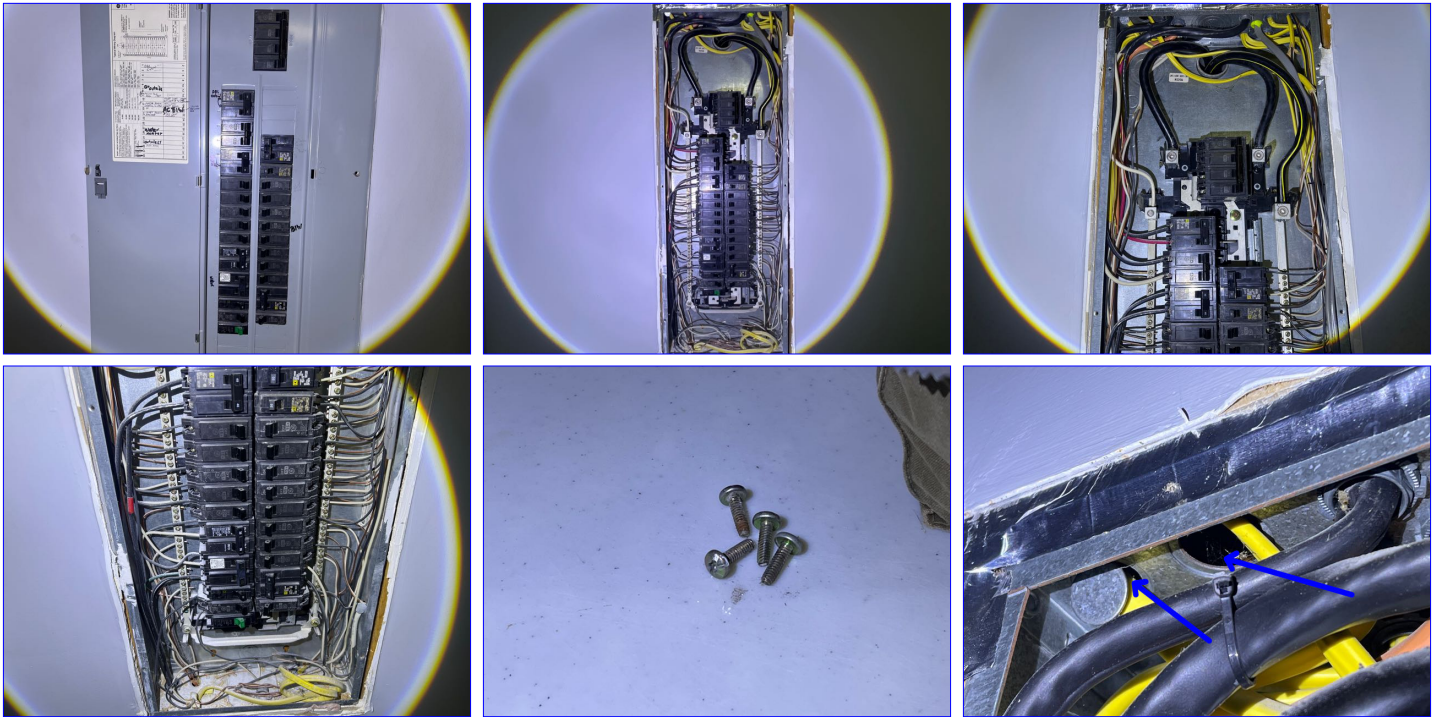
- Service panel missing screws. (Quantity 2) Recommend adding blunt tip screws as needed.
- Bushings missing from around branch wire(s) entering panel box. Recommend adding bushing around grommet to prevent electrical lines from rubbing on sharp metal and be damaged.

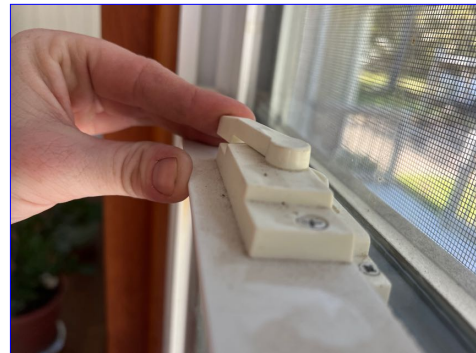
- Various window locks in the structure do not align properly. Recommend adjusting locks or windows for proper operation.

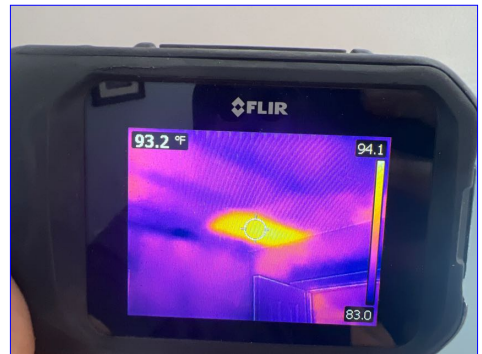
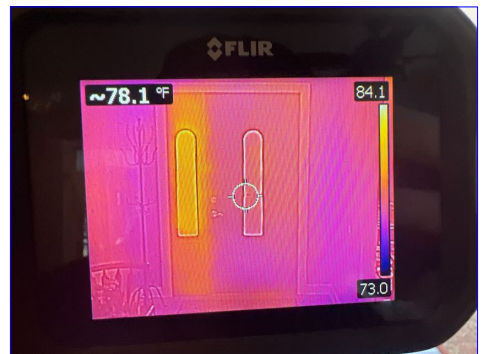
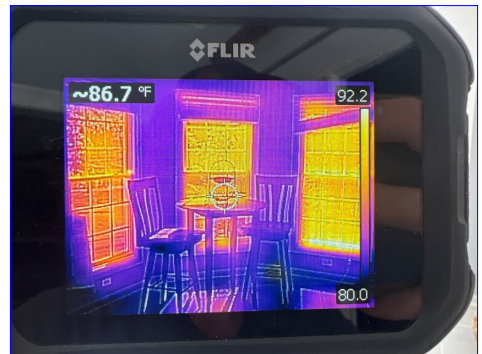
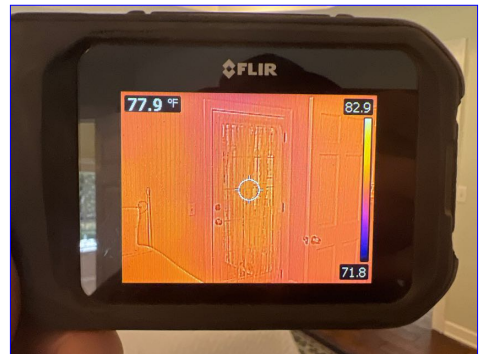
- This thermal scan is not a complete energy scan, it is simply a bonus for our clients. This test may show areas where extra insulation or upgrades to specific items could help with reducing energy costs.
- Thermal scan shows temperature differences at various areas of ceiling. This may indicate low/missing insulation. Recommend adding insulation as needed.

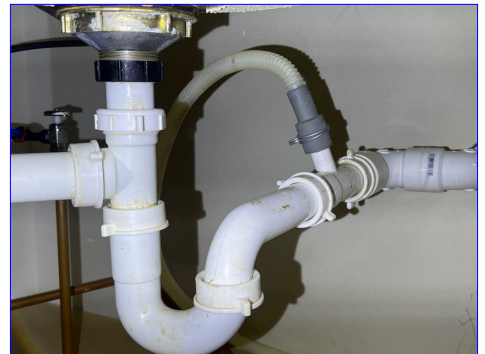
- Dishwasher discharge line is connected downstream of the trap. Recommend installing dishwasher discharge line before trap to prevent gasses from entering house.
- Dishwasher makes irregular noise when operating. Recommend servicing unit as needed.

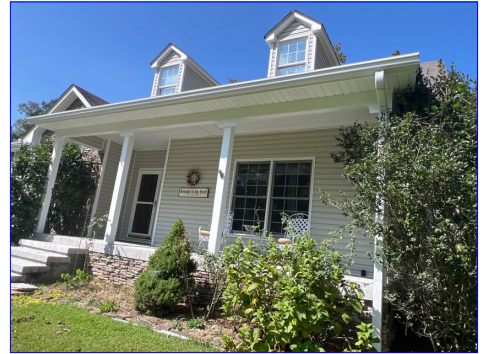
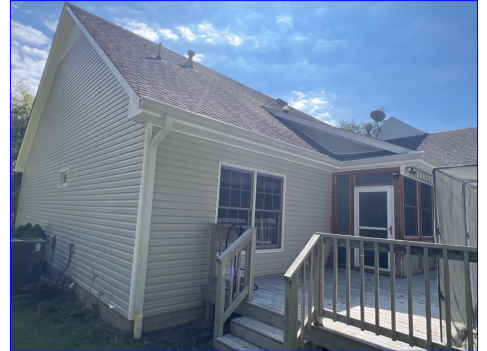
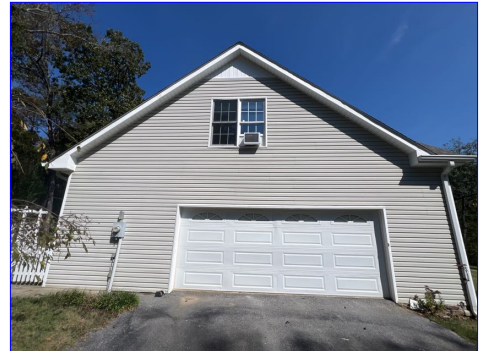
- Exterior siding missing at front porch. Recommend replacing missing siding.

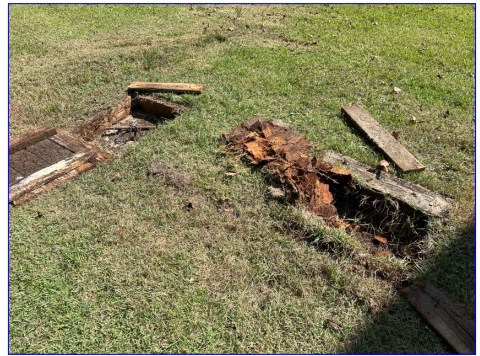
Septic tank lid

- Public water supply meter located at end of driveway near street.
- Sewer/septic system not visible, unable to inspect.
- Damaged covers noted over septic tank. Recommend correction as needed.

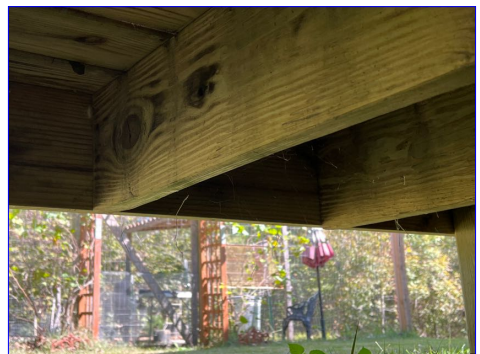
- Deck joists missing joist hangers. Recommend adding joist hangers to deck joists for added support.
- Ledger board (board that is attached to deck and is secured to structure) for deck is missing lag bolts. Recommend adding lag bolts to ledger board.

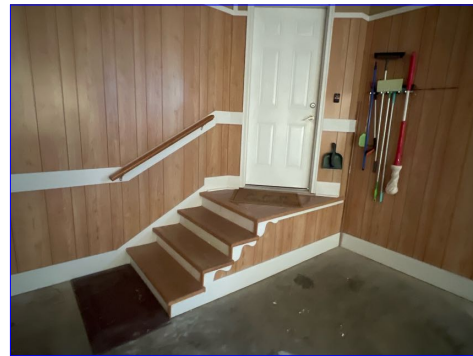
- There were no handrails installed at the steps. Recommend installing handrails on steps that have four or more risers.

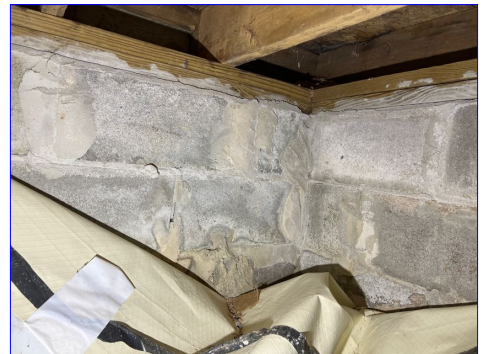
- Silt deposit noted on crawspace floor. This indicates past moisture intrusion into crawspace. Recommend monitoring for moisture intrusion and referring to grounds/grade section for potential corrections.
- Areas of encapsulation have fallen. Recommend correction as needed.

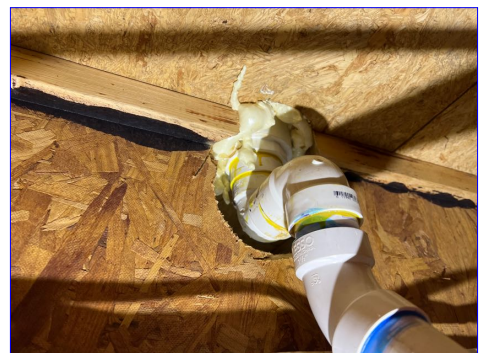
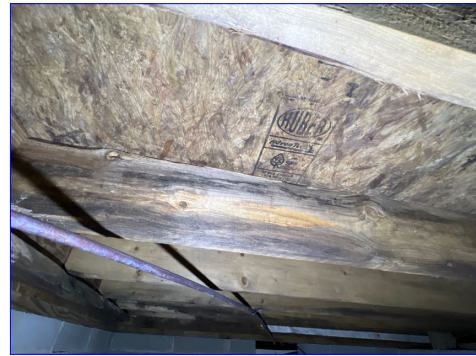
- 2 X 12 engineered I-beams noted.
- Fungal growth noted in areas of crawspace floor structure. Recommend further evaluation and treatment as needed.
- Floor joists have been cut around plumbing lines. Recommend repairing damaged framing members.

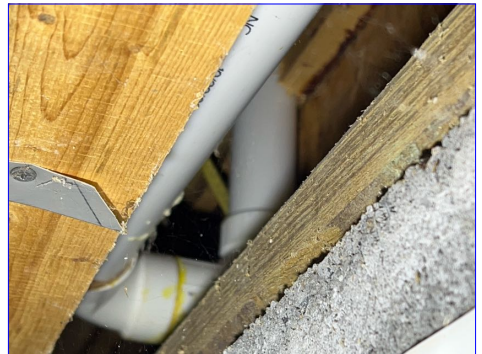
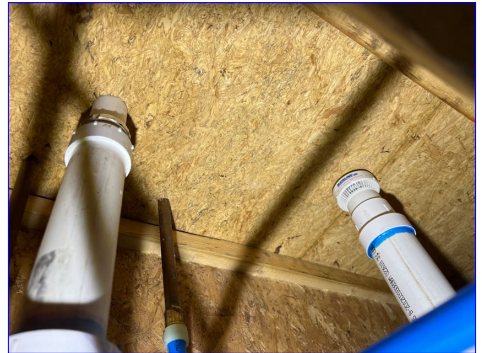
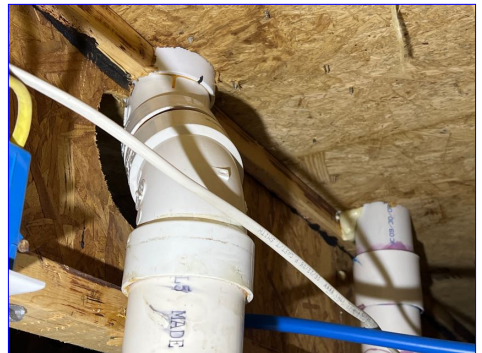
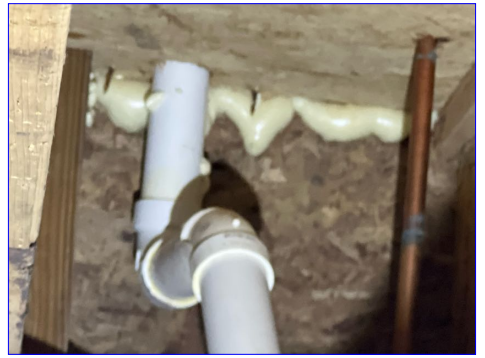
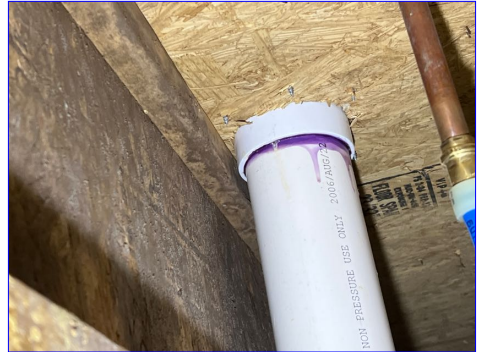
• Water stains noted around plumbing waste lines. This area was tested with a moisture meter and appeared to be dry at this time. Recommend monitoring this area to insure leak is not active.

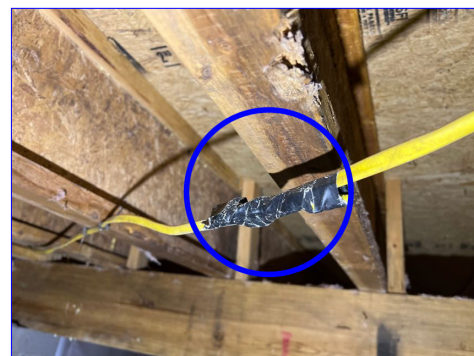
- Exposed electrical wires or splices noted. Recommend all exposed electrical wires be placed into junction boxes with covers.
- Electrical junction boxes missing covers. Recommend adding covers to junction boxes.

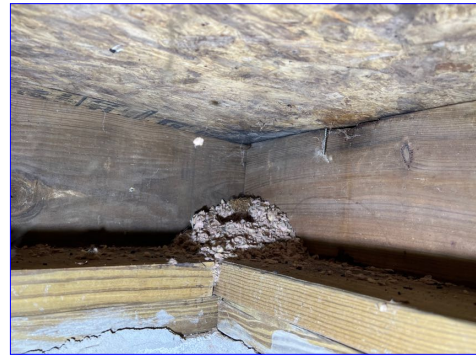
- Evidence of past or present pest intrusion into structure noted.
- Recommend ensuring pests have been removed, access points have been sealed, and any affected materials have been repaired or replaced as needed.

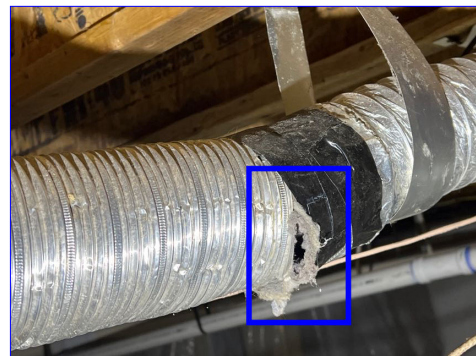
- Damaged dryer vent noted.
- Irregular materials noted for dryer vent. Recommend correction as needed.

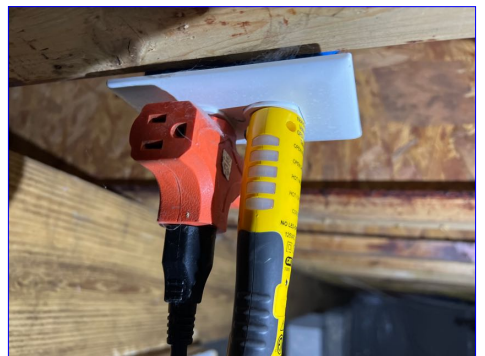
- Inspector had to turn off breaker that was connected to dehumidifier. See bathroom 1 tub section for further details. Recommend correction of whirlpool tub so dehumidifier can properly operate.

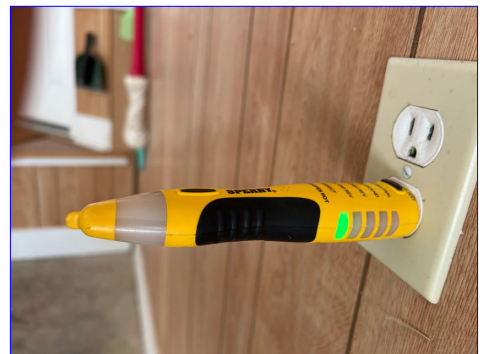
- No GFCI protection in garage. It is recommended that outlets in garage are GFCI protected, however many homes have dedicated outlets in garage that are not GFCI protected to power items such as deep freezers.
- Ungrounded outlets noted in garage and stairwell to upstairs bedroom.

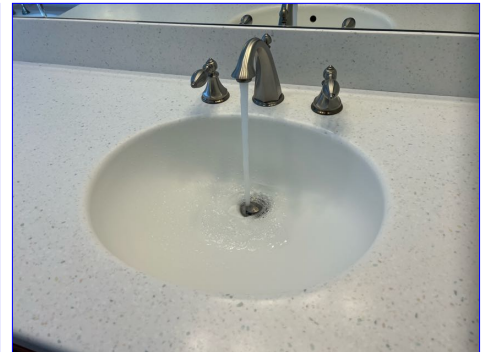
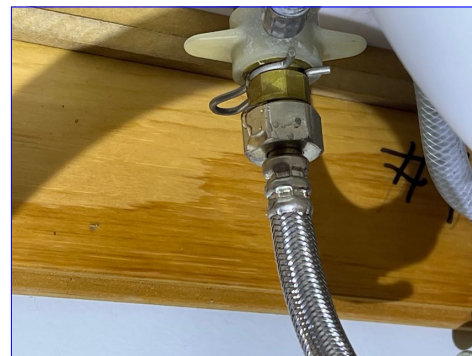
- Leak noted around hot water plumbing connection under right sink. Recommend repairing plumbing connection to prevent leak.

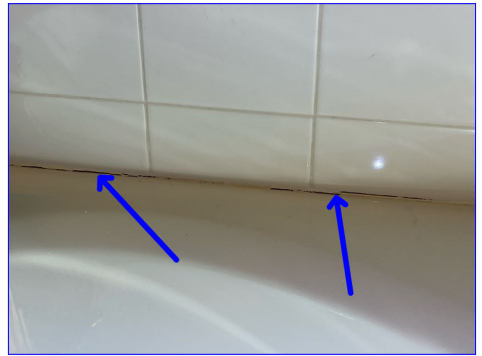
- Whirlpool
- Whirlpool tub was filled and tested. Whirlpool pump would not turn off. Inspector had to turn off breaker. No access to view pump or plumbing lines. Please contact licensed plumber to service tub.
- Tub surround not sealed properly. Recommend adding sealant where needed.

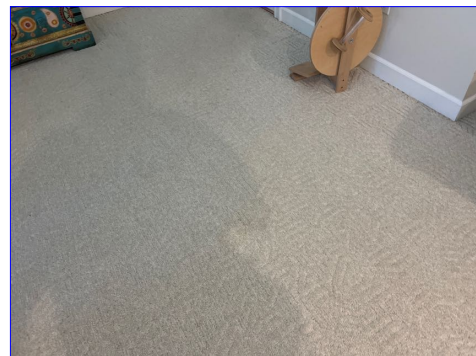
- Loose carpet noted in bedroom.
- Soft flooring noted in bedroom. Recommend correction as needed.

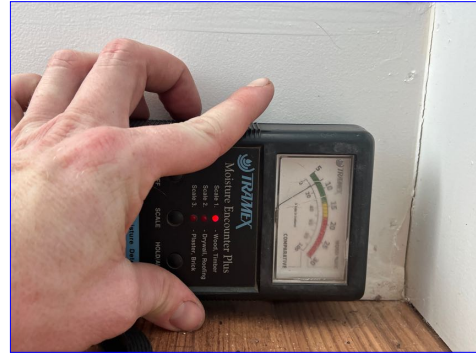
- Moisture staining noted on wall below window. This area tested dry at time of inspection. Recommend monitoring for further moisture intrusion.
