# *Chattanooga Home Inspector LLC*

## Property Inspection Report

123 Home Inspection Way., Chattanooga, TN 37377  
Inspection prepared for: Happy Home Buyer & Sally Sales-a-lot  
Date of Inspection: 1/1/2015 Time: 2:00 PM  
Weather: 74 degrees and sunny.

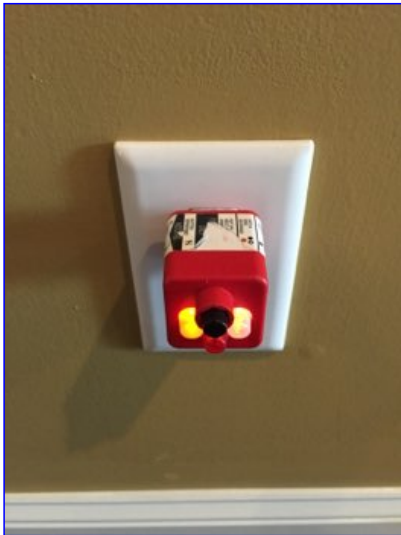
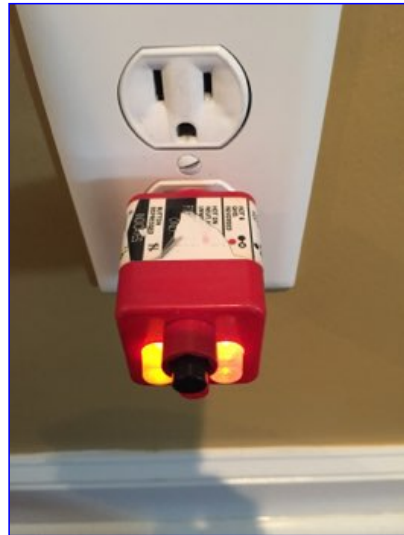
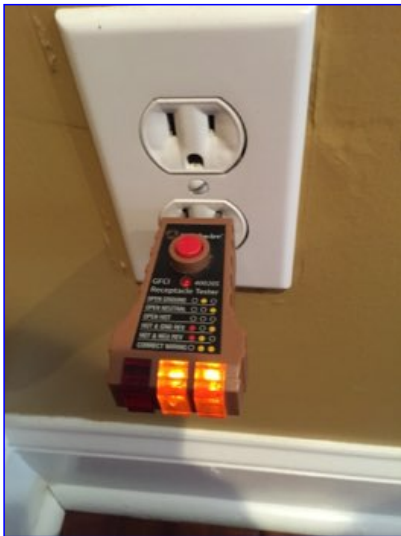
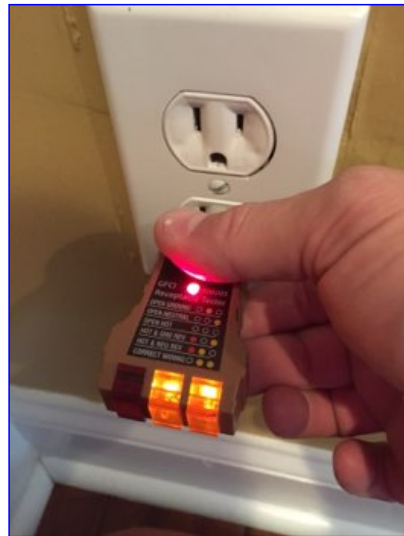
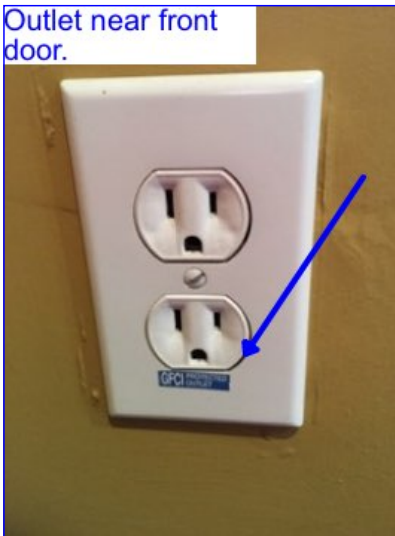
**C. Electrical**

Observations:  
 • A representative number of electrical outlets were tested and wiring appears to be correct. Two amber lights on tester indicate correct wiring.  
 • Outlet near front door is labeled GFCI protected and is not. This outlet is not required to GFCI protected. Recommend removing sticker.

Outlet near front door.

Interior Areas		
Page 4 Item: C	Electrical	<ul style="list-style-type: none"><li>• Outlet near front door is labeled GFCI protected and is not. This outlet is not required to GFCI protected. Recommend removing sticker.</li></ul>
Page 5 Item: F	Stairs & Handrail	<ul style="list-style-type: none"><li>• Landing going downstairs missing handrail. Consider adding handrail.</li></ul>
Exterior Areas		
Page 30 Item: A	Doors	<ul style="list-style-type: none"><li>• Basement door has slight rot around bottom of door. Recommend replacing rotten area.</li></ul>
Page 31 Item: B	Siding Condition	<ul style="list-style-type: none"><li>• Dryer vent broken. Recommend replacing dryer vent.</li></ul>

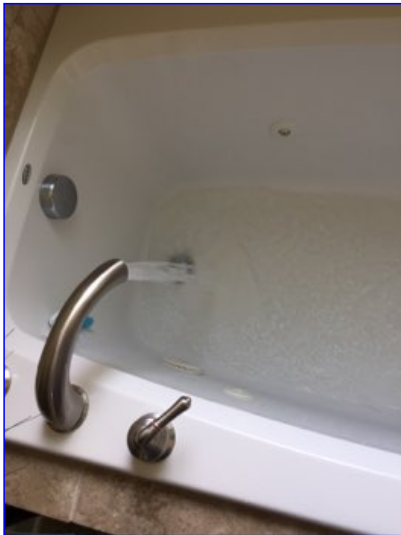
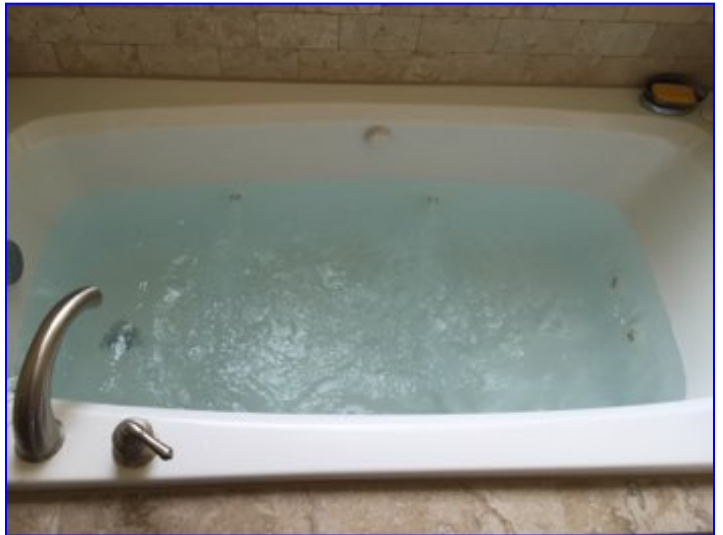
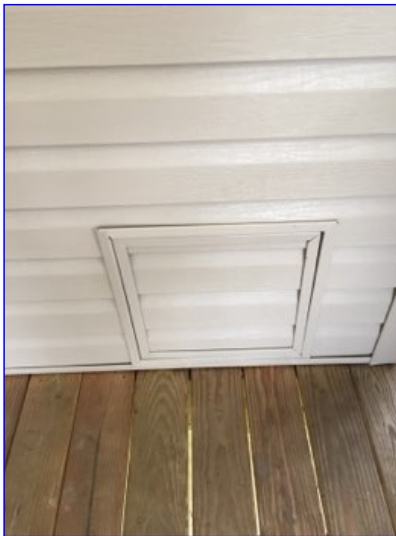
**F. Bath Tubs**

- Whirlpool tub observed. Tub was filled to a level above the water jets and operated to check intake and jets. Tub appeared to operate correctly. Access panel is located outside and is nailed shut, therefore motor, electrical, and plumbing lines were not inspected. If a more detailed report is desired, the client is advised to consult a licensed plumber for a complete review.

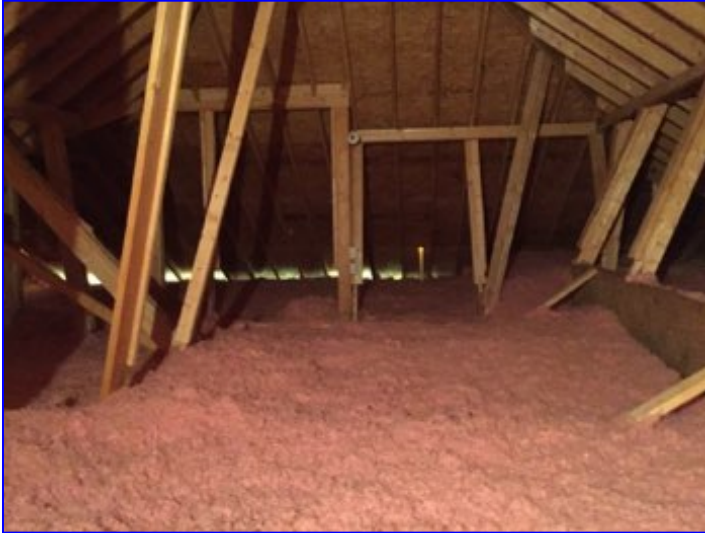
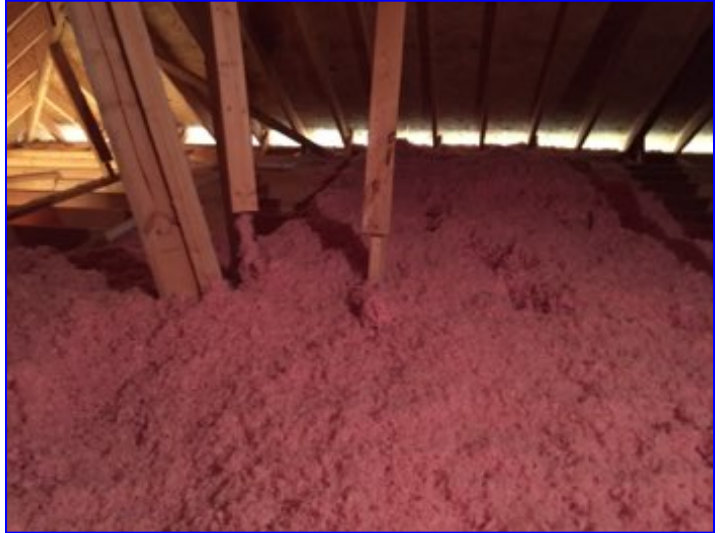
**C. Insulation Condition**

**Materials:** Blown in fiberglass insulation noted.

**Depth:** Average approximate depth of insulation is 13 inches.

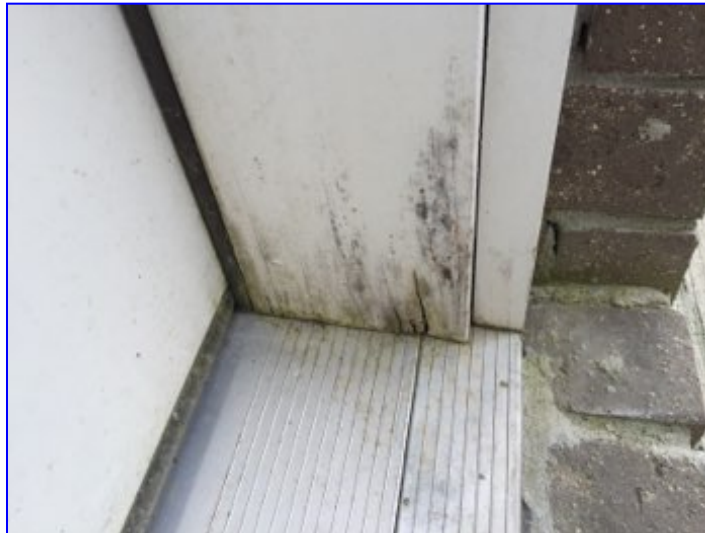
**A. Doors**

- Basement door has slight rot around bottom of door. Recommend replacing rotten area.

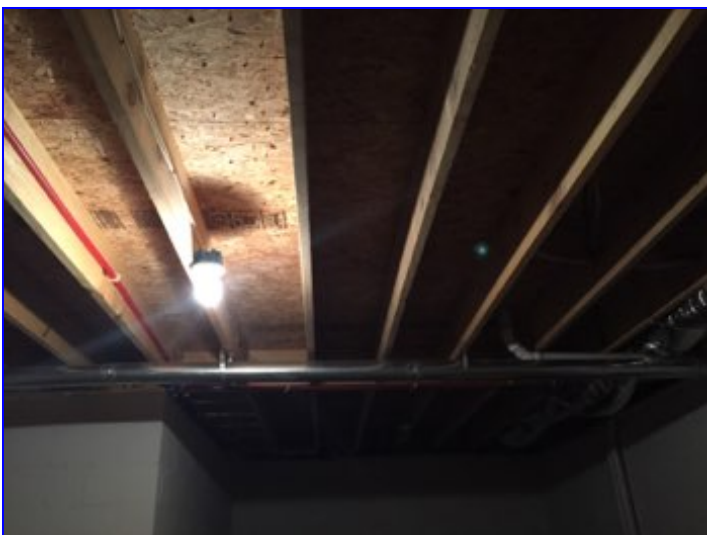
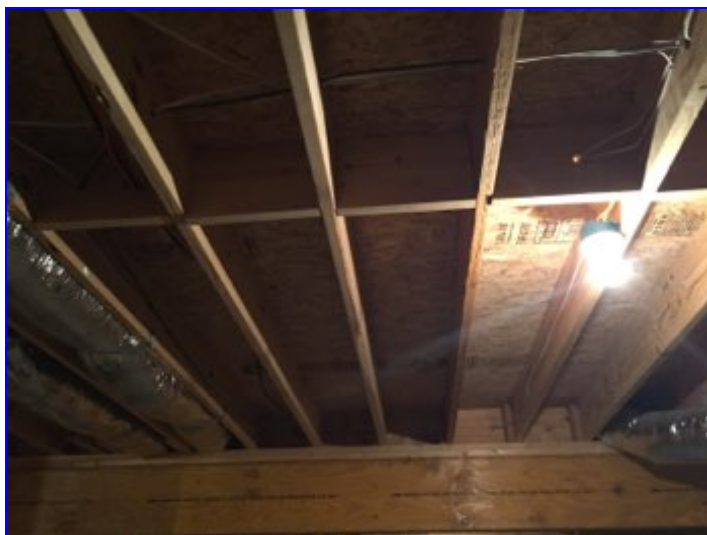
**B. Insulation**

Observations:  
• No insulation found for flooring.
