PROPERTY INSPECTION **REPORT**

2404 Cave Springs Rd, Rising Fawn, GA 30738

DATE OF INSPECTION: 10/8/2024

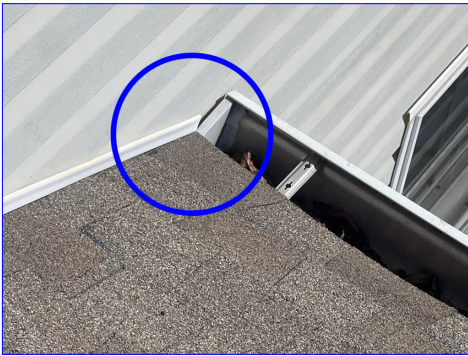
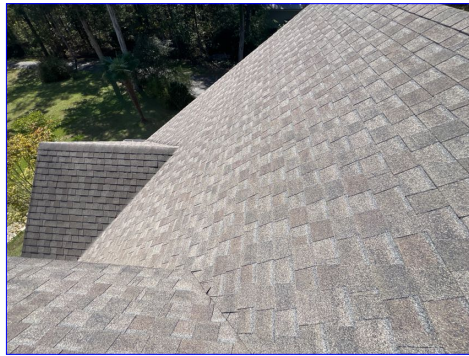
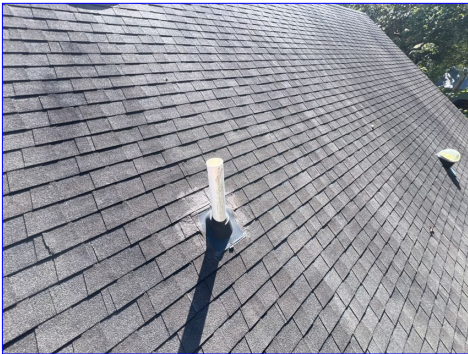
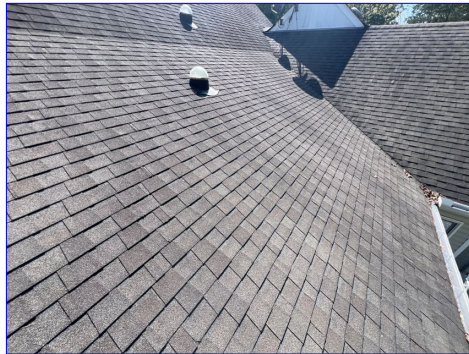
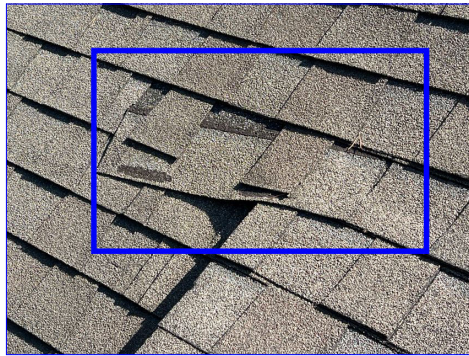
- Pictures and arrows may not represent all damaged surfaces. Recommend a licensed professional ensure all damaged areas be repaired properly.
- Loose shingles noted on roof. Recommend to properly reattach or replace shingles.
- No kick-out flashing noted at areas where the roof meets the structure. Recommend adding kick-out flashing as needed.
- Granule loss, damaged shingles, and/or exposed nails noted on roof. Recommend repairing as needed.

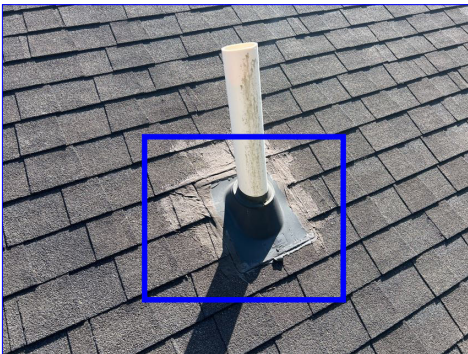
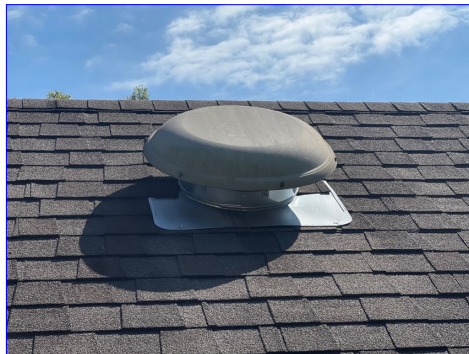
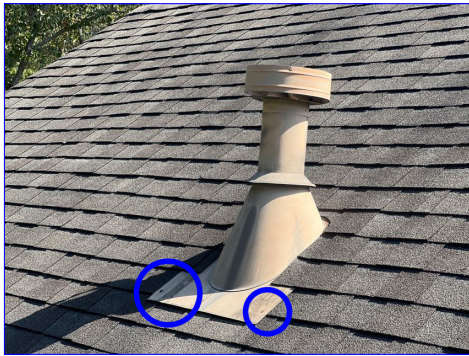
B. Condition

- Improperly installed vent boots noted. Recommend properly installing boots.
- Exposed nails noted on vent boot. Recommend adding roofing grade sealant.

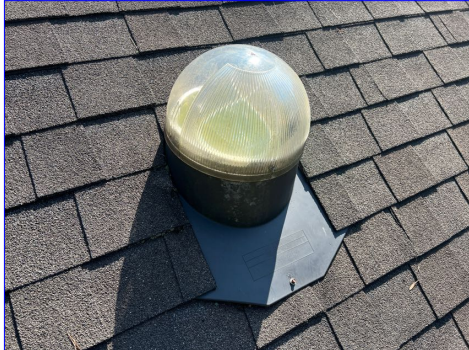
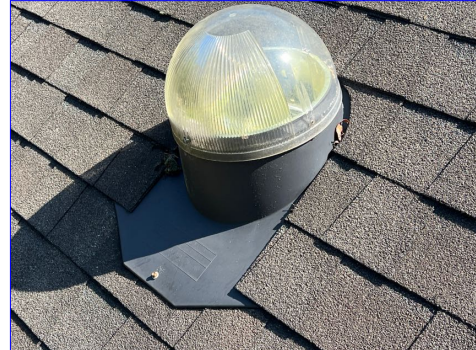
C. Sky Lights

- Damaged/cracked skylight noted. Recommend repair/replacement as needed to prevent moisture intrusion into attic.

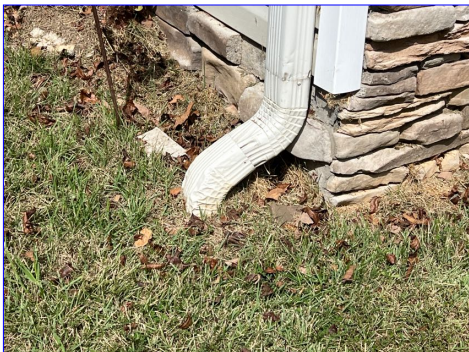
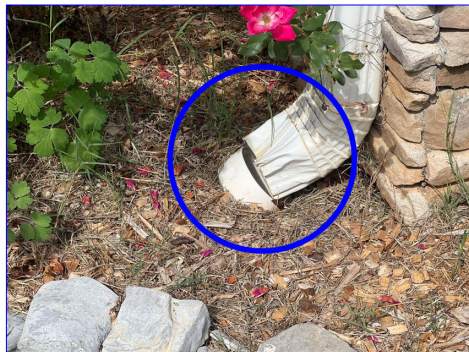
D. Gutters and Downspouts

- Buried gutter drains noted.
- Drain extensions and/or splash blocks are disconnected or improperly installed. Recommend correction as needed.

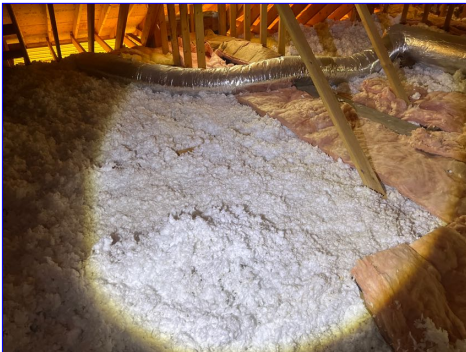
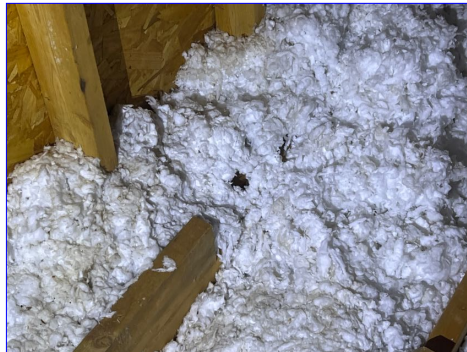
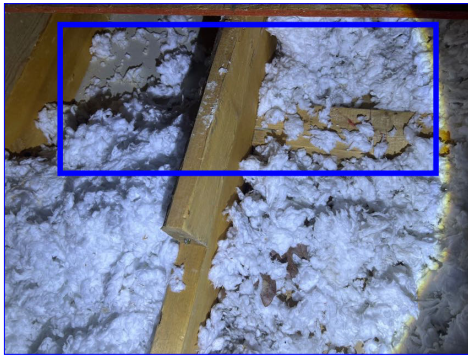
- "Tunneling" noted in attic insulation. This indicates current or past presence of pests in attic. No structural damage is visible at this time.
- Insulation is missing in various areas of attic. Recommend adding insulation where needed.
- Insulation in close proximity to older incandescent can lights in attic. Recommend proper clearance per manufacturer requirements.

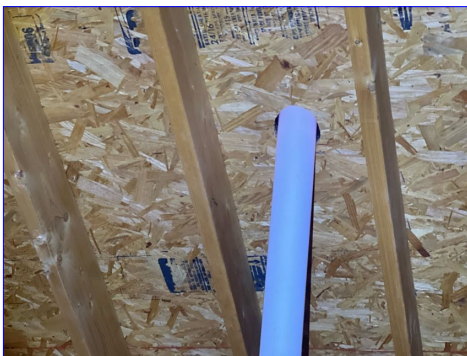
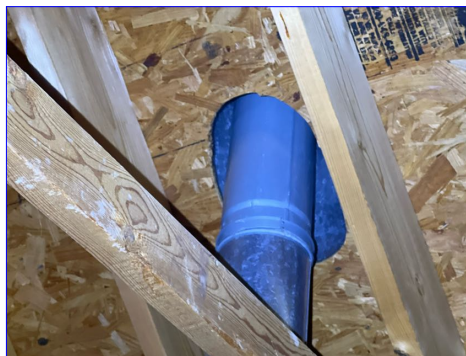
F. Attic Plumbing

Observations:
 • Plumbing vent pipes terminate in the attic with Studer valve that appears to be leaking. Recommend venting plumbing vent lines through roof to exterior of structure to prevent possible gas backup into attic.
 • High moisture noted around plumbing vents in attic. Recommend repairing or reinstalling plumbing boots as needed.

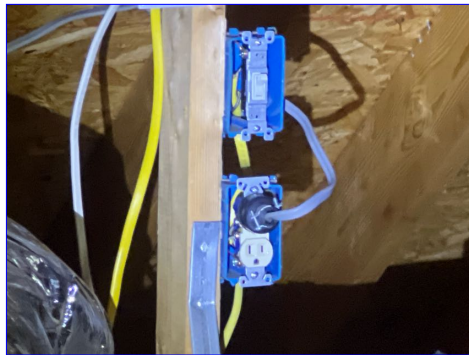
G. Electrical

- Electrical outlet and switch covers are missing. Recommend adding covers as needed.

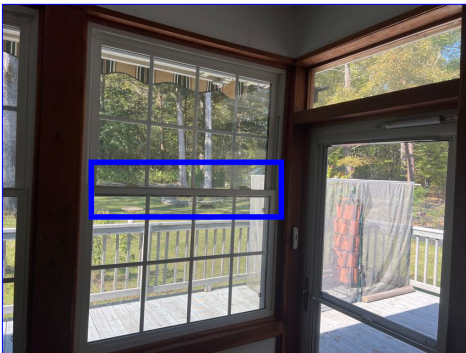
B. Window Condition

- Various window locks in the structure do not align properly. Recommend adjusting locks or windows for proper operation.

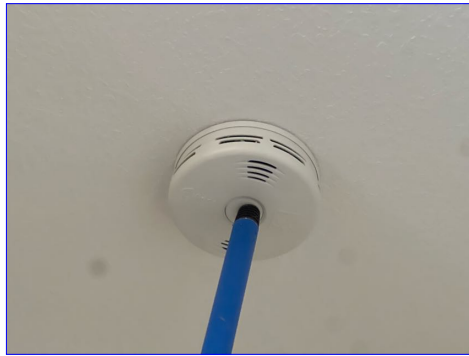
C. Smoke Detectors

- Operated when tested.

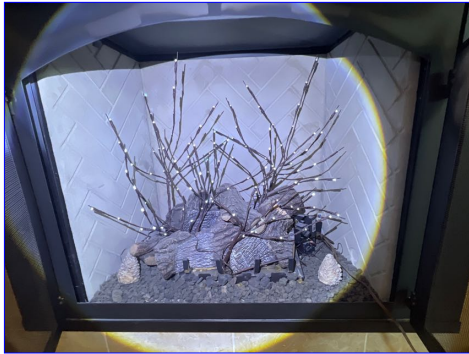
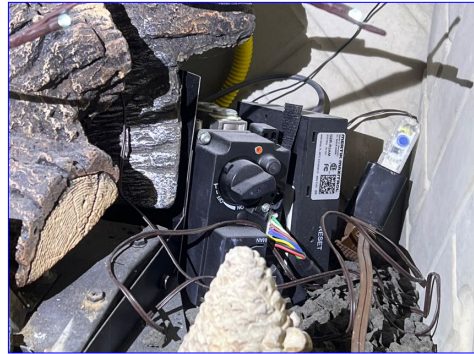
D. Fireplace

- Unable to test gas fireplace due to lights being installed inside firebox.

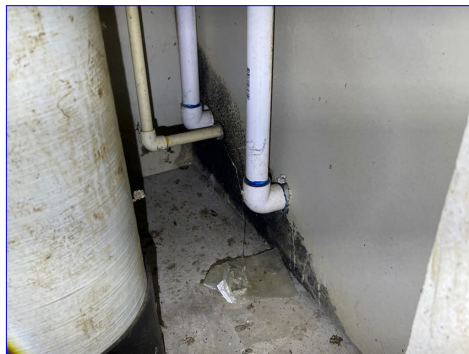
E. Condition

- Fungal growth noted on walls near water filtration system. Recommend further evaluation and treatment as needed.

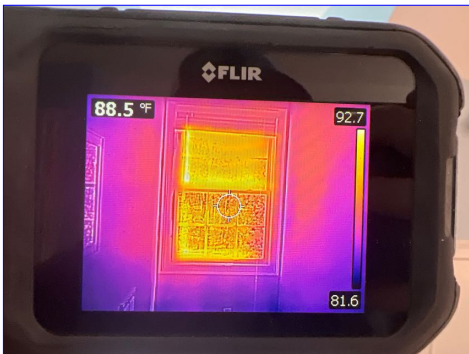
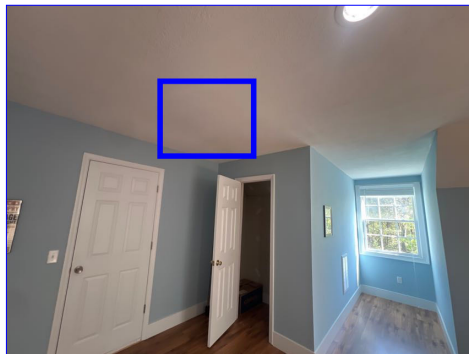
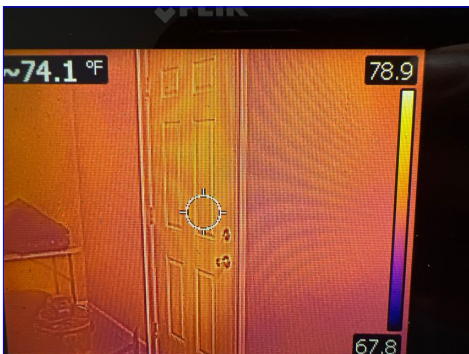
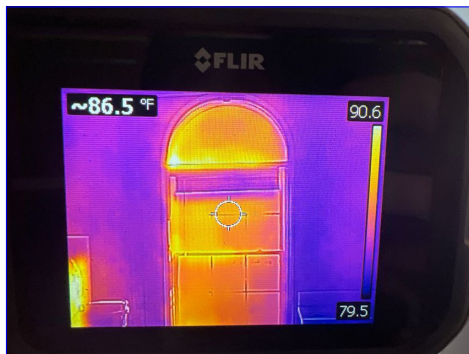
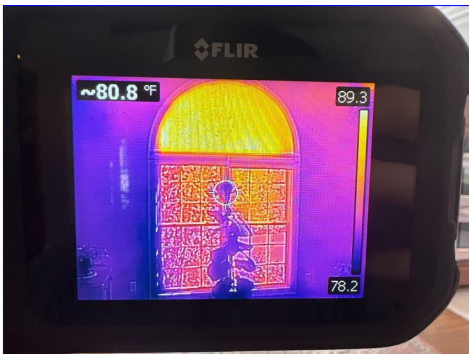
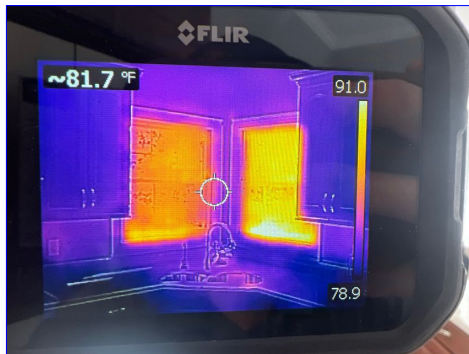
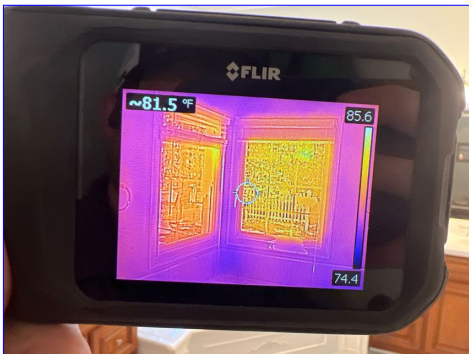
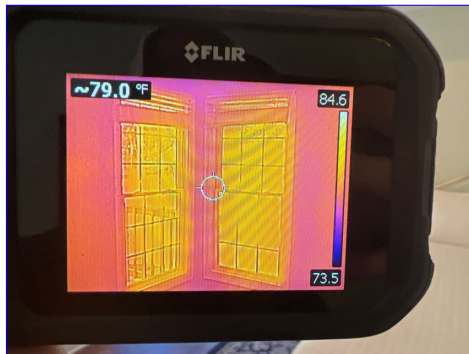
Thermal Scan

- This thermal scan is not a complete energy scan, it is simply a bonus for our clients. This test may show areas where extra insulation or upgrades to specific items could help with reducing energy costs.
- Thermal scan shows temperature differences at various areas of ceiling. This may indicate low/missing insulation. Recommend adding insulation as needed.

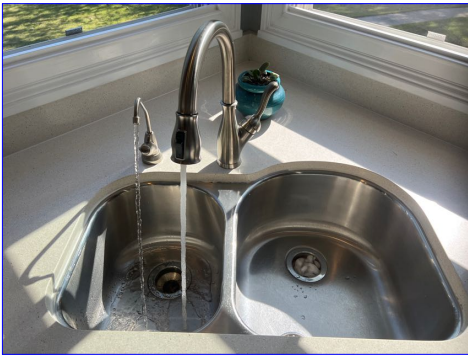
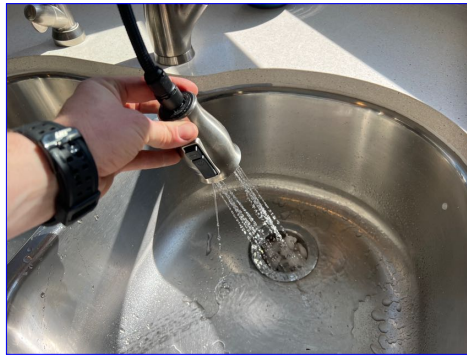
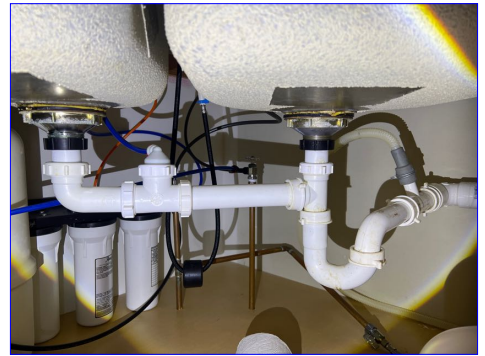
B. Sinks

- Sink operated, tested for flow, drainage, and leaks. Everything appears to function properly.

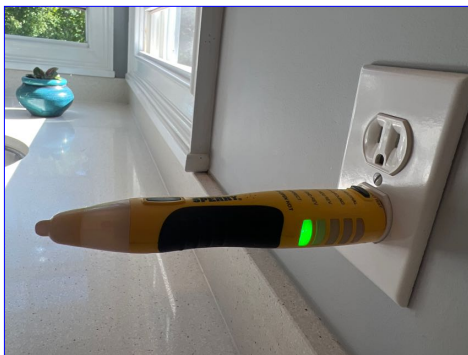
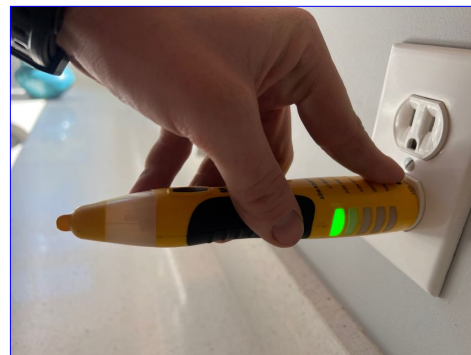
C. GFCI

- No **GFCI** protection present. Recommend installing GFCI outlets for safety.

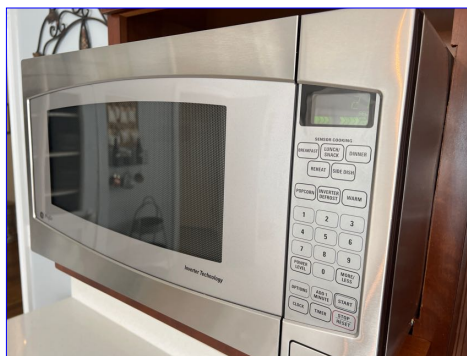
D. Microwave

- Microwave was turned on and appeared to operate correctly, yet temperature difference was unable to be measured.

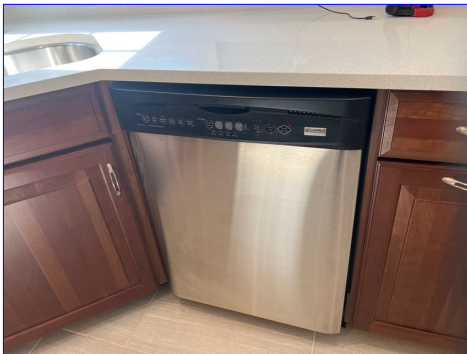
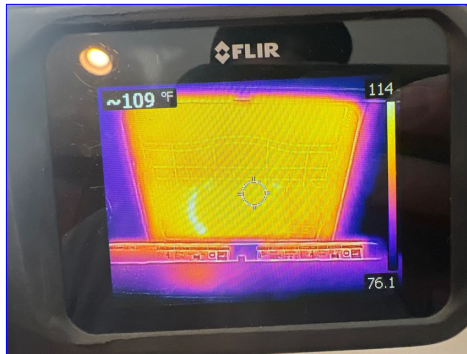
F. Dishwasher

- Dishwasher discharge line is connected downstream of the trap. Recommend installing dishwasher discharge line before trap to prevent gasses from entering house.
- Dishwasher makes irregular noise when operating. Recommend servicing unit as needed.

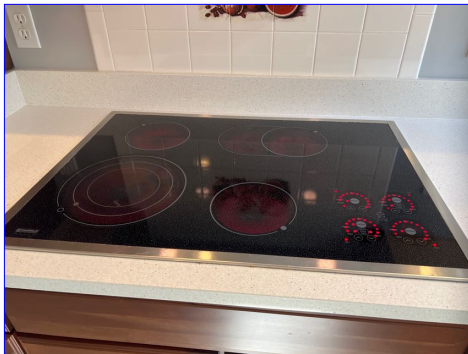
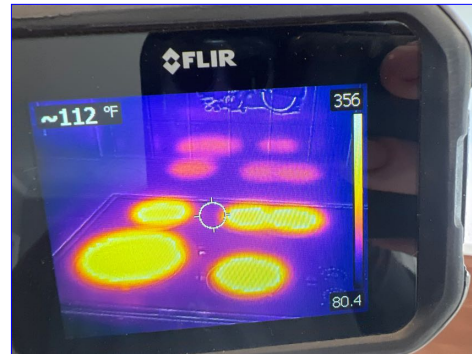
G. Cook top condition

- Electric cook top noted.
- All heating elements appeared to operate correctly at time of inspection.

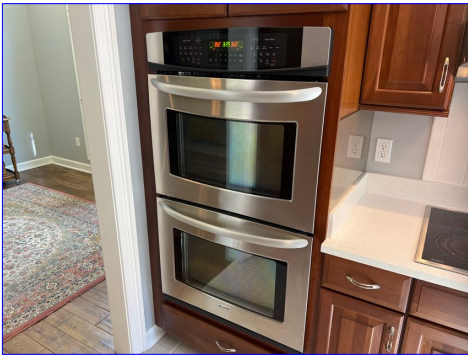
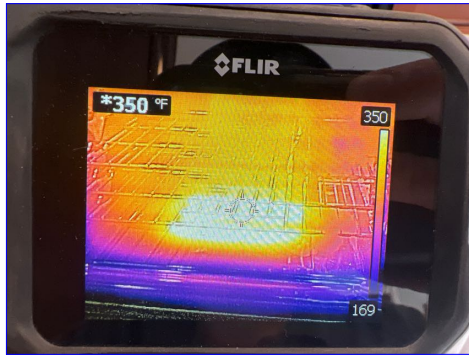
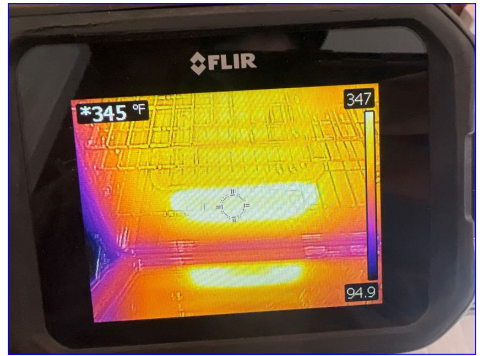
H. Oven & Range

- Oven: Electric radiant heating coils.
- Oven was tested and appeared to operate correctly at time of inspection.

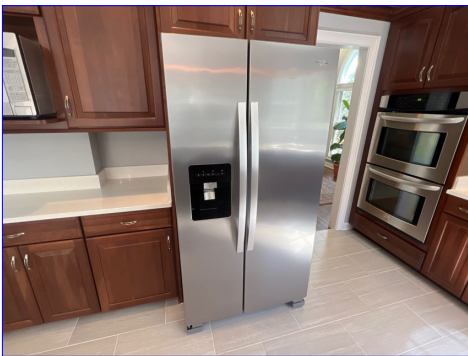
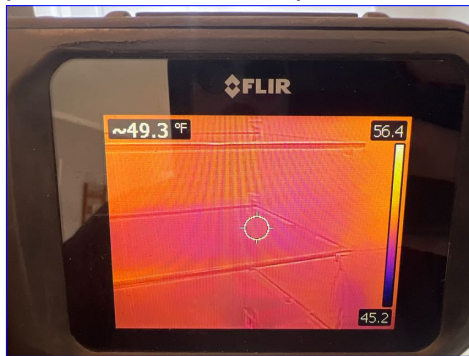
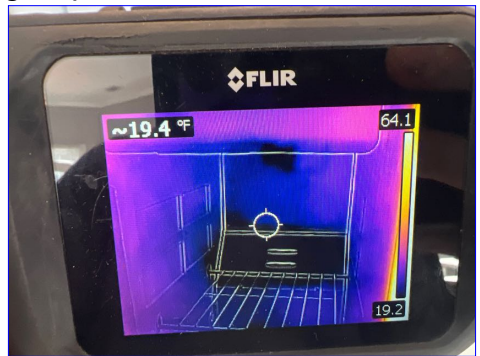
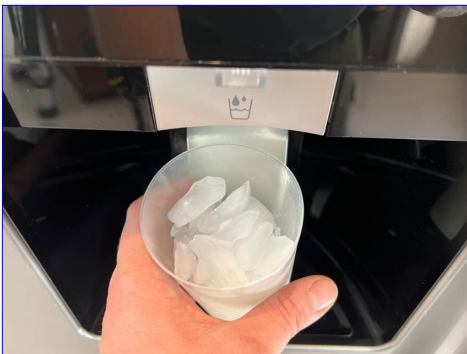
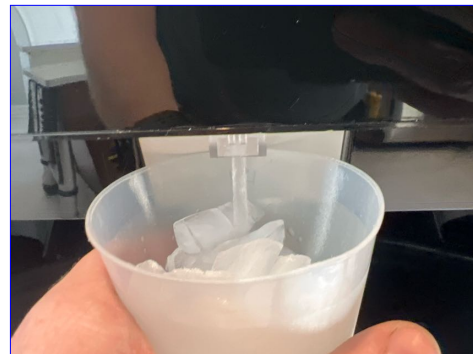
I. Refrigerator Condition

- Refrigerator was on and appeared to operate correctly at time of inspection.
- Water dispenser / ice maker operable during inspection.

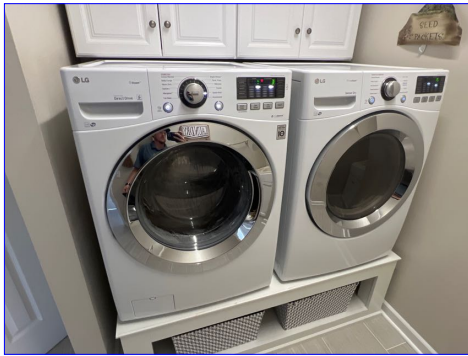
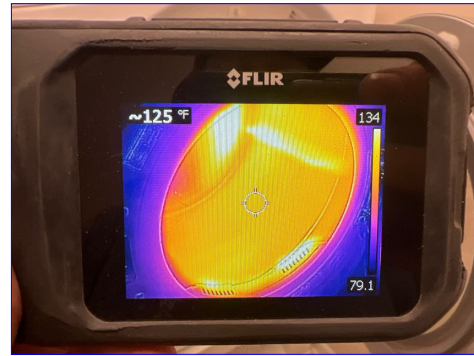
A. Washer and Dryer

- Washer and dryer were operated on short cycle and appeared to operate properly.

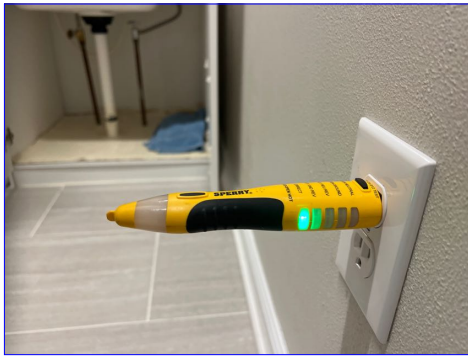
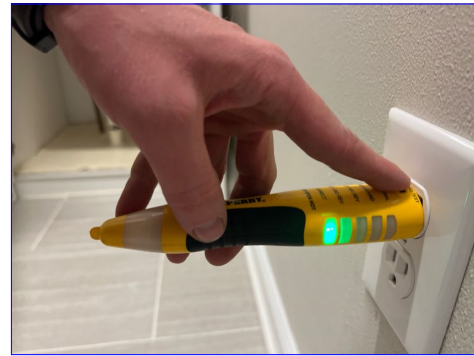
B. GFCI

• GFCI protected receptacles may not have been required when the house was built. We suggest buyer consider upgrading with GFCI's at all receptacles near water sources.

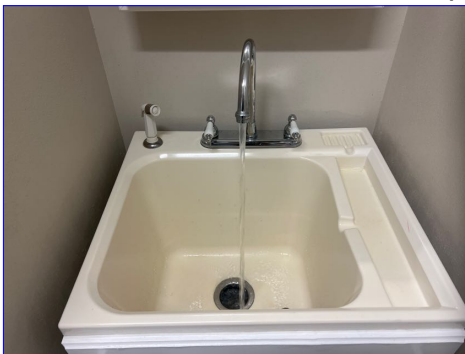
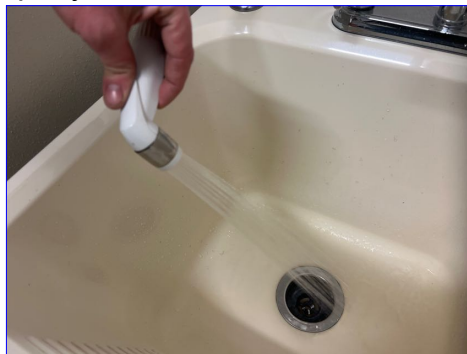
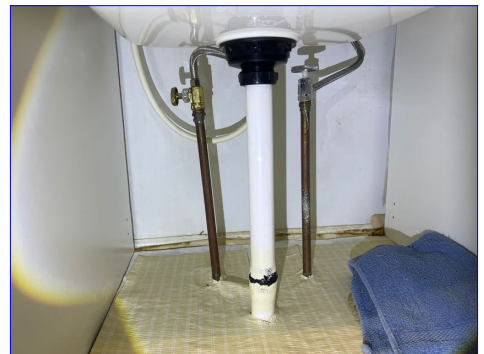
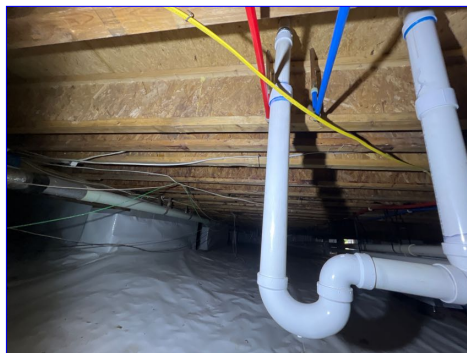
C. Wash Basin

• Sink operated, tested for flow, drainage, and leaks. Everything appears to function properly.

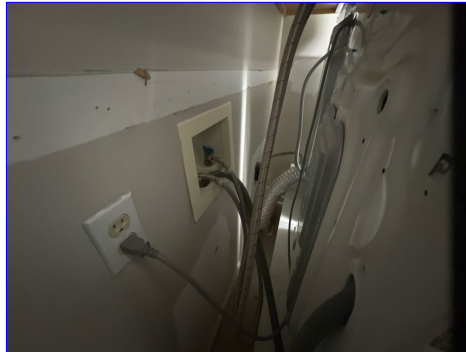
D. Plumbing

- Unable to inspect due to cabinet design, inaccessible.

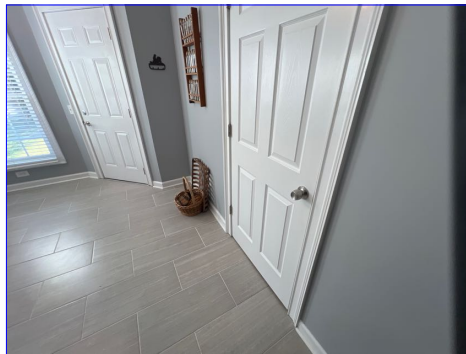
E. Doors

- Door doesn't latch properly.

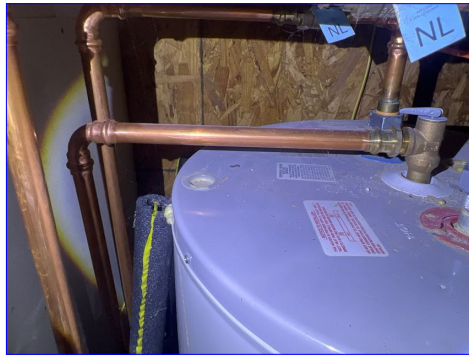
B. TPRV

- Appears to be in satisfactory condition -- no concerns.

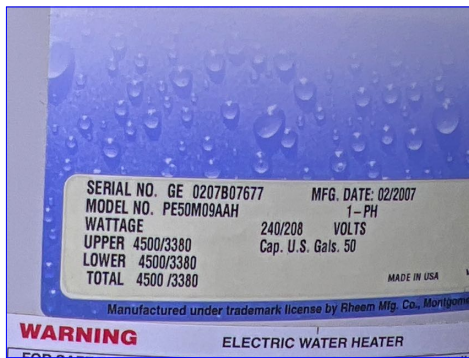
C. Water Heater Age

- Water heater was manufactured in 2007. Average life span for this style water heater is 10-15 years.

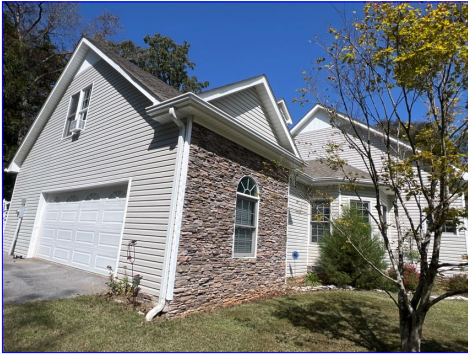
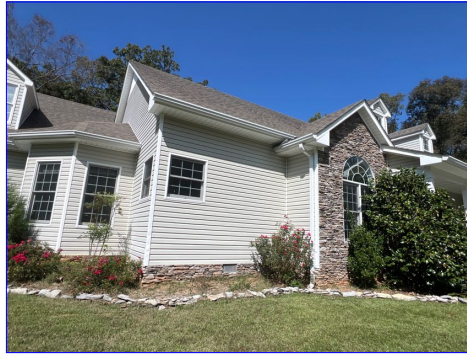
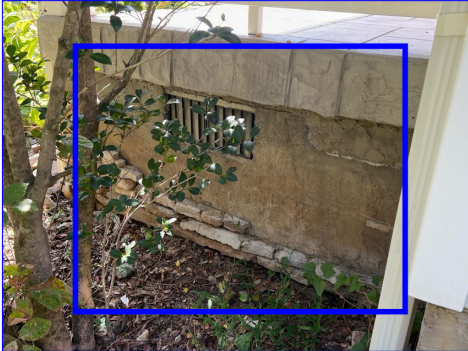
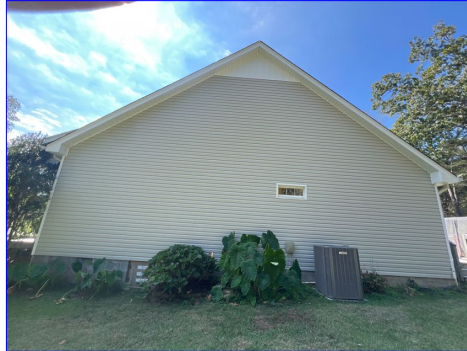
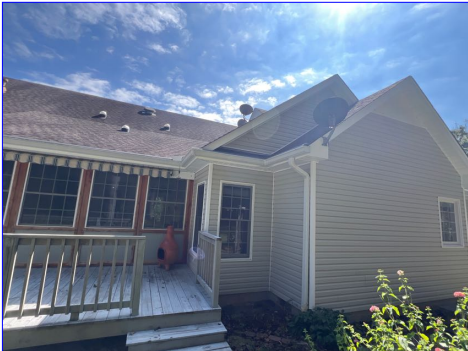
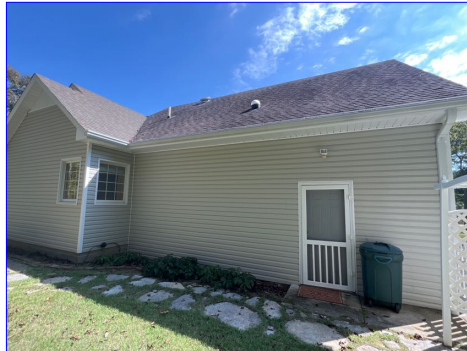
A. Siding Condition

- Exterior siding missing at front porch. Recommend replacing missing siding.

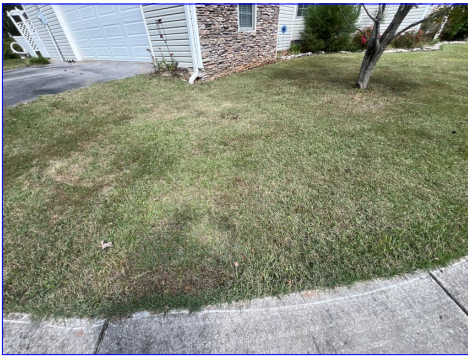
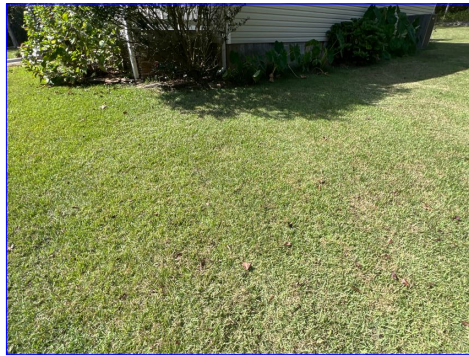
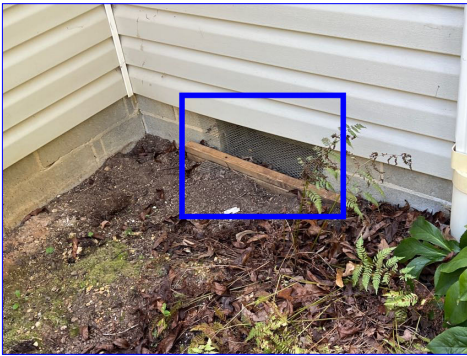
B. Grading

- Crawlspace vents are below grade. Recommend adding window well covers over crawlspace vents that are under grade to prevent water entry into crawlspace.

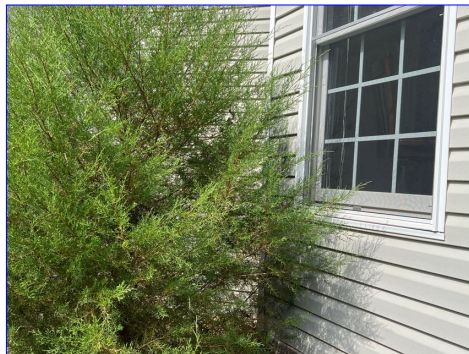
C. Vegetation Observations

- It is recommended to trim all plants and trees that are close to structure to prevent pathways of wood destroying insects.

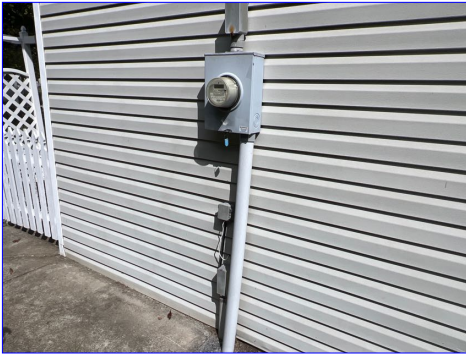
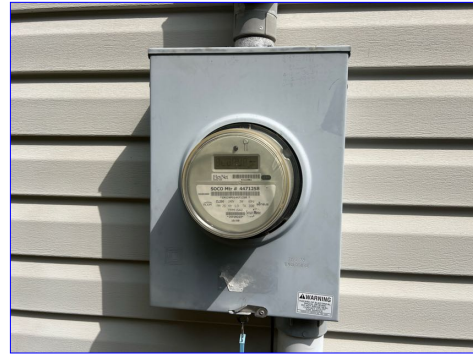
D. Grounds Electrical

- There is an underground service lateral noted.

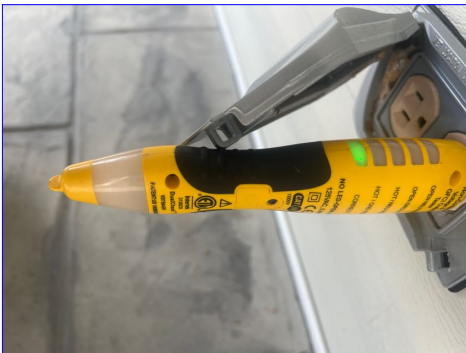
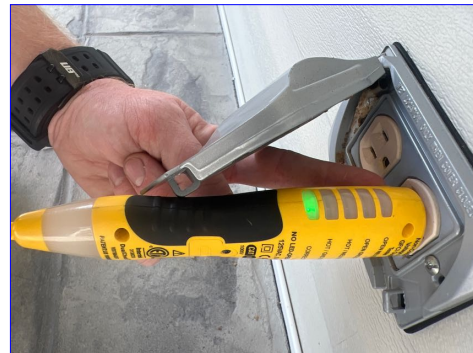
E. GFCI

- Exterior outlets not GFCI protected. Consider replacing outlets with Ground Fault Circuit protection.

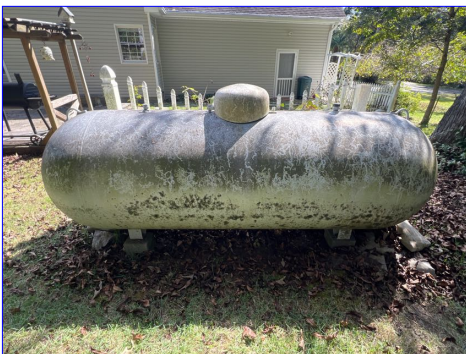
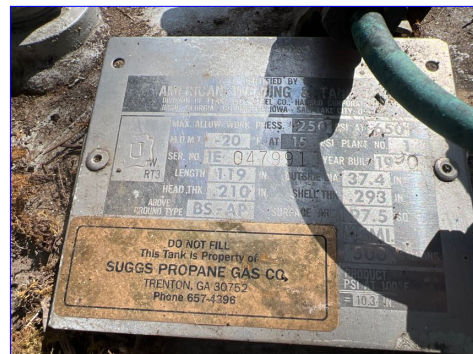
F. Main Gas Valve Condition

- Stand alone propane tank noted.
- 500 gallon propane tank noted.

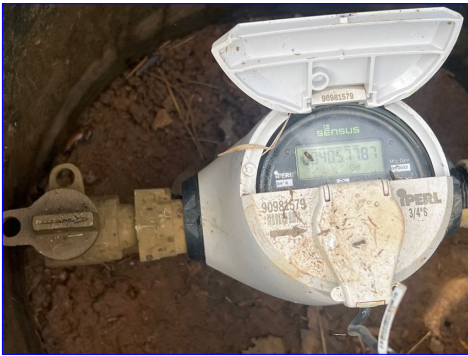
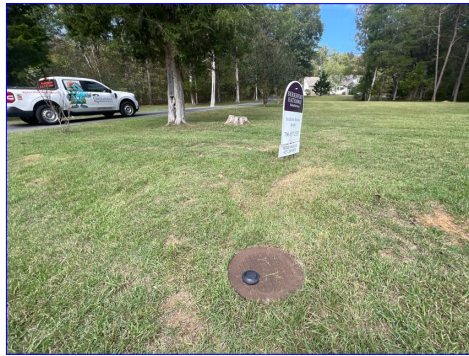
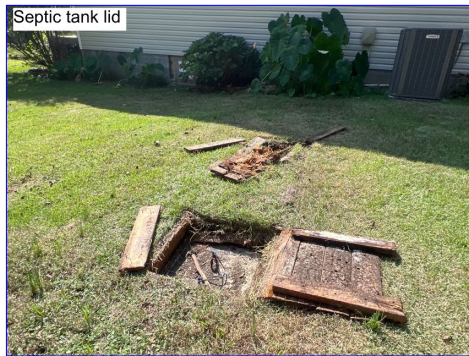
Septic tank lid

- Public water supply meter located at end of driveway near street.
- Sewer/septic system not visible, unable to inspect.
- Damaged covers noted over septic tank. Recommend correction as needed.

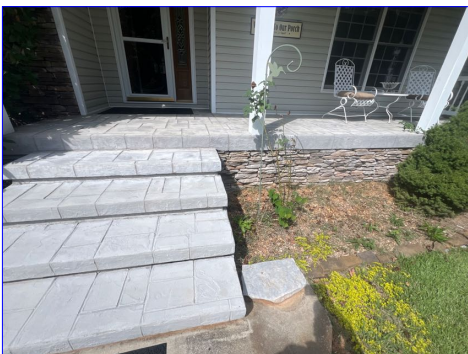
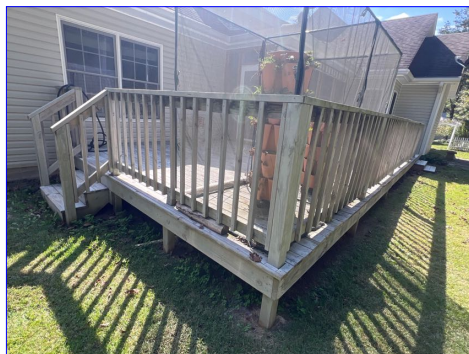
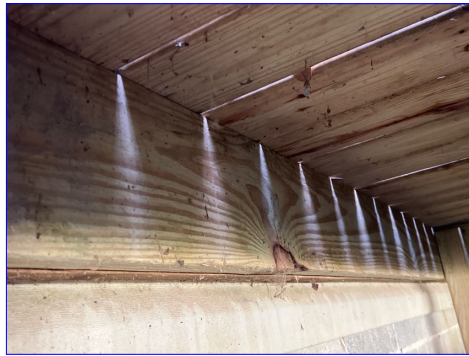
- Deck joists missing joist hangers. Recommend adding joist hangers to deck joists for added support.
- Ledger board (board that is attached to deck and is secured to structure) for deck is missing lag bolts. Recommend adding lag bolts to ledger board.

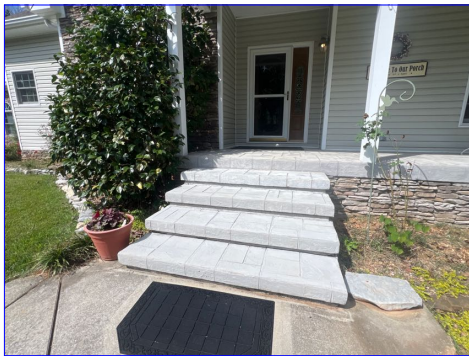
- There were no handrails installed at the steps. Recommend installing handrails on steps that have four or more risers.

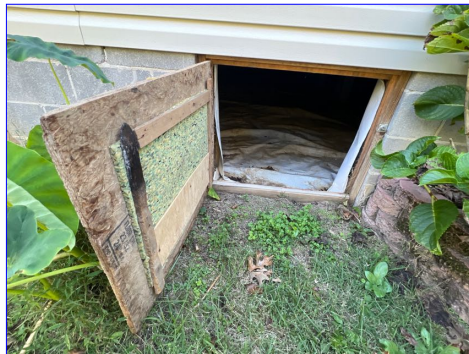
- Crawlspace door noted.
- Inspected from inside crawlspace.
- Crawlspace walls and/or columns were fully encapsulated at time of inspection. Though no evidence of termites was noted, inspector was unable to view all potentially affected areas. Recommend considering treatment as a preventative measure.

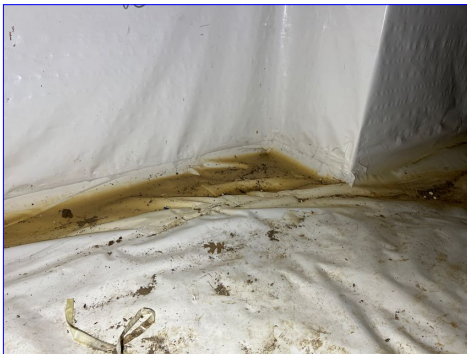
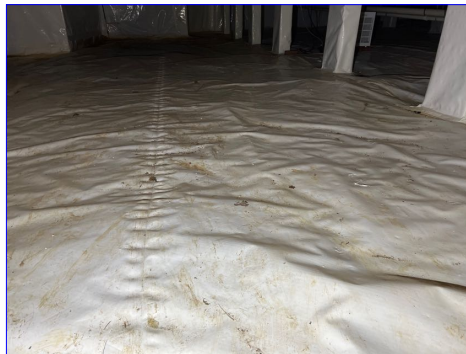
- Silt deposit noted on crawspace floor. This indicates past moisture intrusion into crawspace. Recommend monitoring for moisture intrusion and referring to grounds/grade section for potential corrections.
- Areas of encapsulation have fallen. Recommend correction as needed.

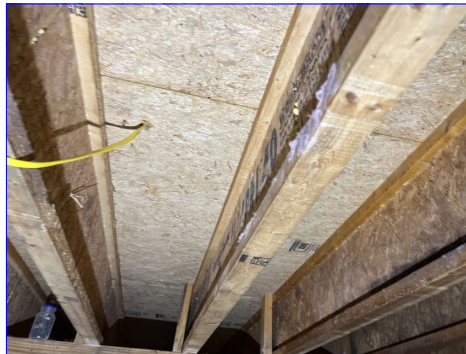
- No insulation found for flooring.

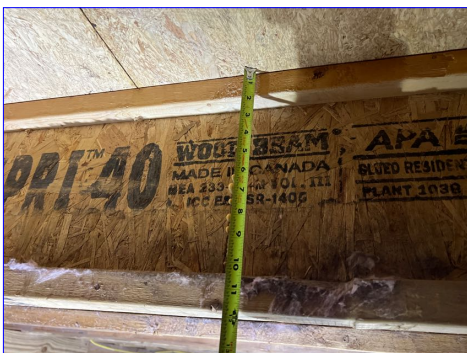
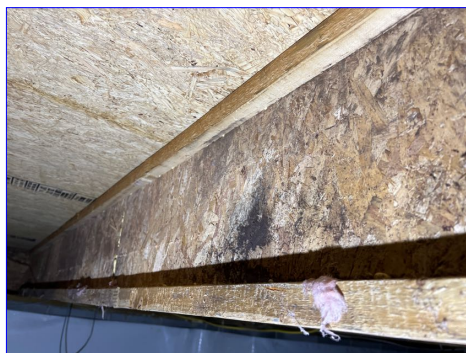
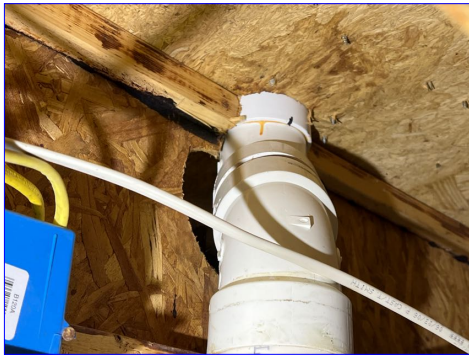
- 2 X 12 engineered I-beams noted.
- Fungal growth noted in areas of crawspace floor structure. Recommend further evaluation and treatment as needed.
- Floor joists have been cut around plumbing lines. Recommend repairing damaged framing members.

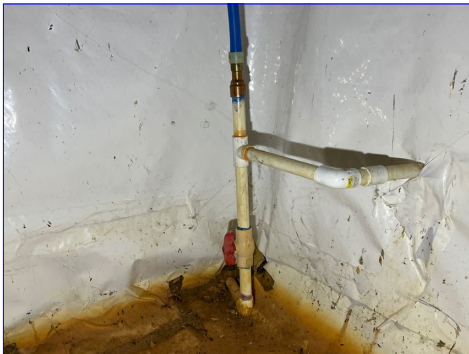
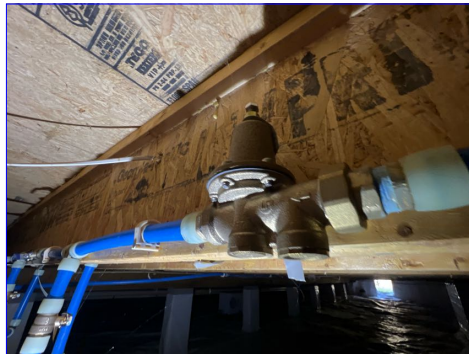
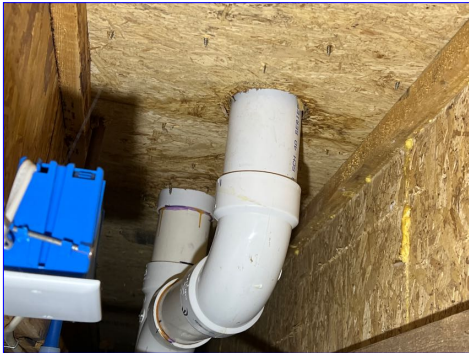
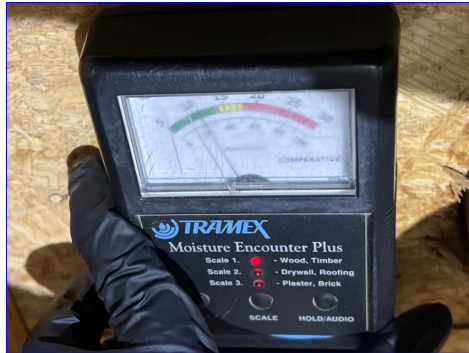
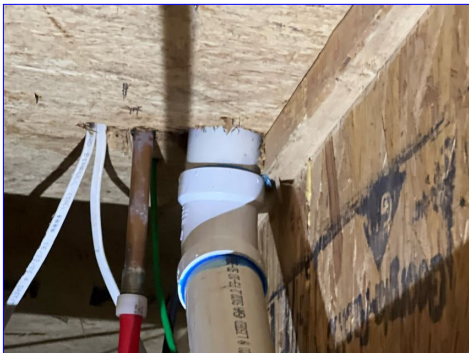
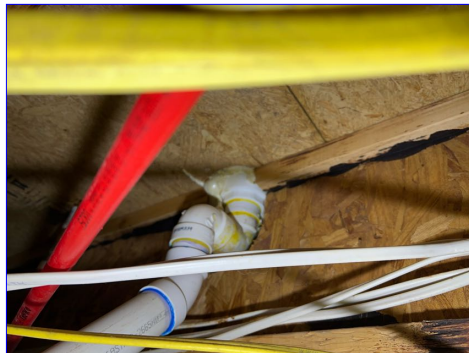
• Water stains noted around plumbing waste lines. This area was tested with a moisture meter and appeared to be dry at this time. Recommend monitoring this area to insure leak is not active.

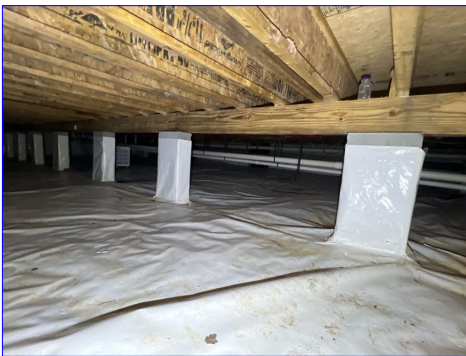
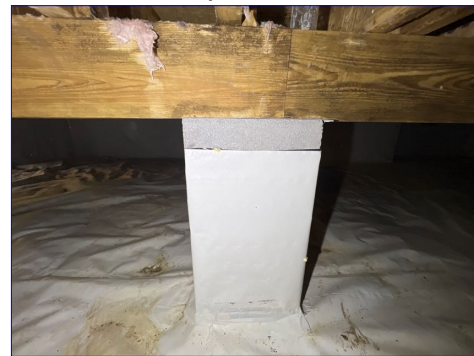
- Concrete block columns noted.
- Columns are finished or concealed, unable to inspect.

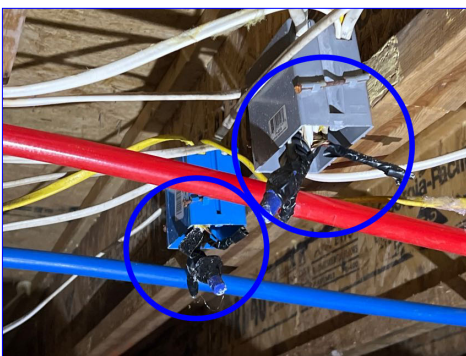
- Exposed electrical wires or splices noted. Recommend all exposed electrical wires be placed into junction boxes with covers.
- Electrical junction boxes missing covers. Recommend adding covers to junction boxes.

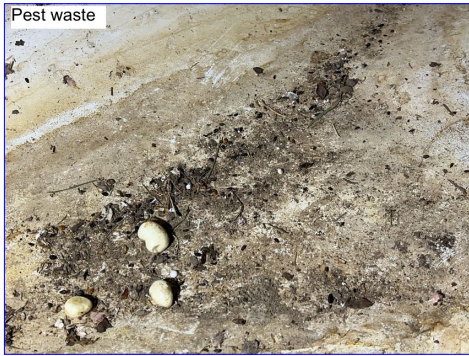
- Evidence of past or present pest intrusion into structure noted.
- Recommend ensuring pests have been removed, access points have been sealed, and any affected materials have been repaired or replaced as needed.

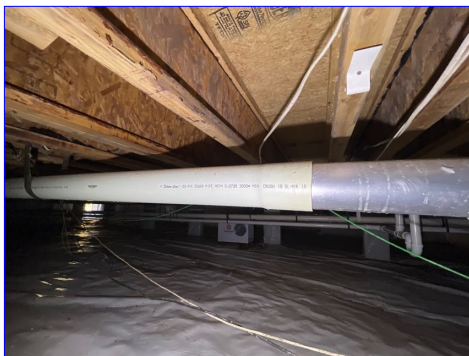
- Damaged dryer vent noted.
- Irregular materials noted for dryer vent. Recommend correction as needed.

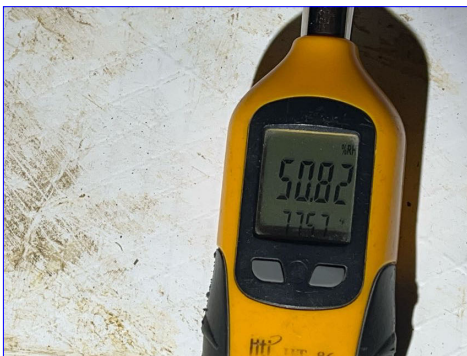
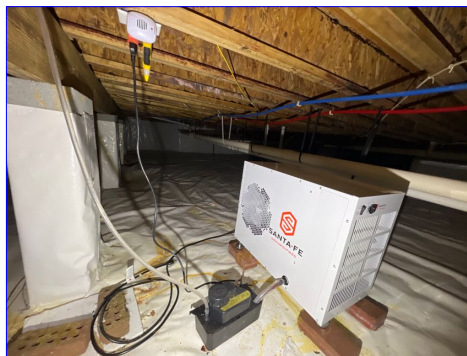
- Inspector had to turn off breaker that was connected to dehumidifier. See bathroom 1 tub section for further details. Recommend correction of whirlpool tub so dehumidifier can properly operate.

- Whirlpool
- Whirlpool tub was filled and tested. Whirlpool pump would not turn off. Inspector had to turn off breaker. No access to view pump or plumbing lines. Please contact licensed plumber to service tub.
- Tub surround not sealed properly. Recommend adding sealant where needed.

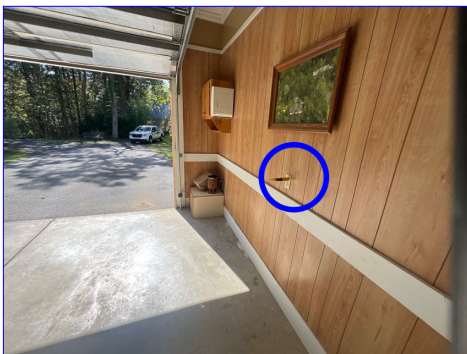
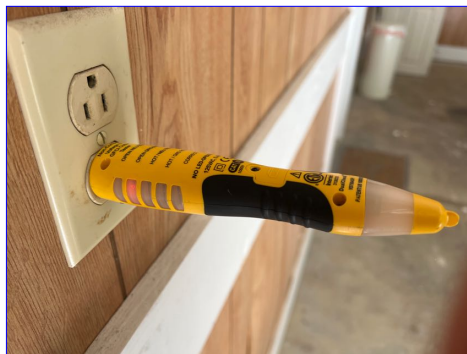
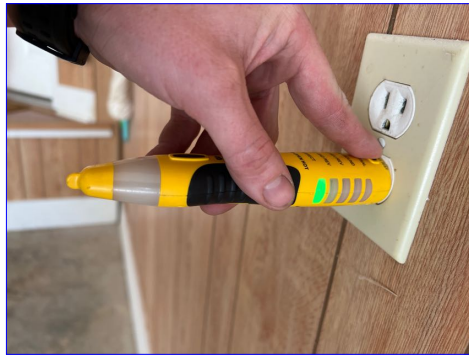
C. GFCI

- No GFCI protection in garage. It is recommended that outlets in garage are GFCI protected, however many homes have dedicated outlets in garage that are not GFCI protected to power items such as deep freezers.
- Ungrounded outlets noted in garage and stairwell to upstairs bedroom.

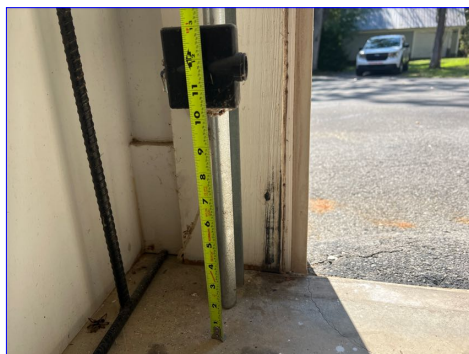
F. Garage Door's Reverse Status

Observations:
 • Garage safety sensors are installed too high. Modern safety standards state no more than 6" from floor. Recommend adjust sensors as needed.

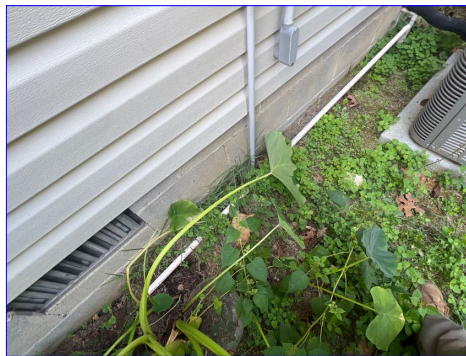
- HVAC condensation drip lines terminates too close to structure. Recommend adding extension to drain line to allow condensation to flow away from structure.

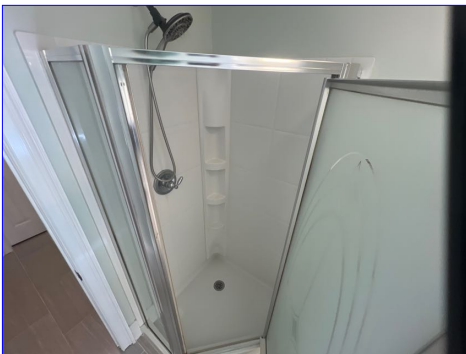
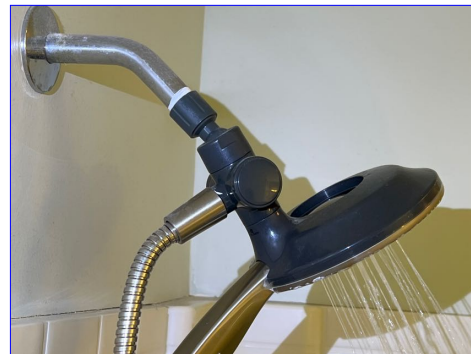
D. Showers

- Hot/cold reversed plumbing observed. Shower should deliver hot water when turned to the far left position.

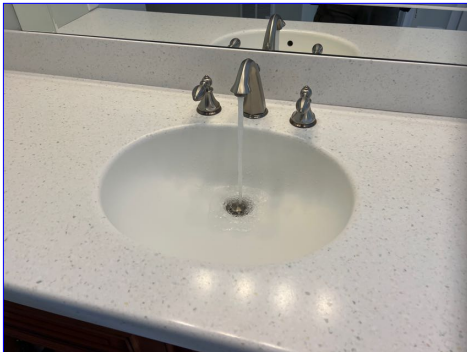
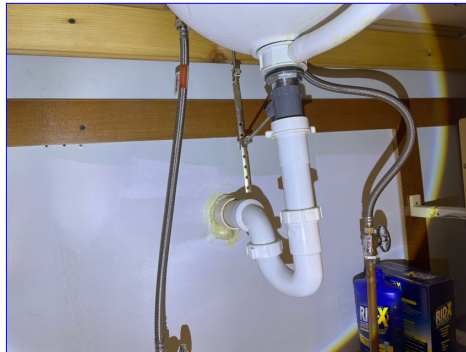
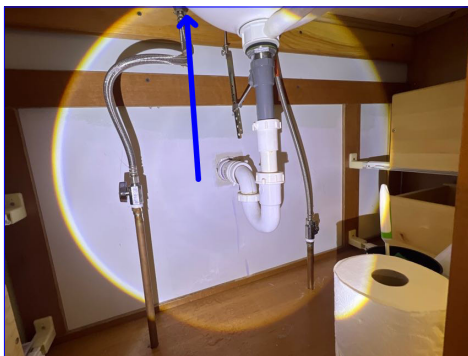
F. Sinks

- Leak noted around hot water plumbing connection under right sink. Recommend repairing plumbing connection to prevent leak.

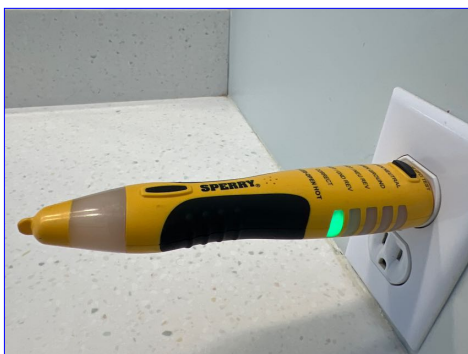
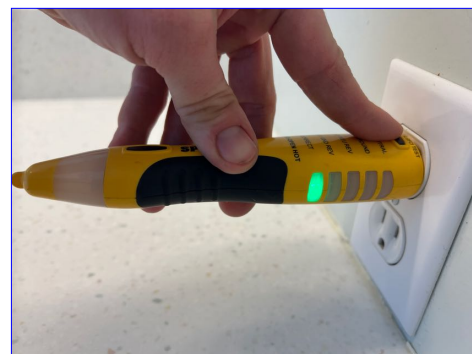
- Outlet in bathroom is not GFCI protected. Recommend replacing outlet with GFCI outlet (Ground Fault Circuit Interrupter).

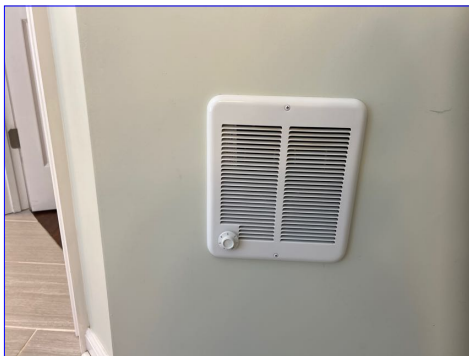
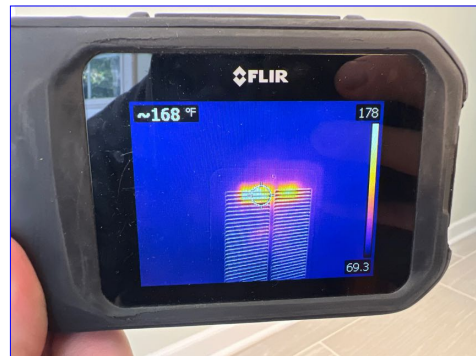
I. Heating

- Electric wall heater operating properly at time of inspection.

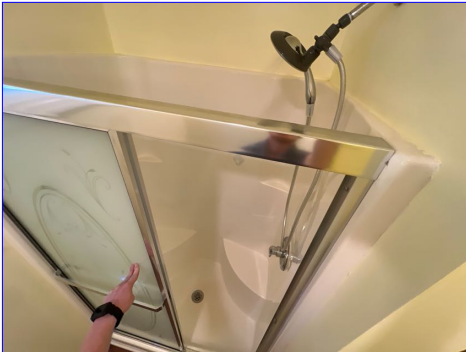
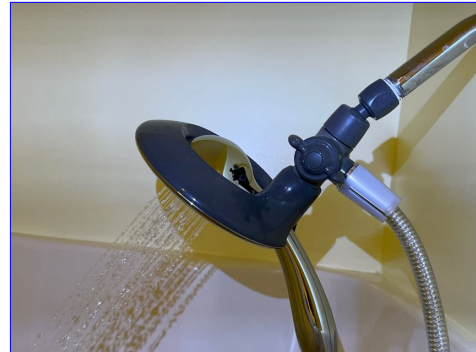
D. Showers

- Shower faucet tested, appeared to flow and drain correctly.

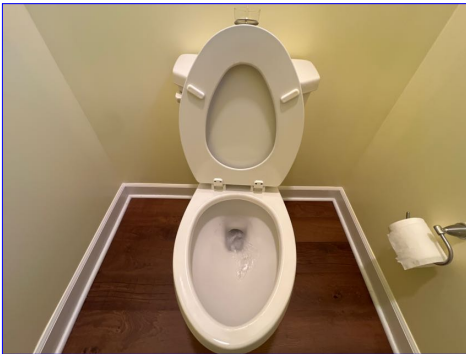
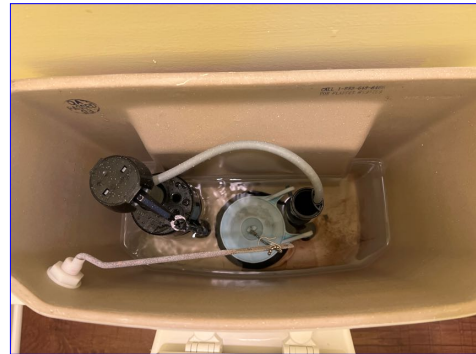
E. Toilets

- Operated when tested. No deficiencies noted.
