PROPERTY INSPECTION **REPORT**

2404 Cave Springs Rd, Rising Fawn, GA 30738

DATE OF INSPECTION: 10/8/2024

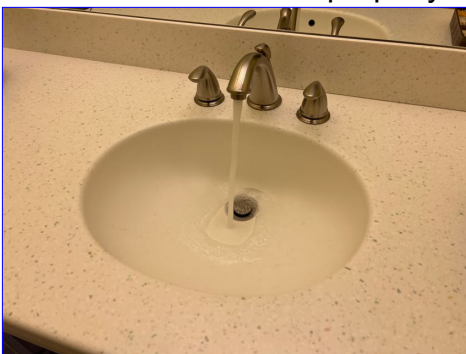
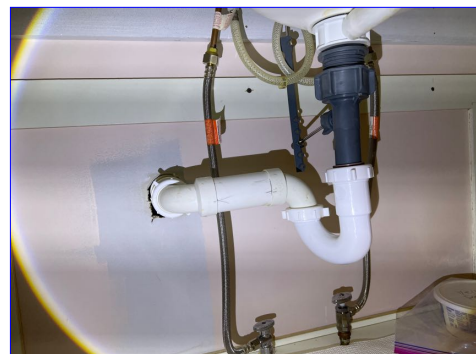
F. Sinks

- Sink operated, tested for flow, drainage, and leaks. Everything appears to function properly.

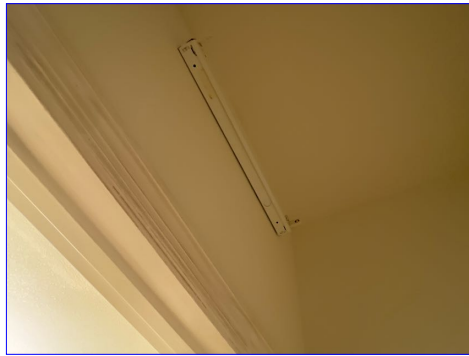
G. Electrical

- Bathroom closet light is missing bulb.

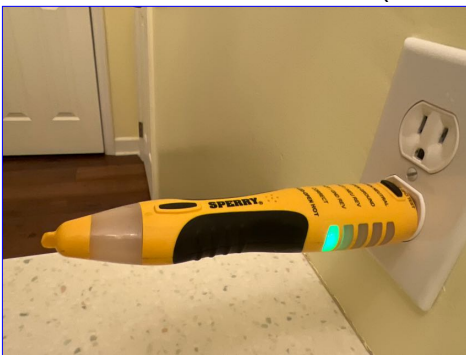
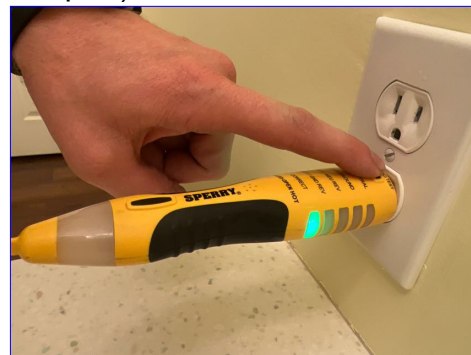
H. GFCI

- Outlet in bathroom is not GFCI protected. Recommend replacing outlet with GFCI outlet (Ground Fault Circuit Interrupter).

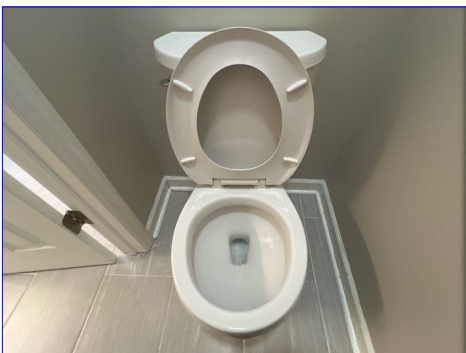
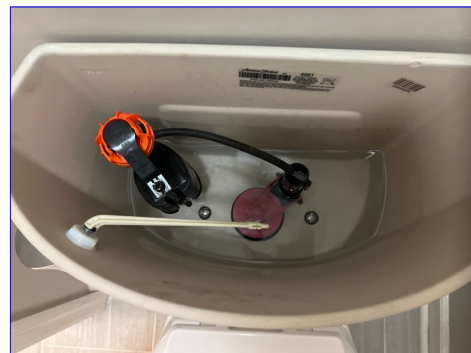
- Operated when tested. No deficiencies noted.

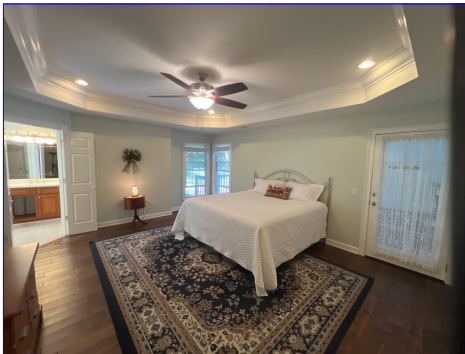
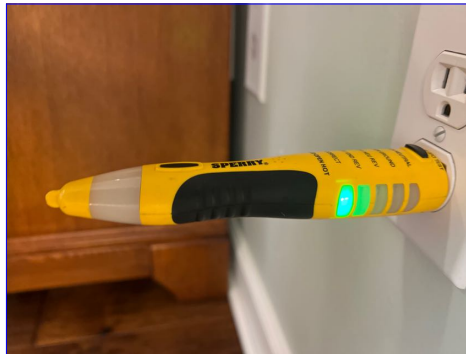
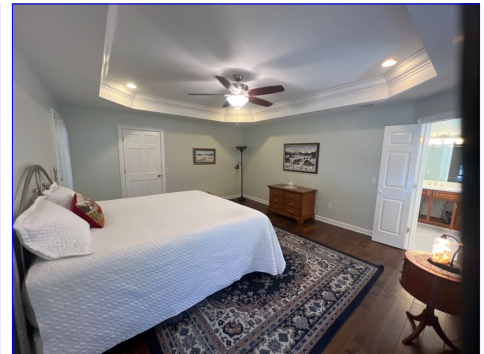
- All accessible ceiling fans, light fixtures, outlets, windows, doors, and cabinetry were tested.

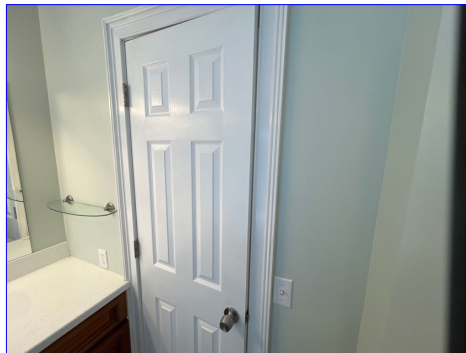
C. Closets

- Door to closet does not close properly. Recommend adjusting door or strike plate for door to operate properly.

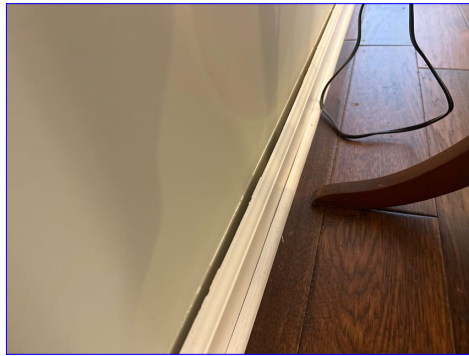
D. Wall Condition

- Loose baseboard noted in bedroom. This is cosmetic in nature.

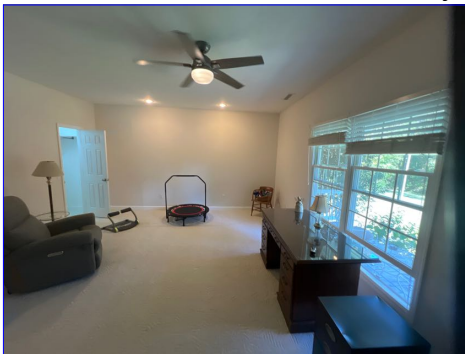
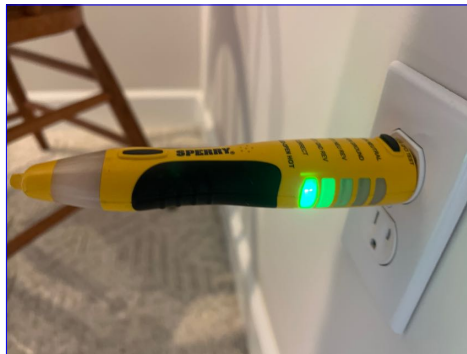
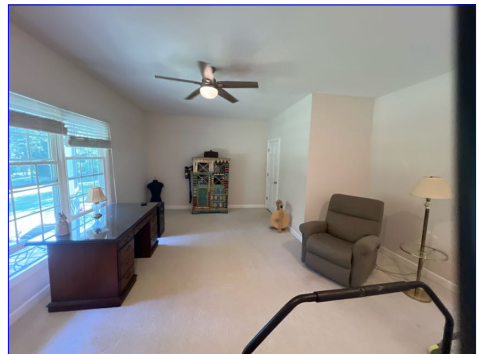
- All accessible ceiling fans, light fixtures, outlets, windows, doors, and cabinetry were tested.

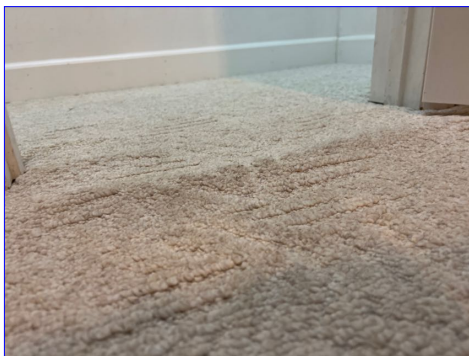
C. Floor Condition

- Loose carpet noted in bedroom.
- Soft flooring noted in bedroom. Recommend correction as needed.

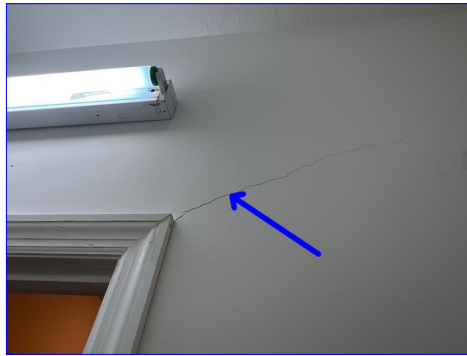
D. Wall Condition

- Settling cracks noted in walls. Recommend to repair and monitor for further movement.

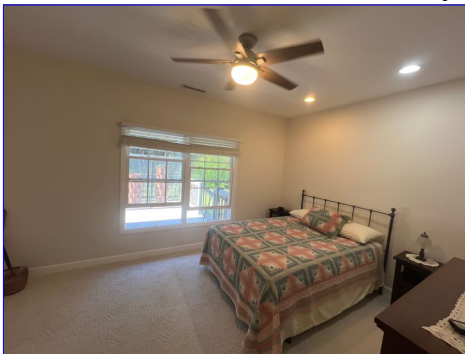
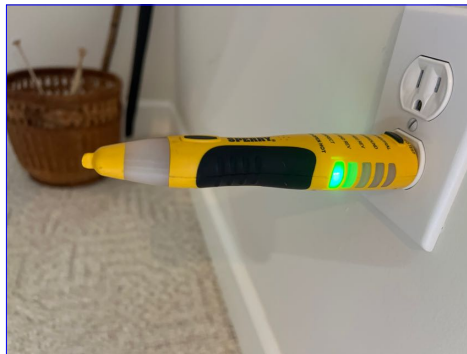
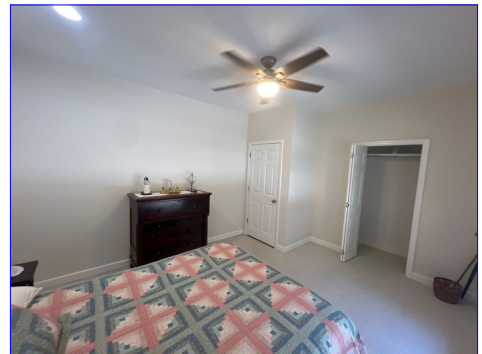
- All accessible ceiling fans, light fixtures, outlets, windows, doors, and cabinetry were tested.

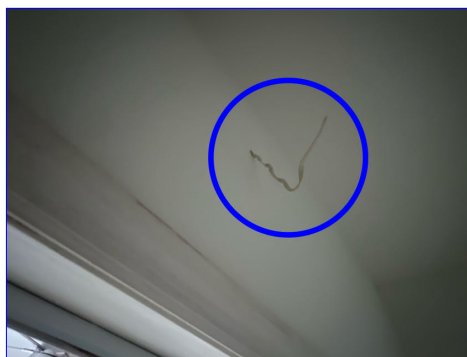
C. Electrical

- Exposed electrical wires noted in bedroom closet. Recommend terminating electrical wires properly to prevent injury.

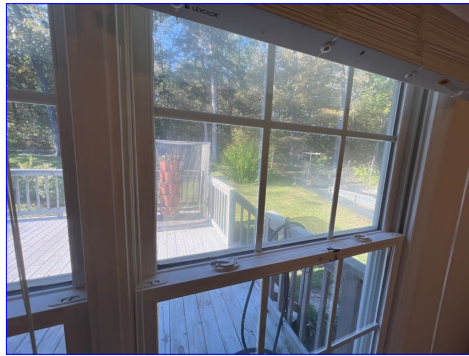
D. Window Condition

- Condensation noted between window panes in this bedroom. This indicates bad seal around window.

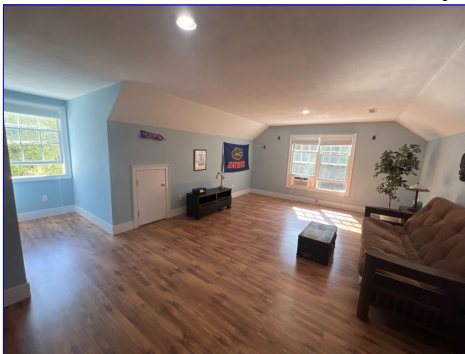
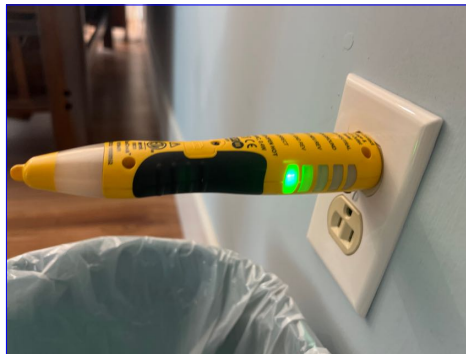
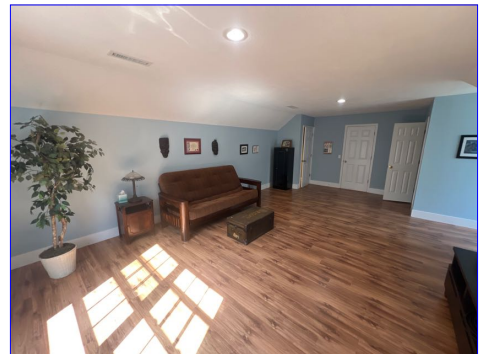
- All accessible ceiling fans, light fixtures, outlets, windows, doors, and cabinetry were tested.

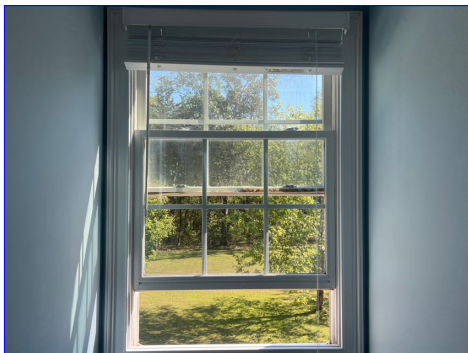
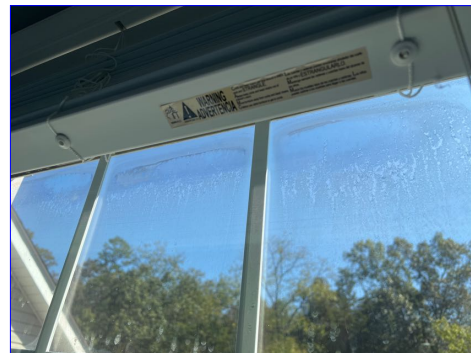
C. Window Condition

- Condensation noted between window panes in this bedroom. This indicates bad seal around window.

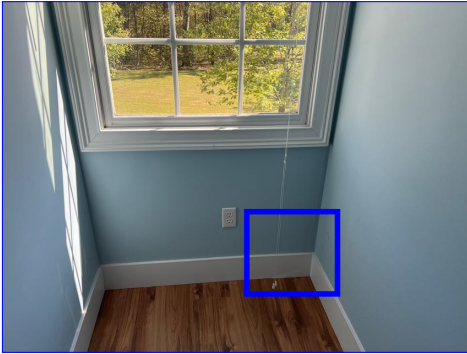
D. Wall Condition

- Moisture staining noted on wall below window. This area tested dry at time of inspection. Recommend monitoring for further moisture intrusion.

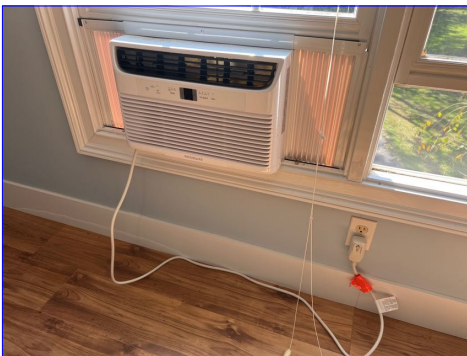
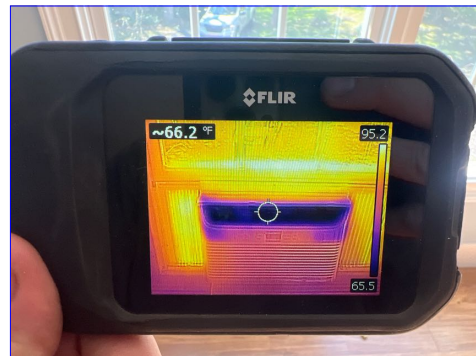
- AC unit tested and functions properly.

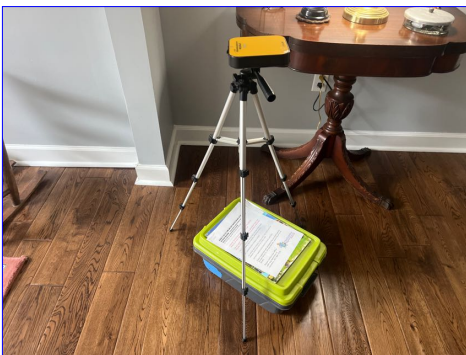
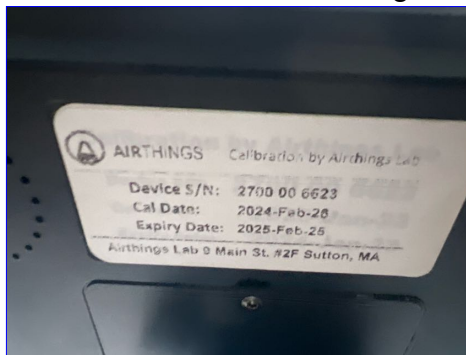
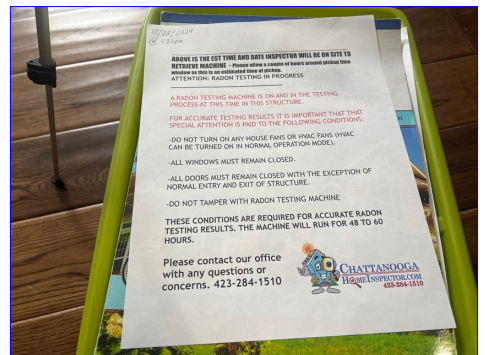
A. Radon testing equipment

- Radon test was performed by Corentium Pro Air Things continuous radon monitor
- Pump was located in lowest living area in living room.
- Information was left at home instructing homeowners to leave house in "closed" conditions.
- Radon test pump was set for a 12 hour delay to allow structure to reach "closed home" conditions before testing.

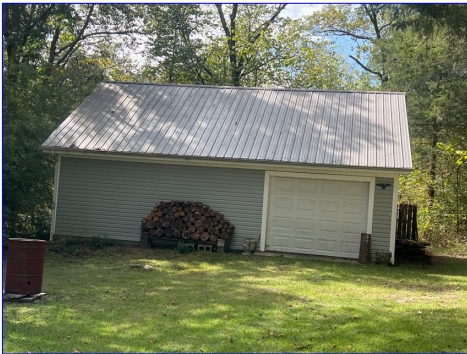
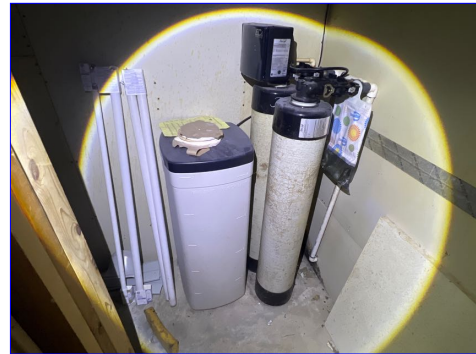
- Barn / Outbuilding not inspected due to client agreement.
- Water filtration system not tested.
