Chattanooga Home Inspector

Property Inspection Report

123 Inspection Way, Chattanooga, TN 37421
Inspection prepared for: Mrs. Buyer & Mr. Buyer
Date of Inspection: 1/5/2021 Time: 8:00 AM
Age of Home: 2007 Size: 3100
Weather: 30 degrees and sunny
Order ID: 11652

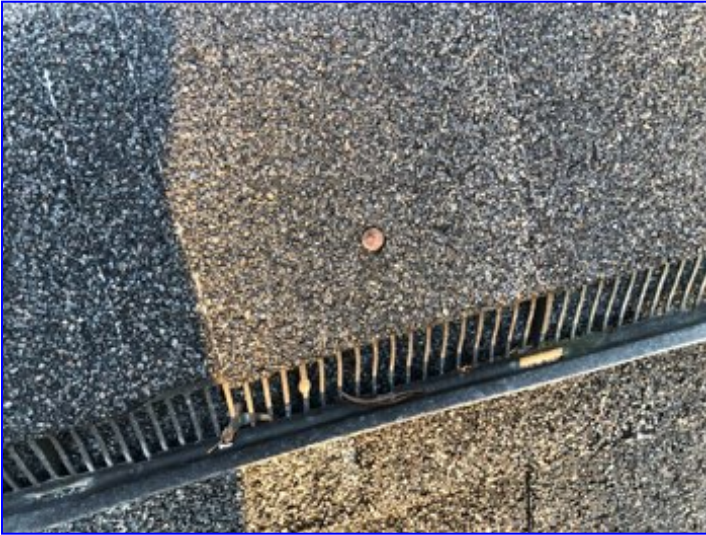
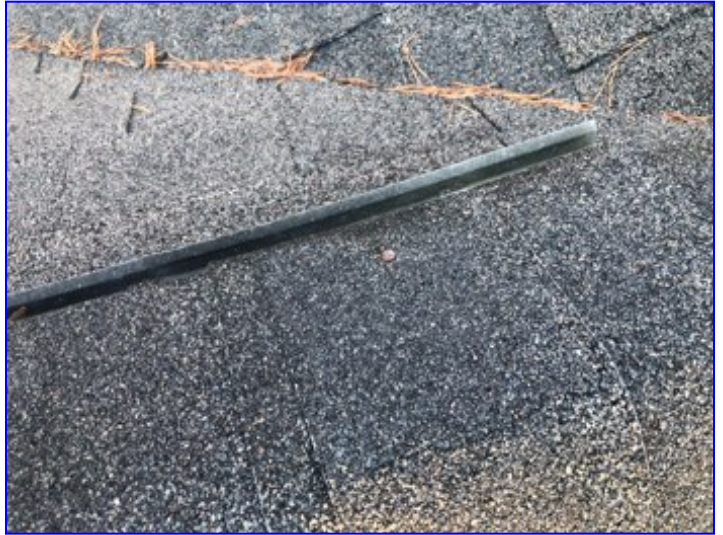
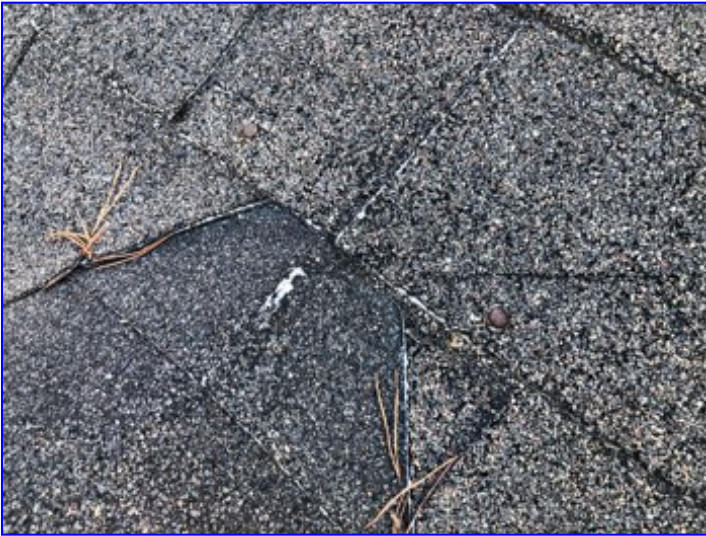
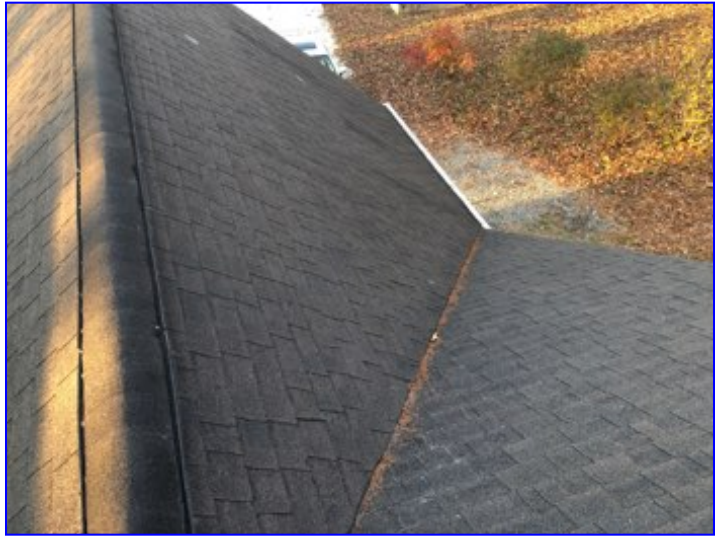
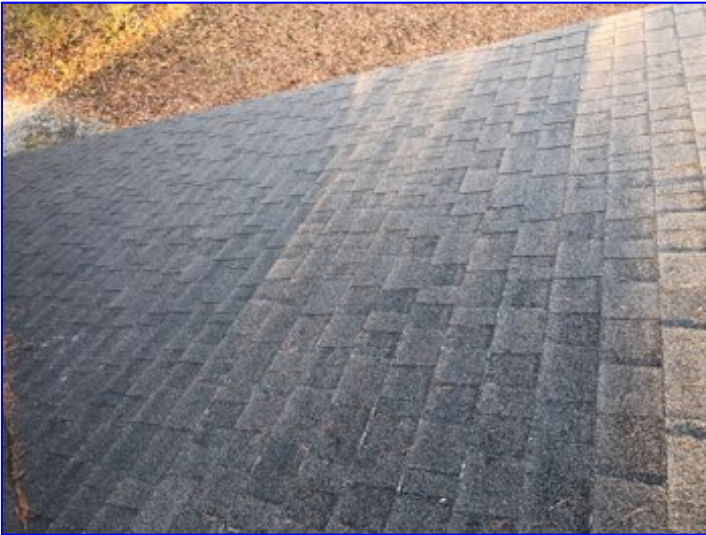
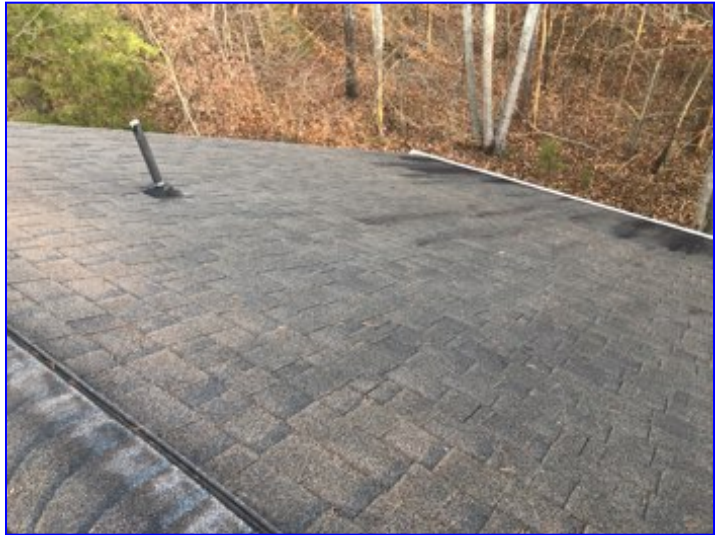
A. Roof Condition

- Granules on asphalt shingles are deteriorated and appear to be nearing the end of their service life, especially on the south slope. Recommend licensed roofer review roof and repair / replace as needed.
- Various roof shingles are damaged. Recommend licensed roofer review roofing system and repairing / replacing damaged areas as needed.
- Exposed nails noted in areas of roof. Recommend adding roof grade silicone to exposed nails to prevent water entry.
- No **drip edge** flashing noted. Recommend adding drip edge flashing as needed.

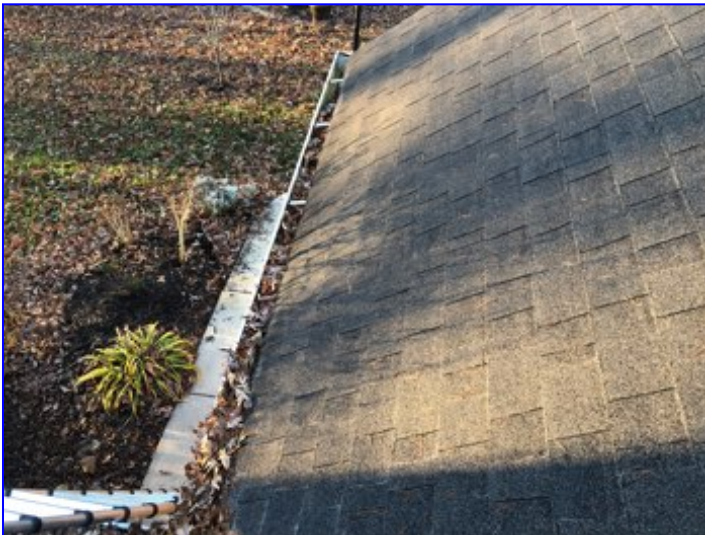
**B. Gutter**

- Gutters not attached in some areas. Recommend repairing gutters to flow correctly.
- Excessive debris noted in gutters. Recommend cleaning gutters as a part of regular home maintenance.

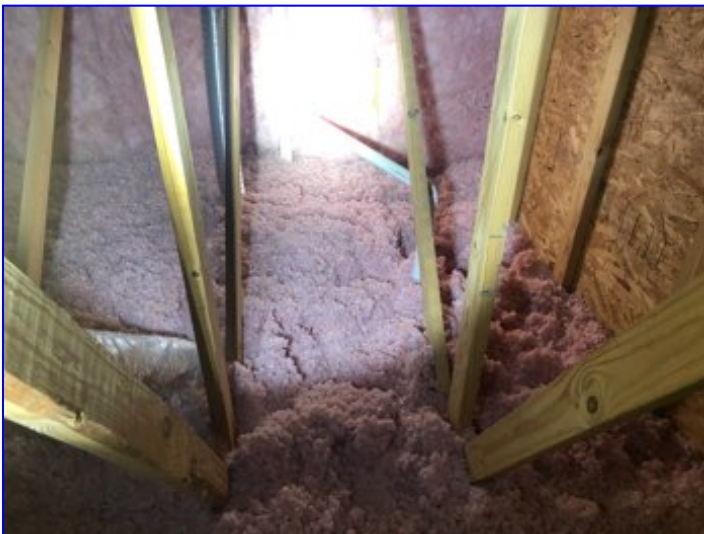
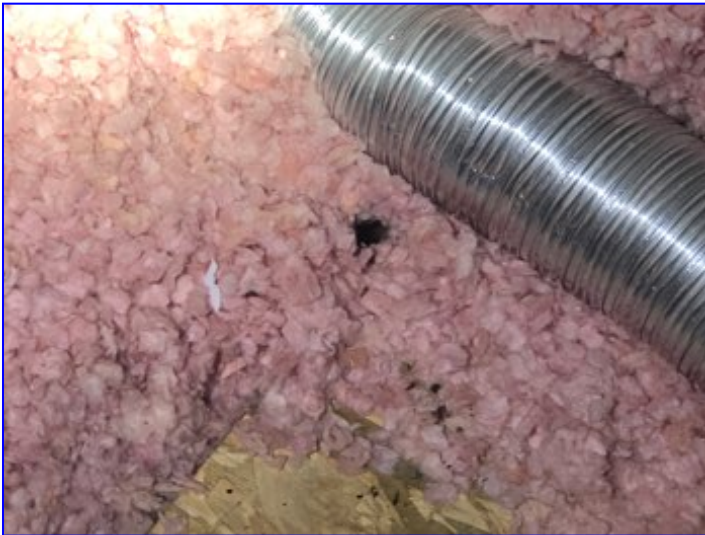
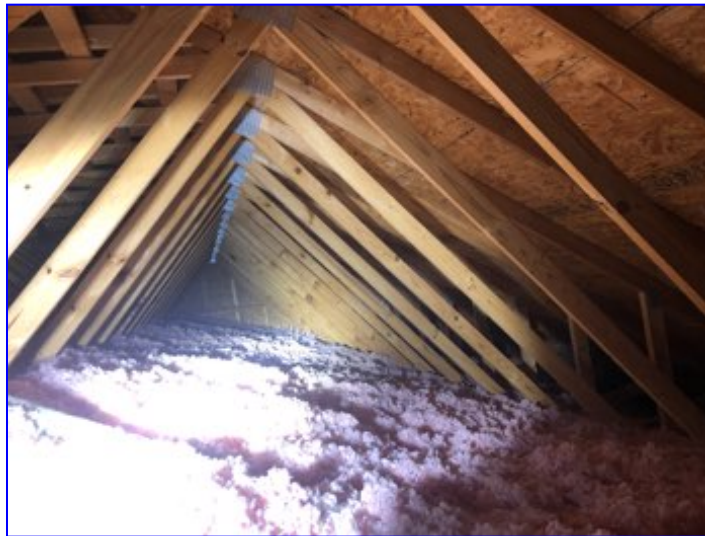
F. Insulation Condition

- "Tunneling" noted in attic insulation. This indicates current or past presence of pests in attic. No structural damage is visible at this time.

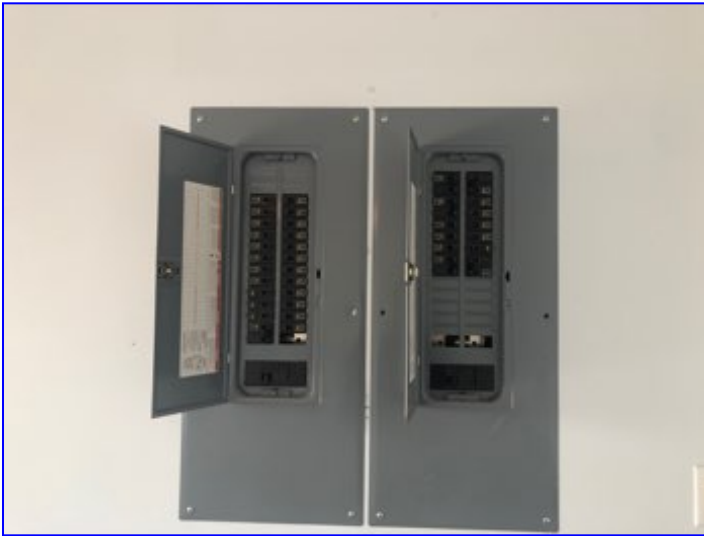
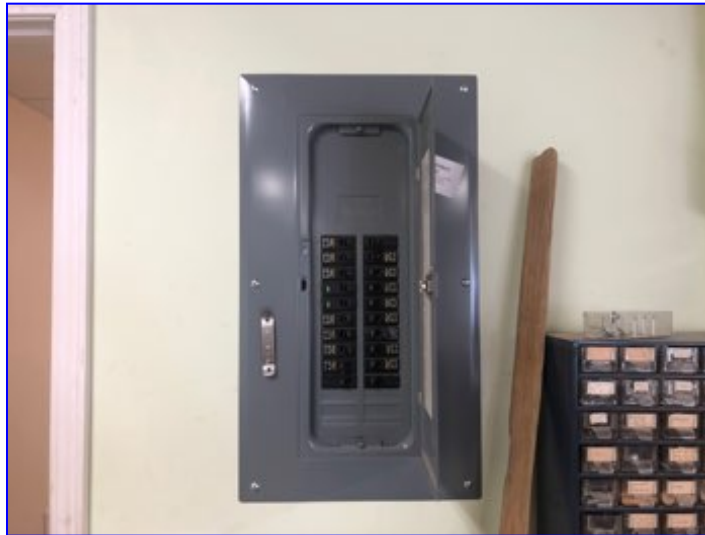
- Service panel missing screws. (Quantity 3) Recommend adding blunt tip screws as needed.
- Service panel is missing "knock-outs" where breakers could be installed. Recommend installing covers where breakers are missing.
- Abandoned exposed wires noted in electrical panel. Recommend removing or properly terminating wires by adding wire nuts over exposed wires.

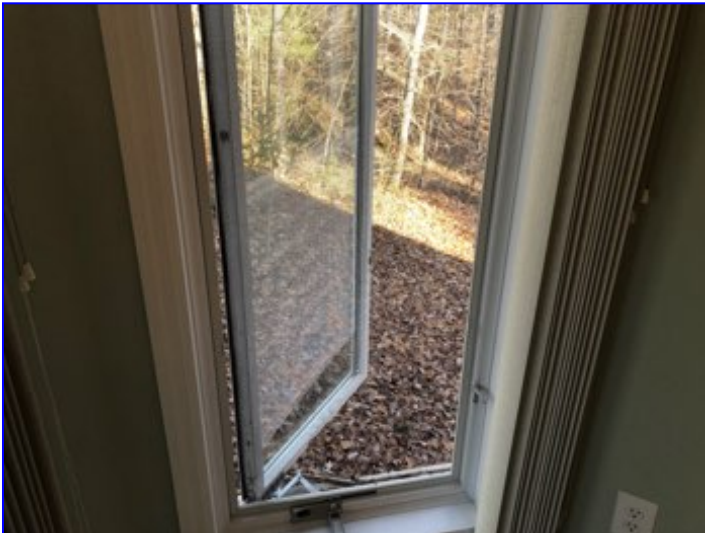
D. Window Condition

- Broken window pane noted. Recommend replacing damaged window pane. (Total Quantity 2)

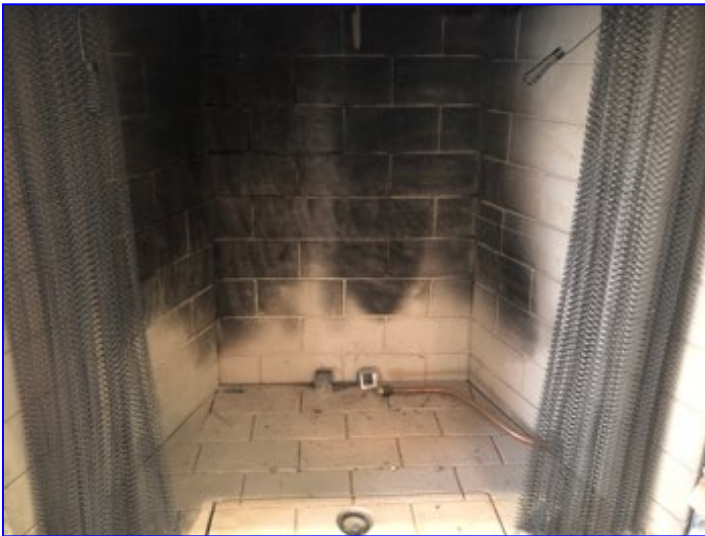
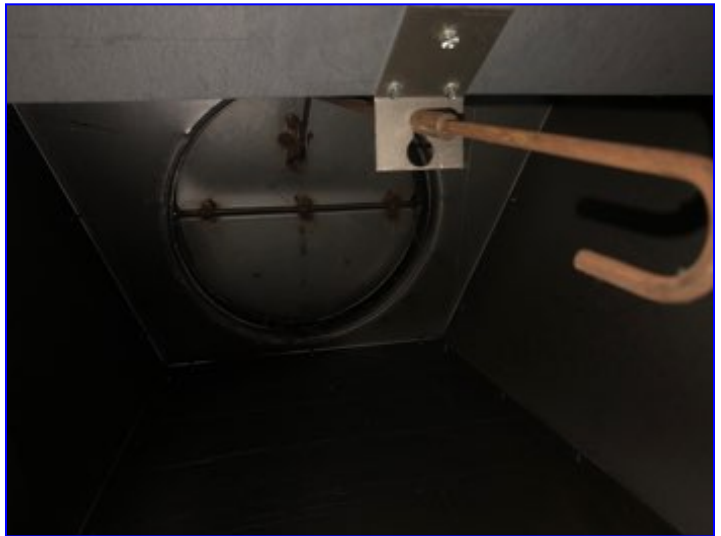
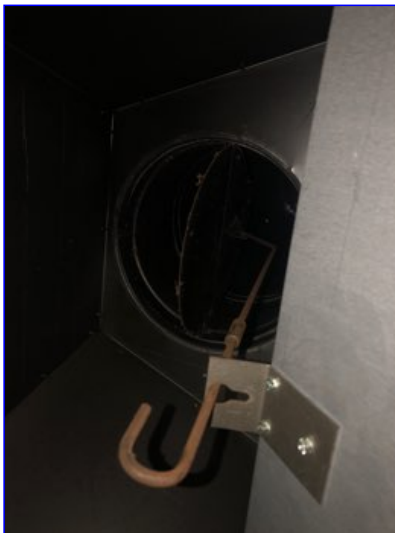
**E. Fireplace**

- Unable to test fireplace due to no logs being installed.

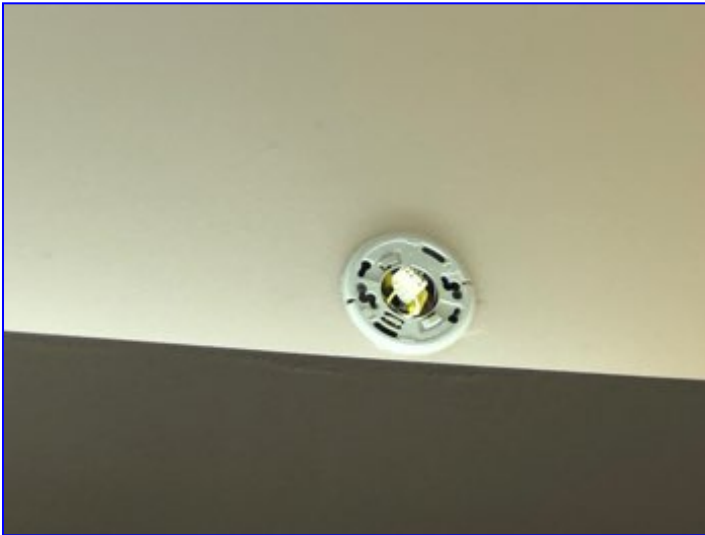
F. Smoke Detectors

- Smoke detectors have been removed throughout home. Recommend reinstalling smoke detectors.

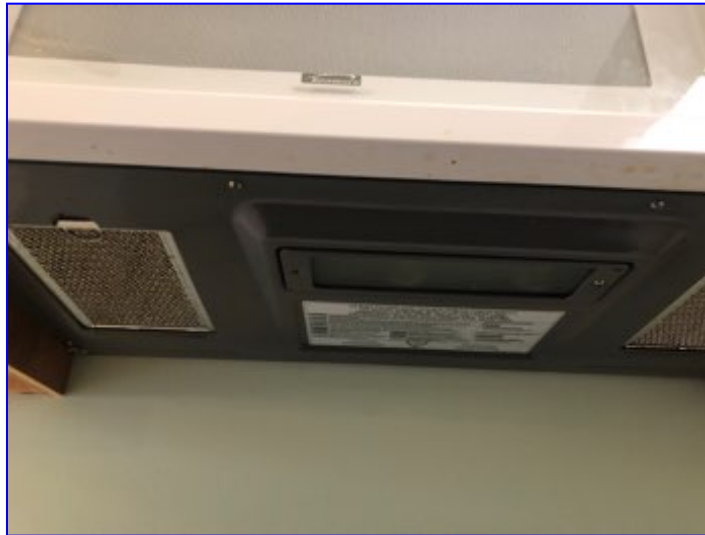
**G. Vent Condition**

Materials: Recirculating

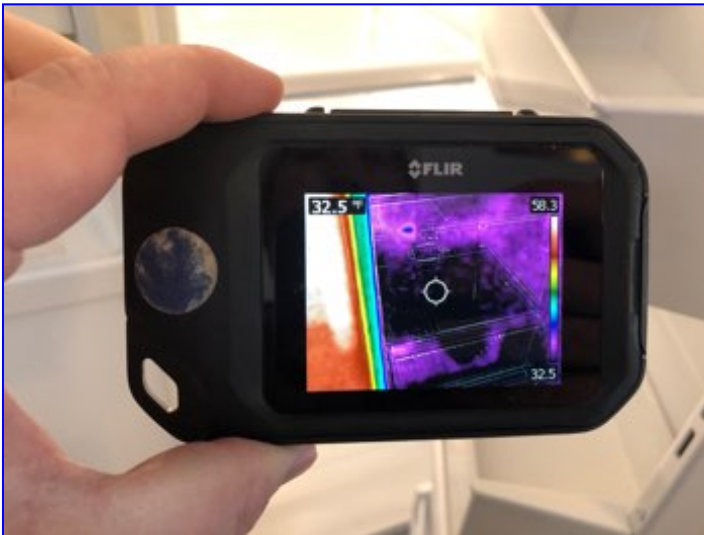
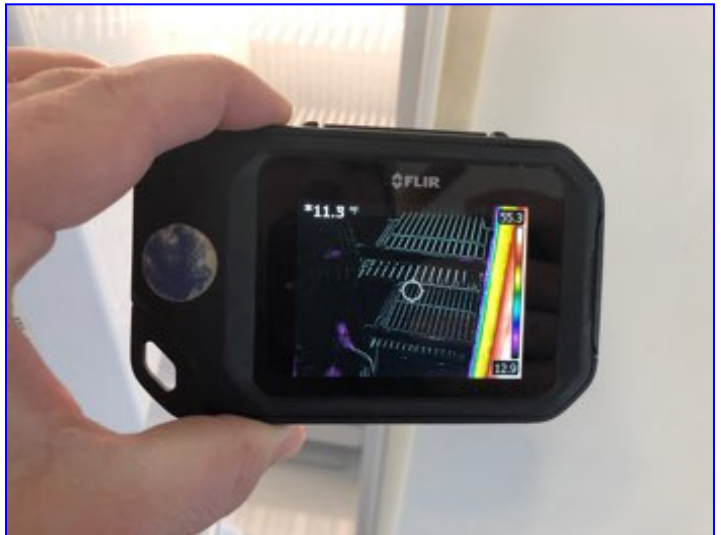
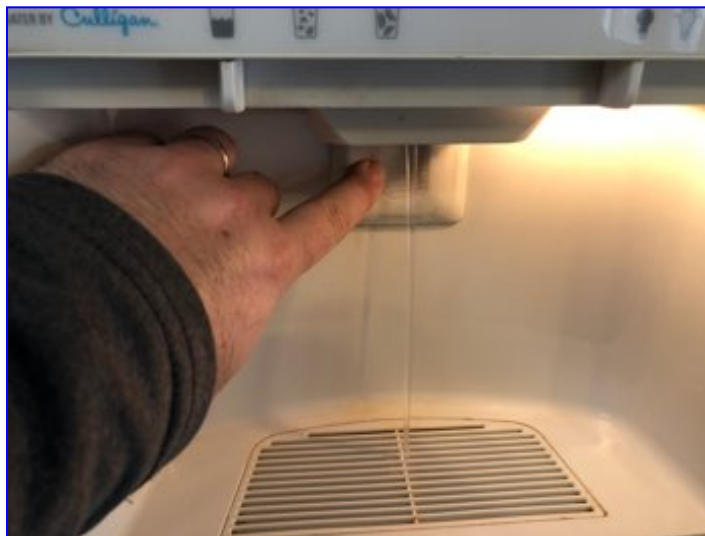
H. Refrigerator Condition

- Refrigerator was on and appeared in working condition at time of inspection.

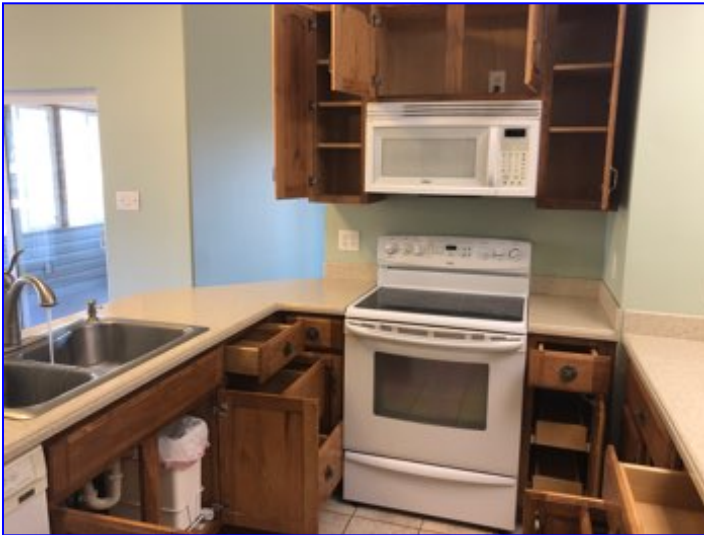
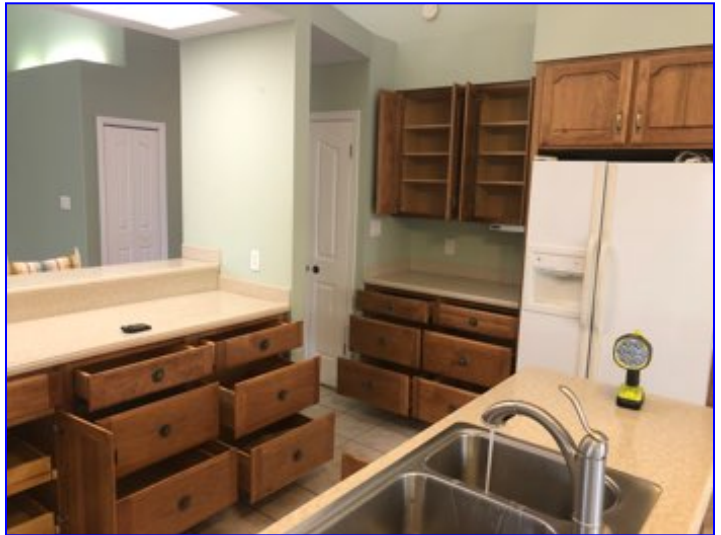
I. Cabinets

- A representative number of cabinets were opened and appeared to operate correctly.

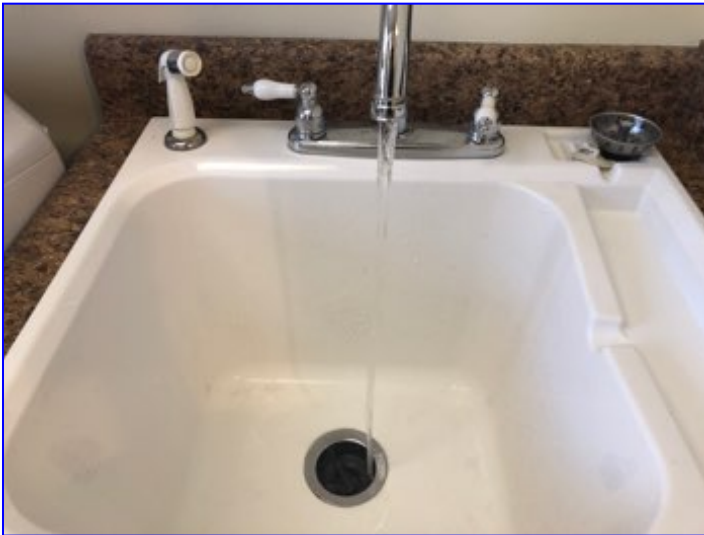
**B. Wash Basin**

- Drain line leaks under sink. Recommend repairing leak.

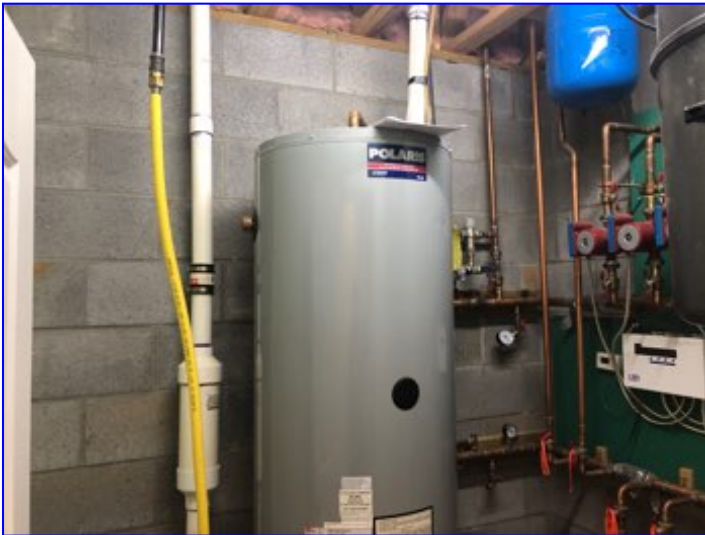
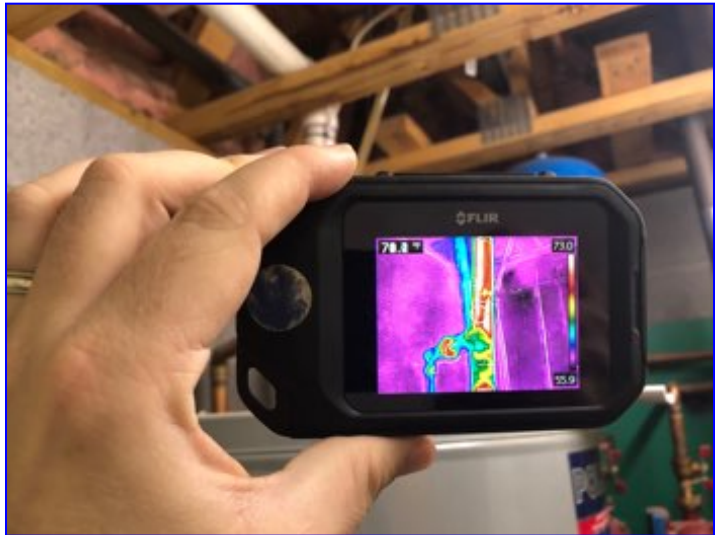
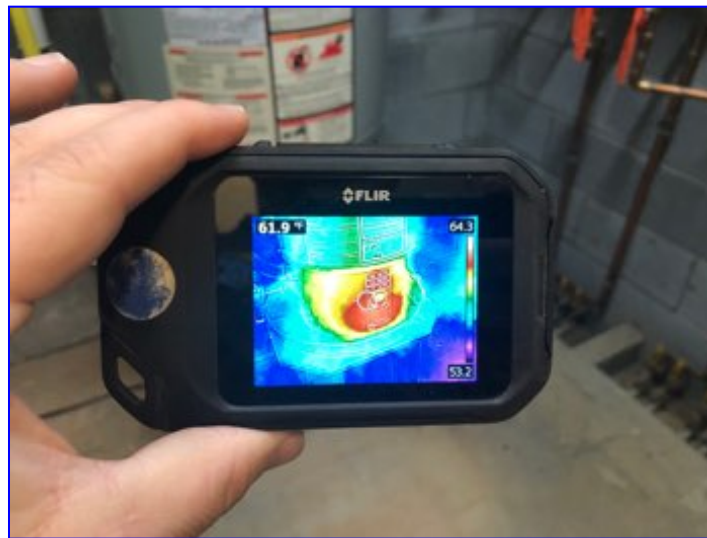
A. Water Heater Condition

- Tank appears to be in satisfactory condition -- no concerns.

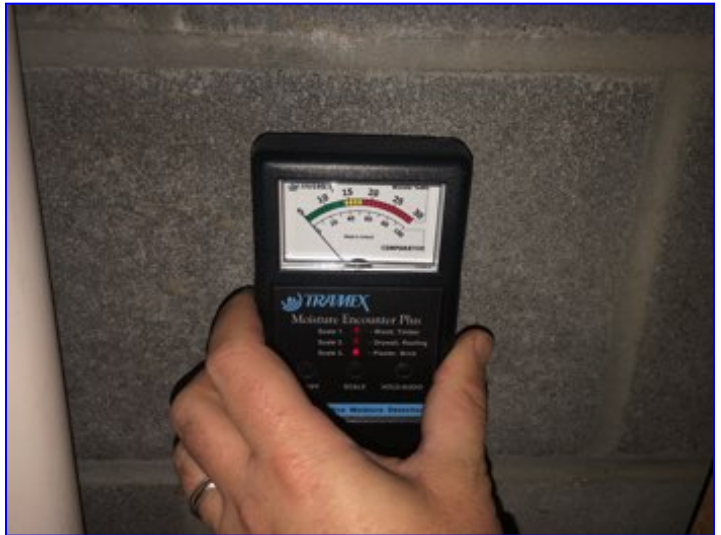
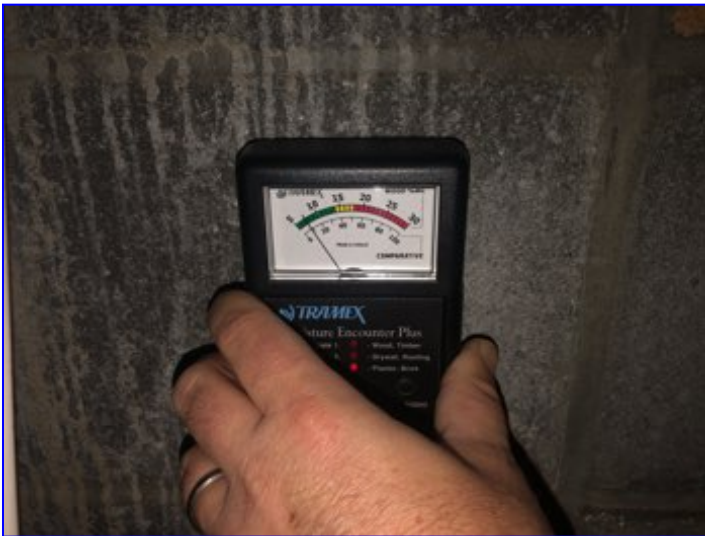
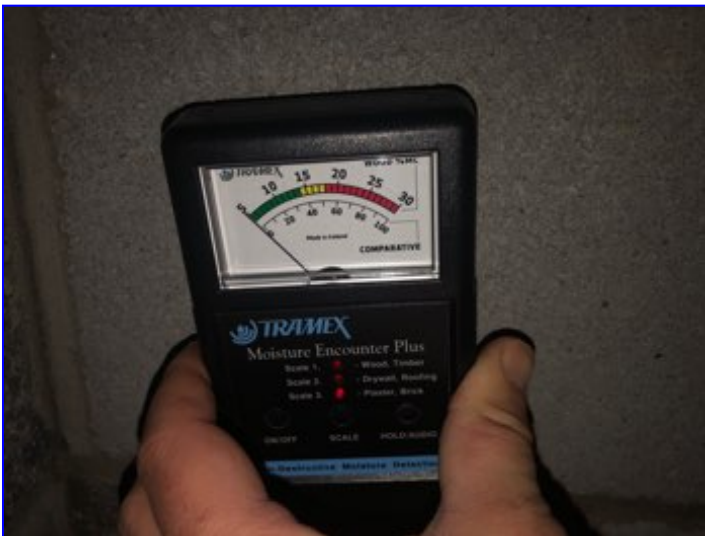
B. Foundation

• Concrete block foundation noted.

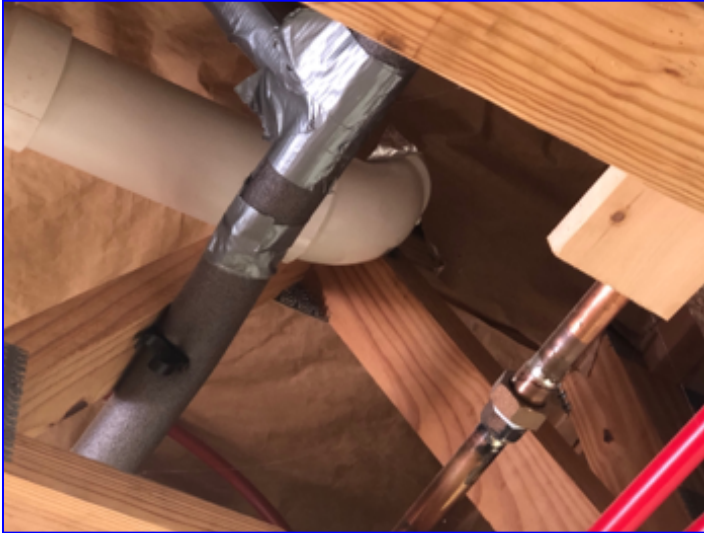
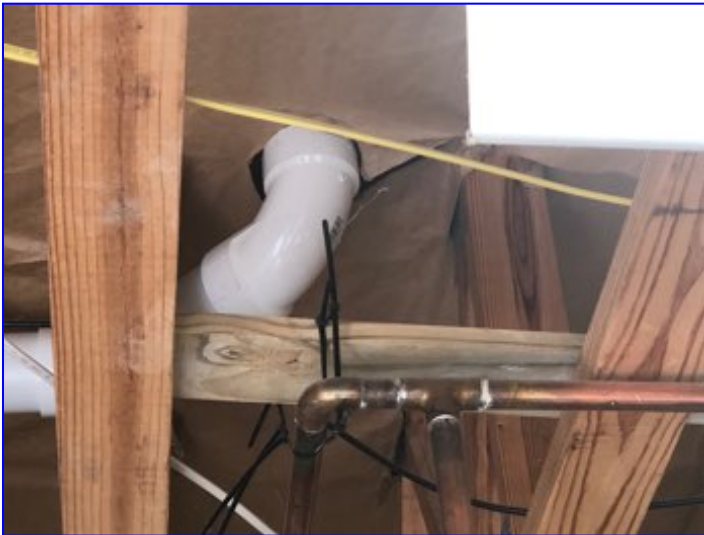
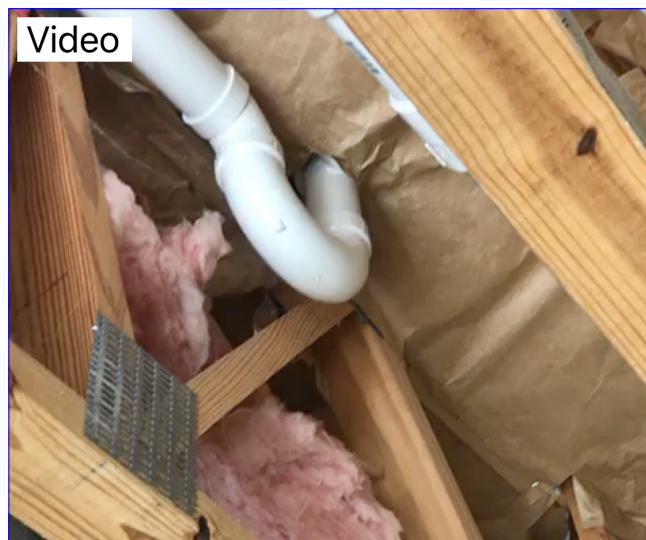
- Active leak noted in basement, which appears to be under the master bathroom. Unable to view subfloor to determine if damaged. Recommend repairing leak and replacing damaged areas due to leak.

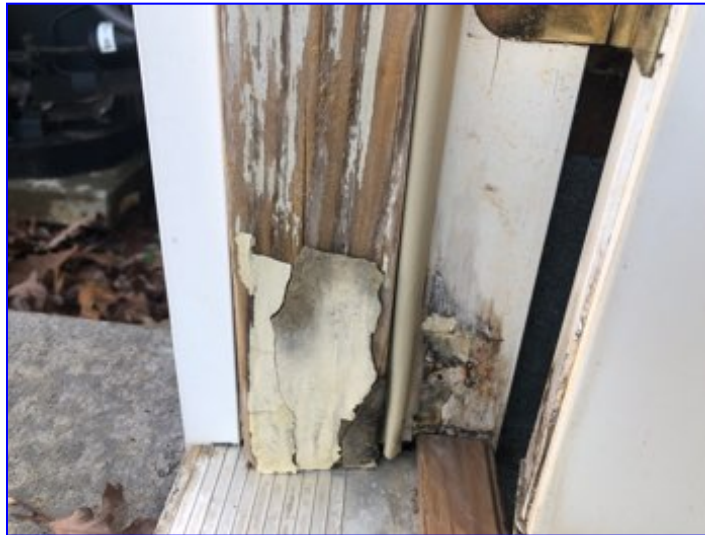
- Bottom of door trim shows signs of rot. Recommend replacing rotten areas.

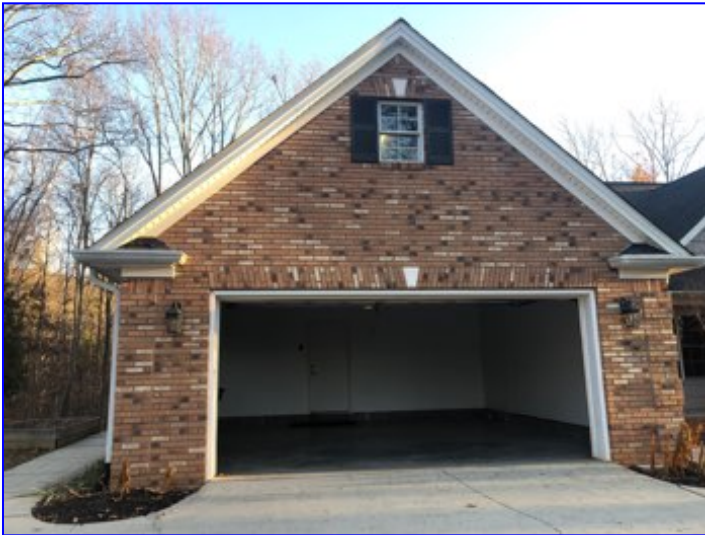
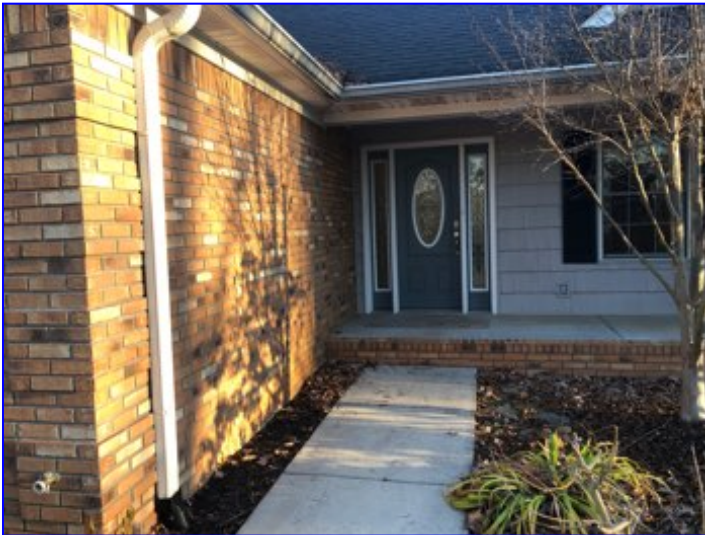
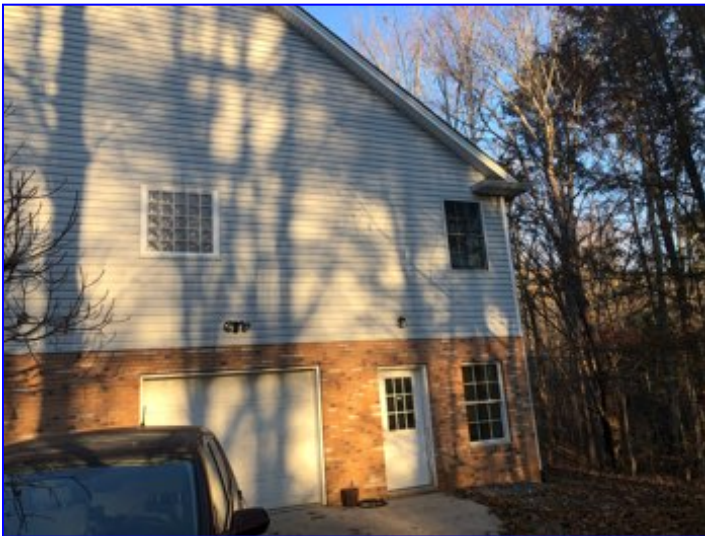
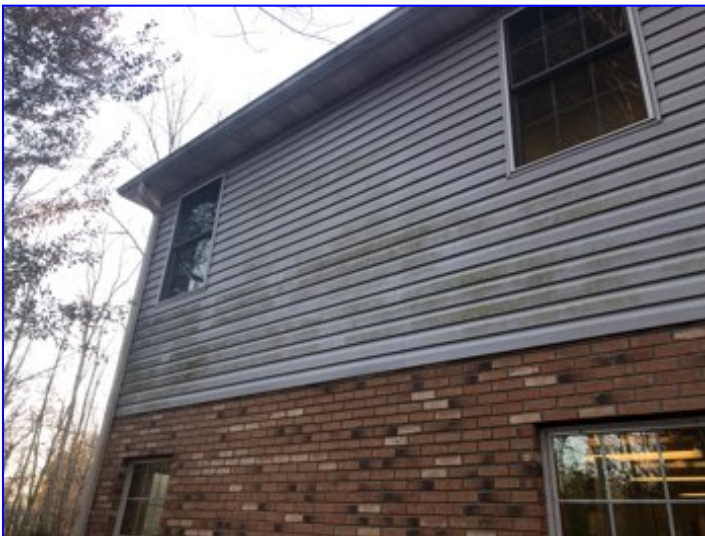
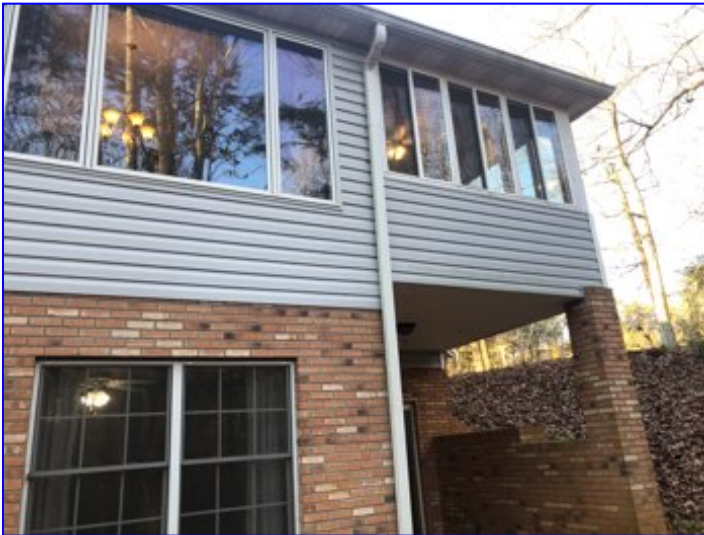
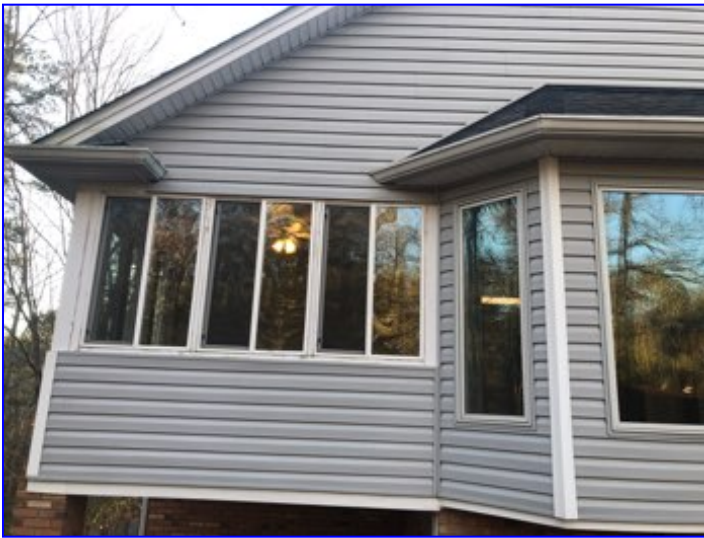
**B. Siding Condition**

- Small holes or damaged area noted in siding. Recommend sealing these areas to prevent water entry.
- Pictures and arrows may not represent all exterior damaged surfaces. Recommend a professional that can repair damaged exterior surfaces ensure all damaged or rotten areas be repaired properly.

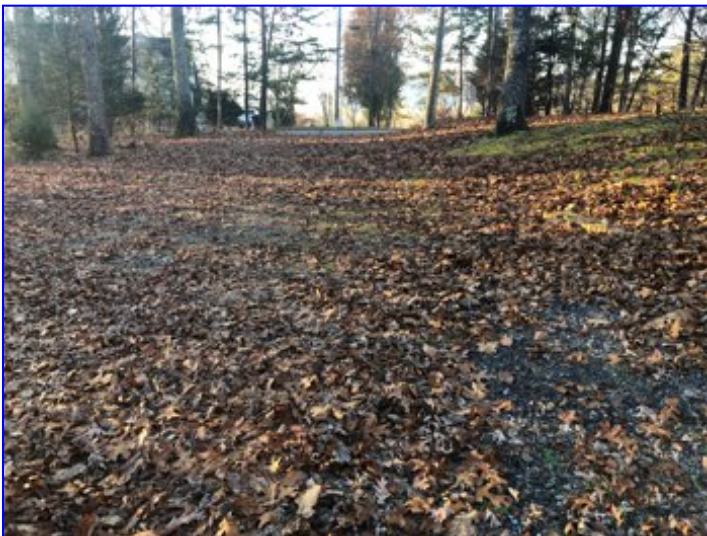
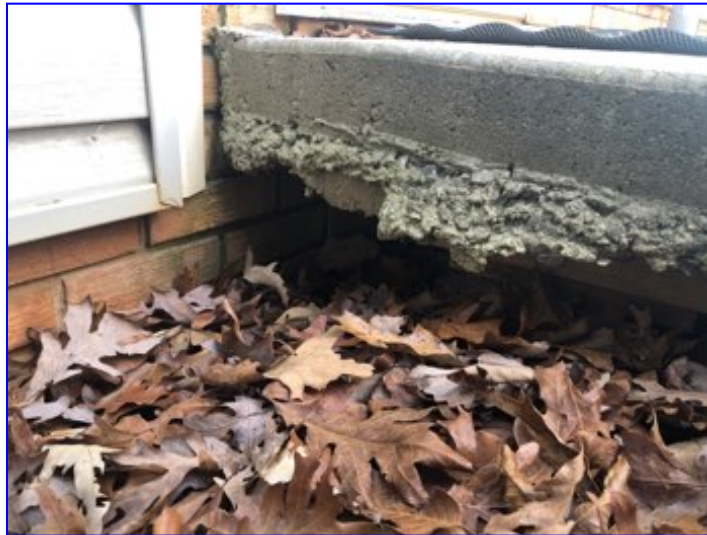
A. Driveway and Walkway Condition

- Typical cracks noted.
- Loose sidewalk material noted. Recommend securing sidewalk material to prevent trip hazard.
- Washed out area noted on northwest sidewalk. Recommend monitoring concrete for cracking/settling and repairing as needed.

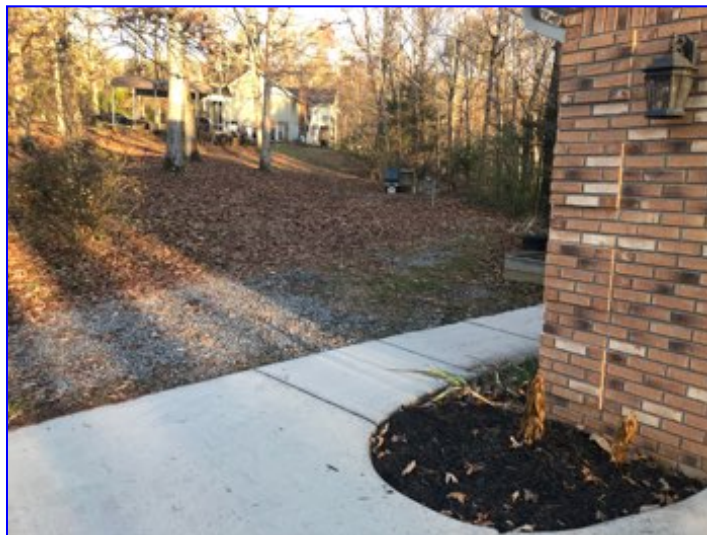
**B. Grading**

- Grading is sloped towards structure. Lot grading should slope away and fall a minimum of one (1) inch every foot for a distance of six (6) feet around the perimeter of the building. Recommend improving grade by adding swale or french drain.

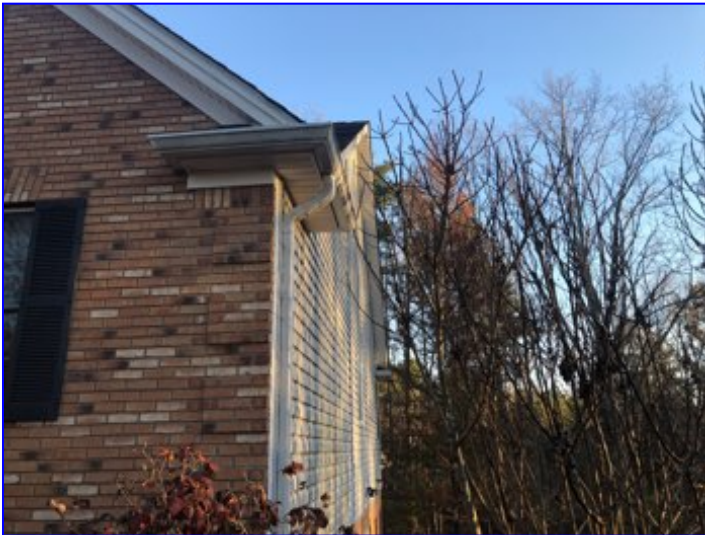
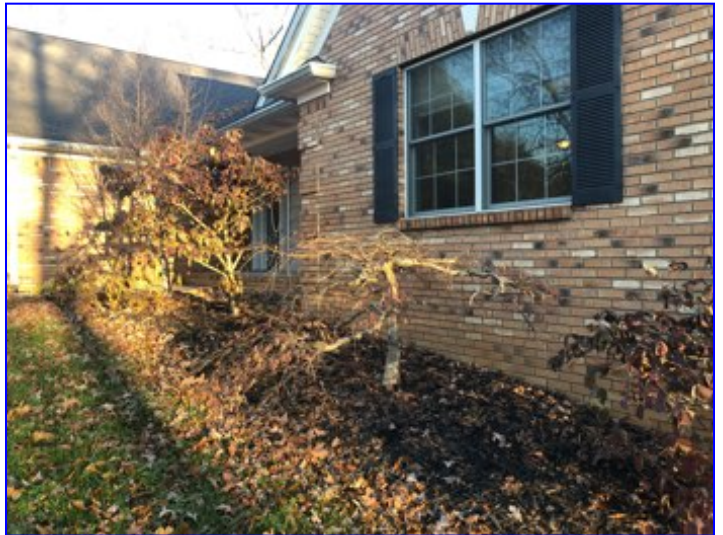
**C. Vegetation Observations**

- It is recommended to trim all plants and trees that are close to structure to prevent pathways of wood destroying insects.

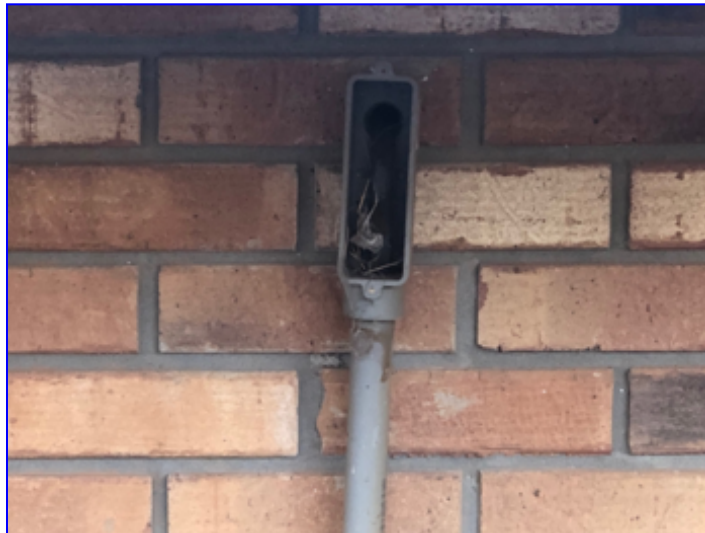
D. Grounds Electrical

- Electrical wire at northwest wall is exposed. Recommend adding cover to protect electrical wires.

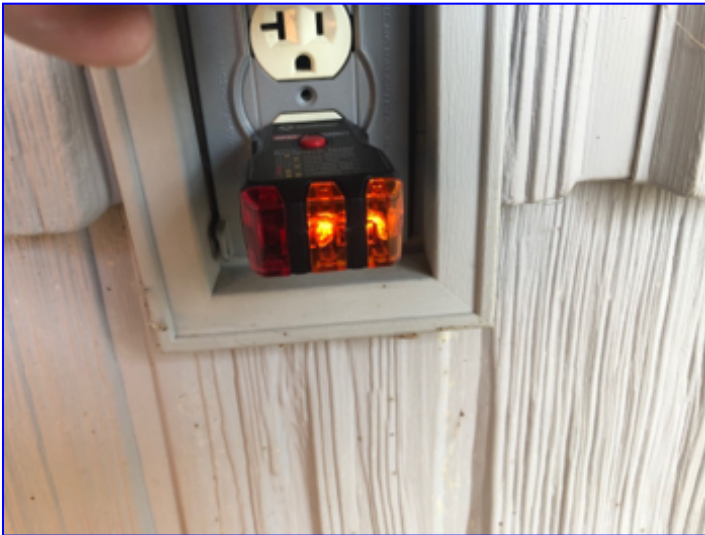
E. GFCI

- Exterior outlets not **GFCI** protected. Consider replacing outlets with Ground Fault Circuit protection.

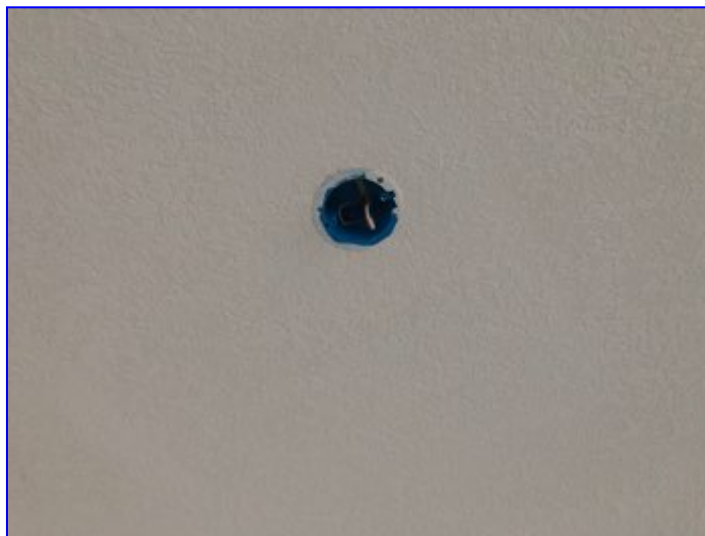
B. Electrical

- Exposed electrical splices in garage. Recommend placing electrical work in electrical boxes with covers.

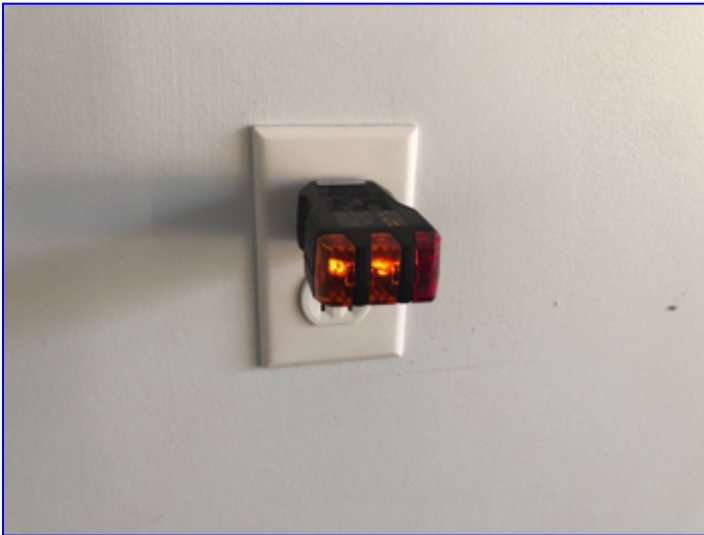
C. GFCI

- No GFCI protection in garage. It is recommended that outlets in garage are GFCI protected, however many homes have dedicated outlets in garage that are not GFCI protected to power items such as deep freezers.

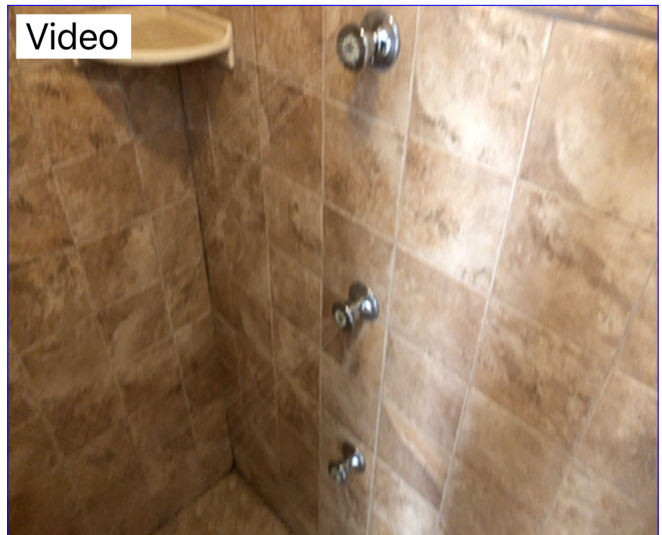
- Shower head leaks around shower arm. Recommend tightening shower head to stop leak.

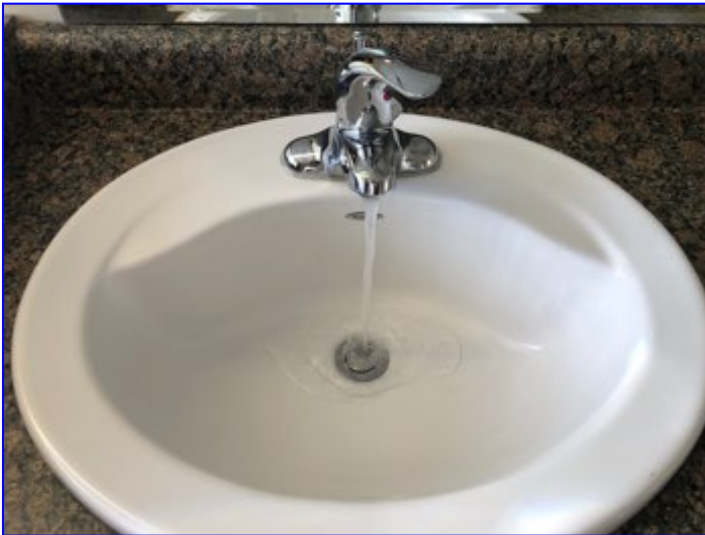
E. Sinks

- Drain line leaks under sink on left side. Recommend repairing leak.

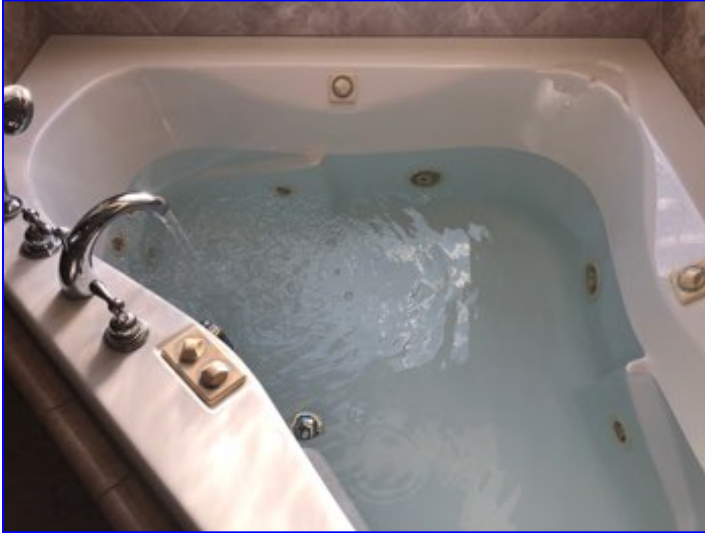
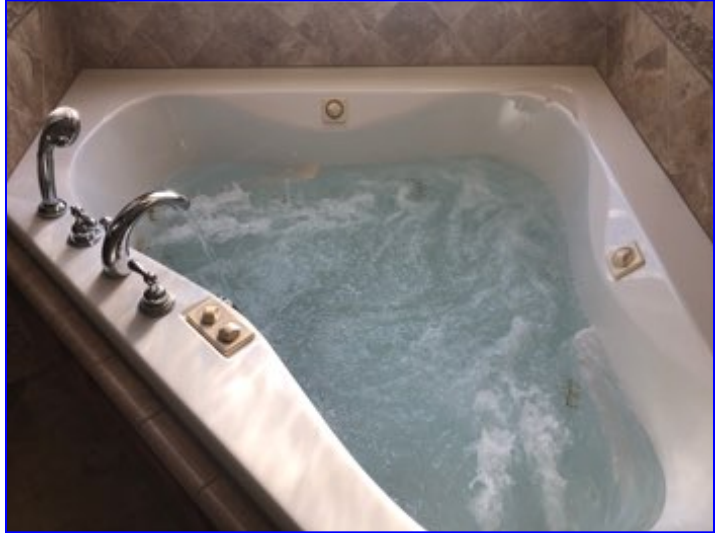
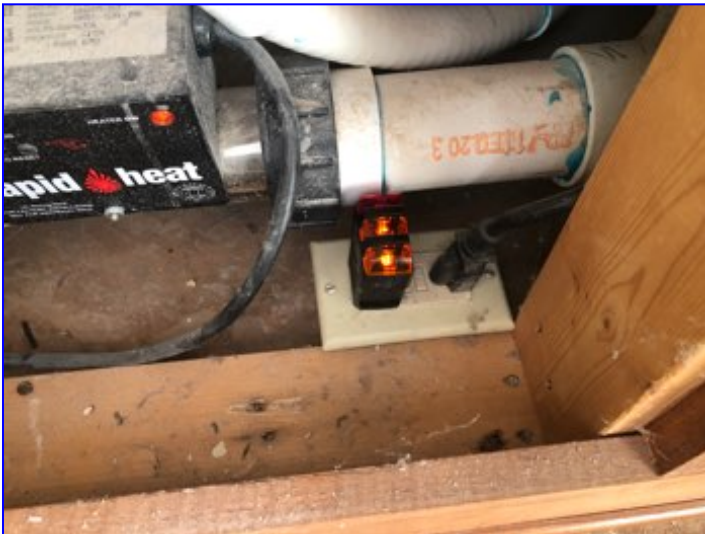
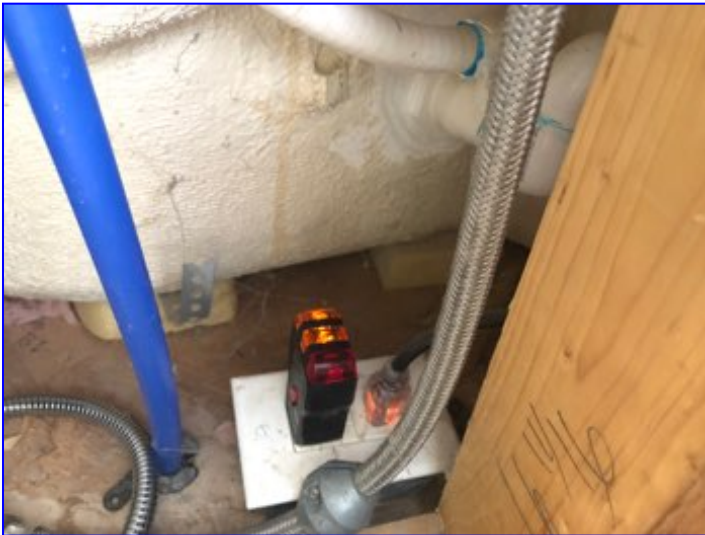
- Whirlpool
- Whirlpool tub observed. Tub was filled to a level above the water jets and operated to check intake and jets. The tub was then drained to check for leaks and/or damage. Pump and supply lines were not completely visible or accessible. GFCI was present and was tested. The items tested appeared to be in good condition. If a more detailed report is desired, the client is advised to consult a licensed plumber for a complete review.
- GFCI outlet powering the heat unit is not operating properly and will not trip when tested. Recommend repairing or replacing outlet.

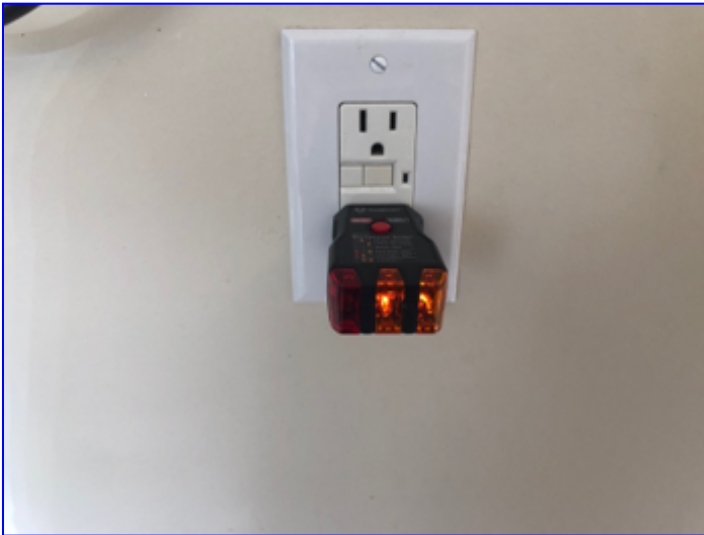
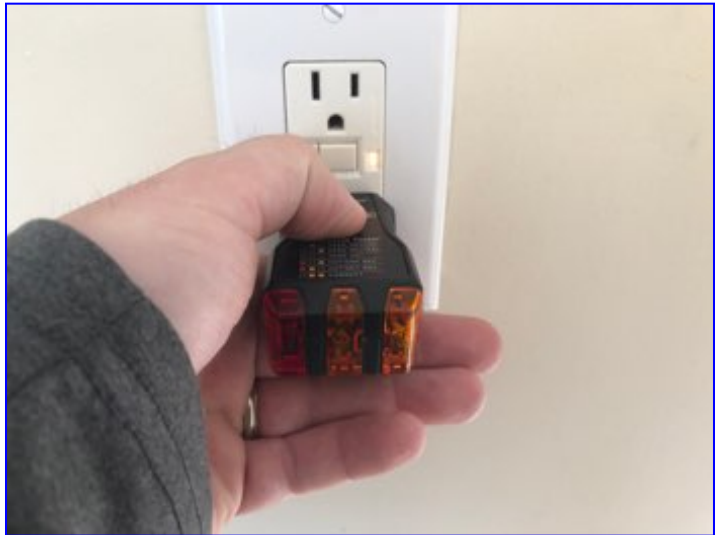
**H. GFCI**

- GFCI outlets were tested and appear operational.
