Chattanooga Home Inspector

Property Inspection Report

123 Inspection Way, Chattanooga, TN 37421
Inspection prepared for: Mrs. Buyer & Mr. Buyer
Date of Inspection: 1/5/2021 Time: 8:00 AM
Age of Home: 2007 Size: 3100
Weather: 30 degrees and sunny
Order ID: 11652

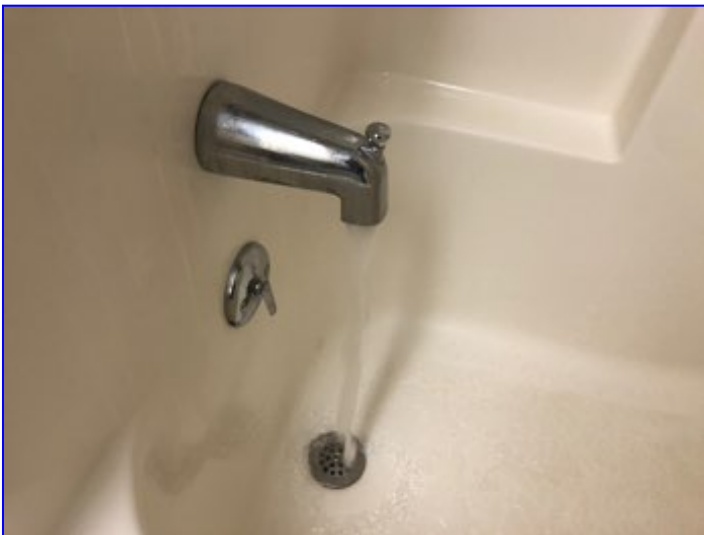
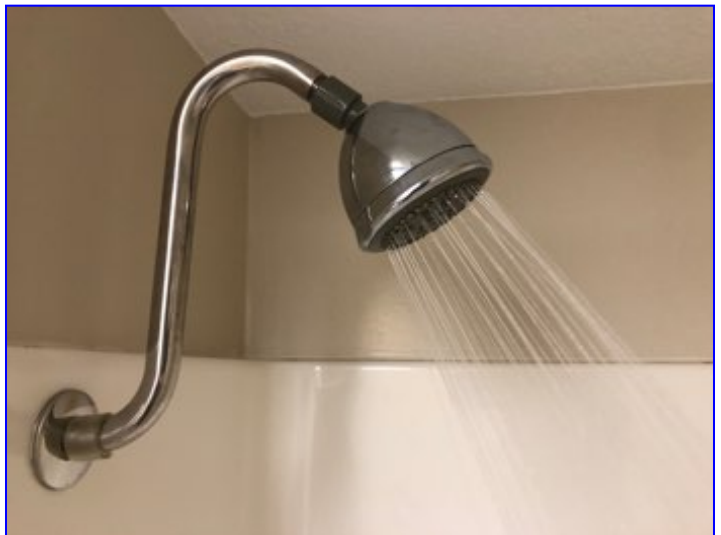
- Shower faucet tested, appeared to flow and drain correctly.

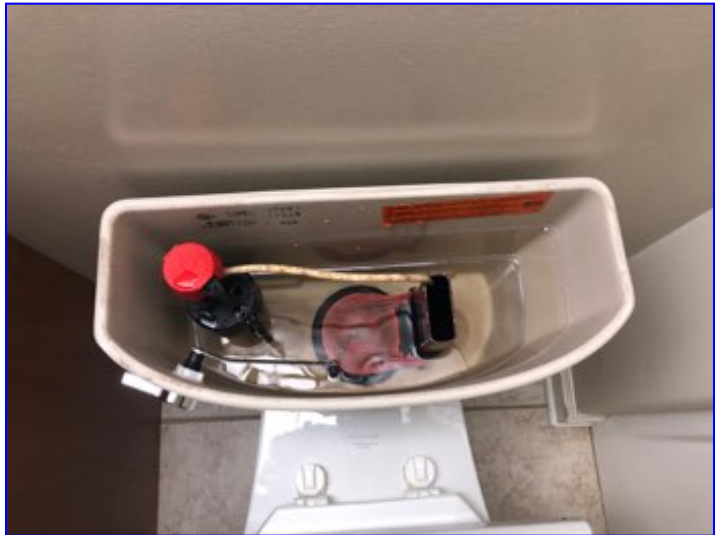
D. Toilets

- Operated when tested. No deficiencies noted.

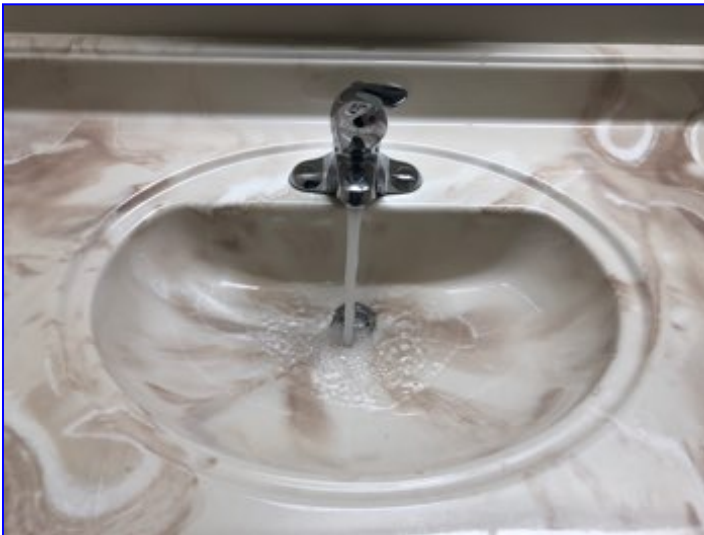
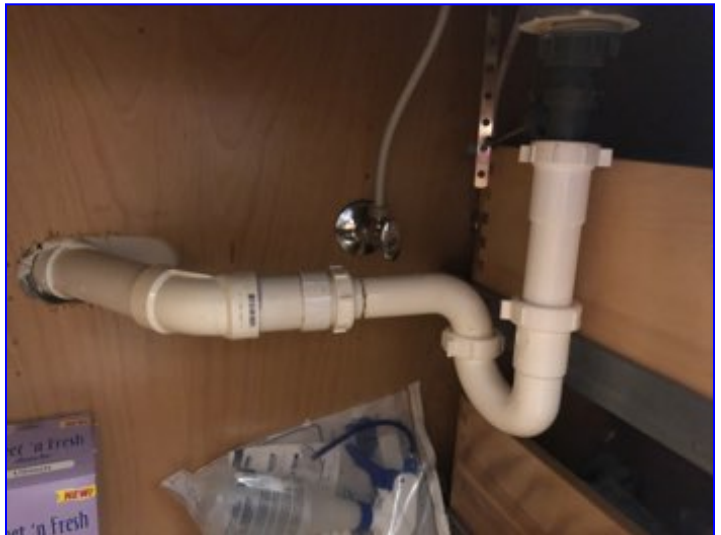
**E. Sinks**

- Sink operated, tested for flow, drainage, and leaks. Everything appears to function properly.

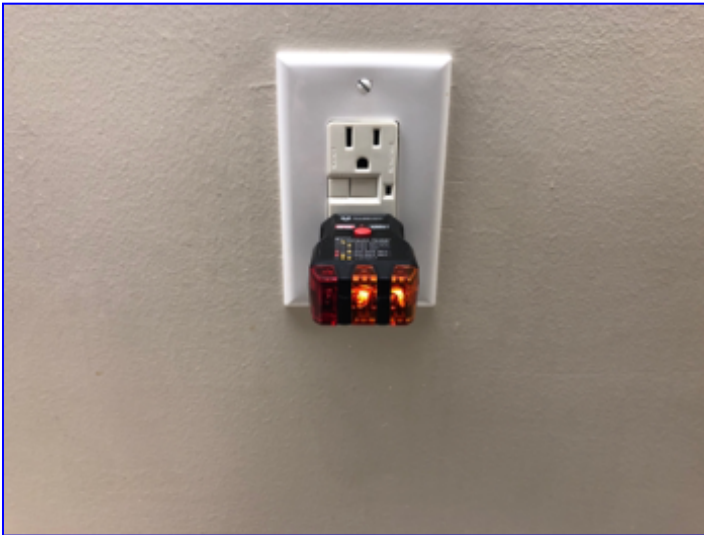
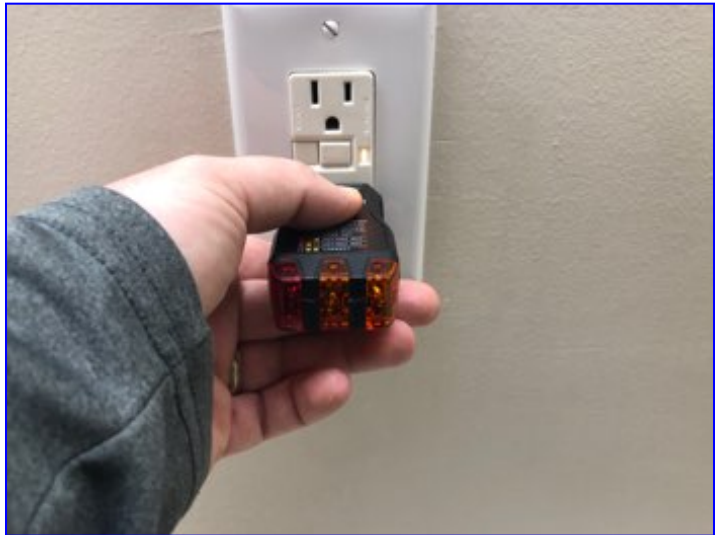
**F. GFCI**

- GFCI outlets were tested and appear operational.

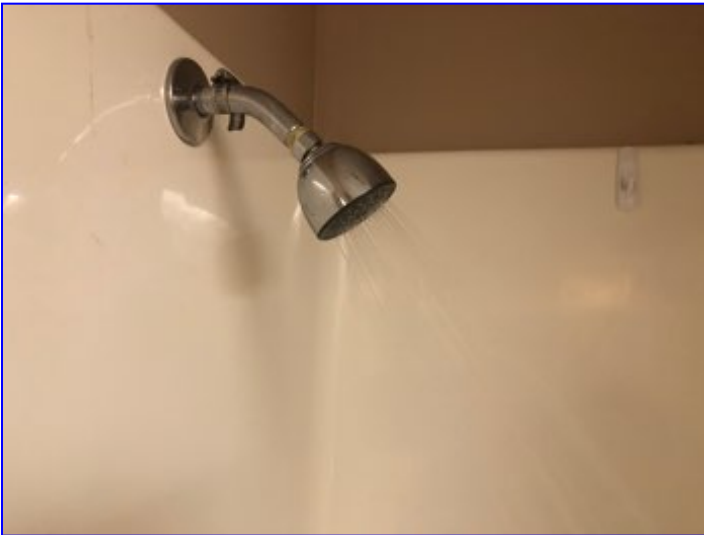
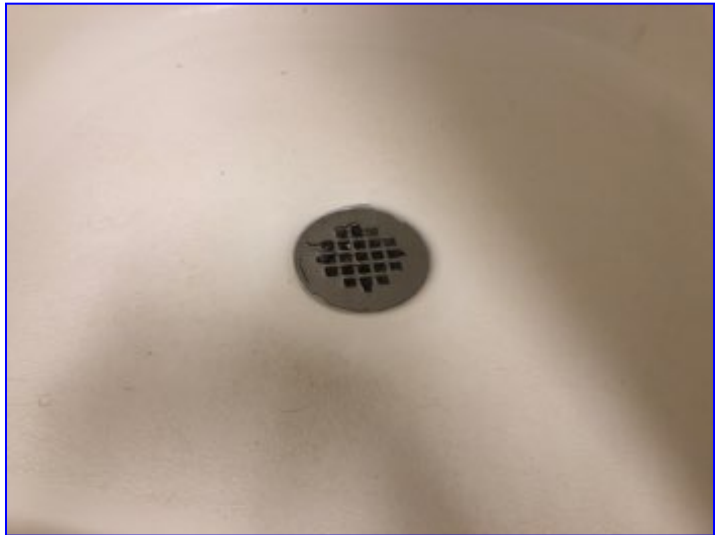
- Shower faucet tested, appeared to flow and drain correctly.

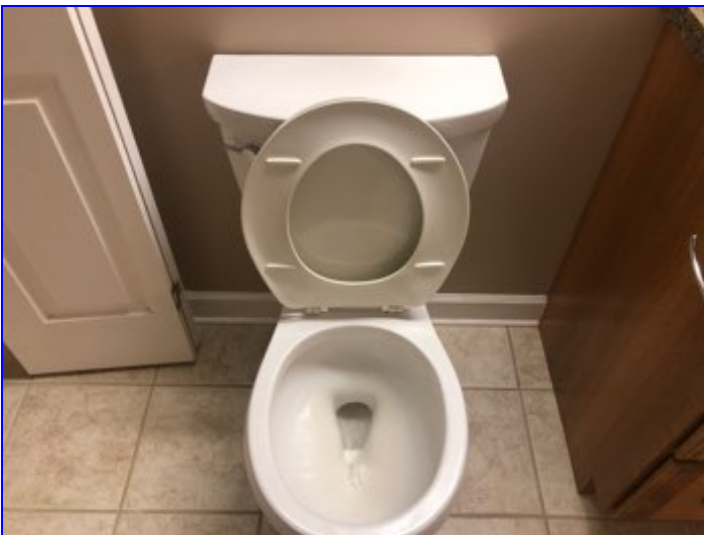
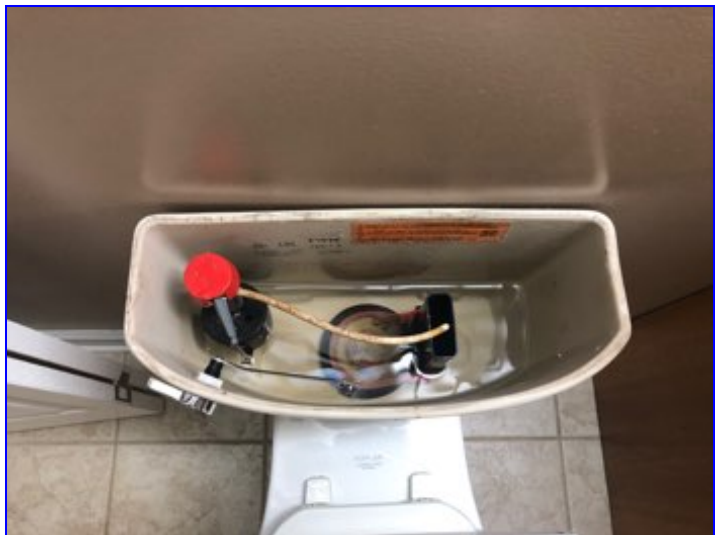
D. Toilets

- Operated when tested. No deficiencies noted.

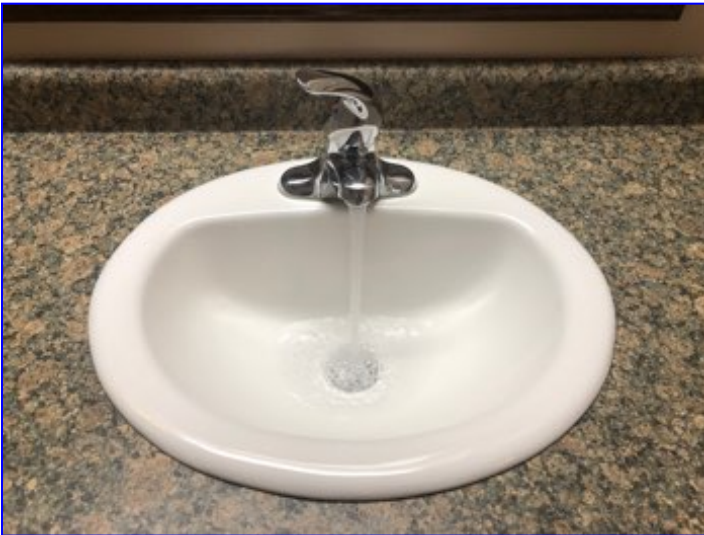
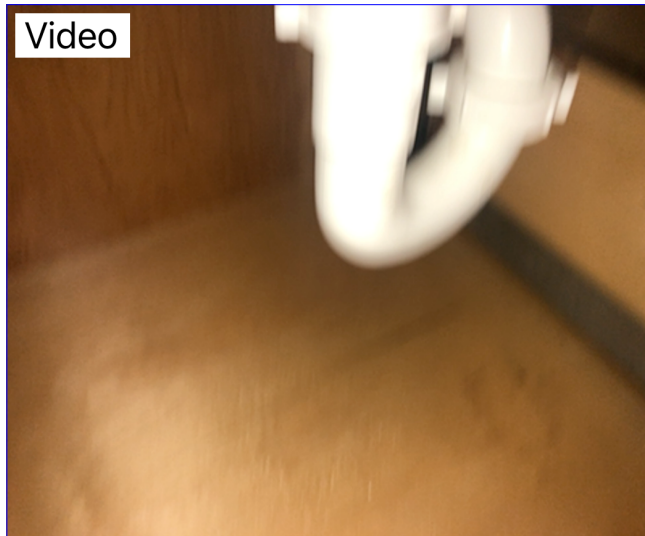
E. Sinks

- Drain line leaks under sink. Recommend repairing leak.

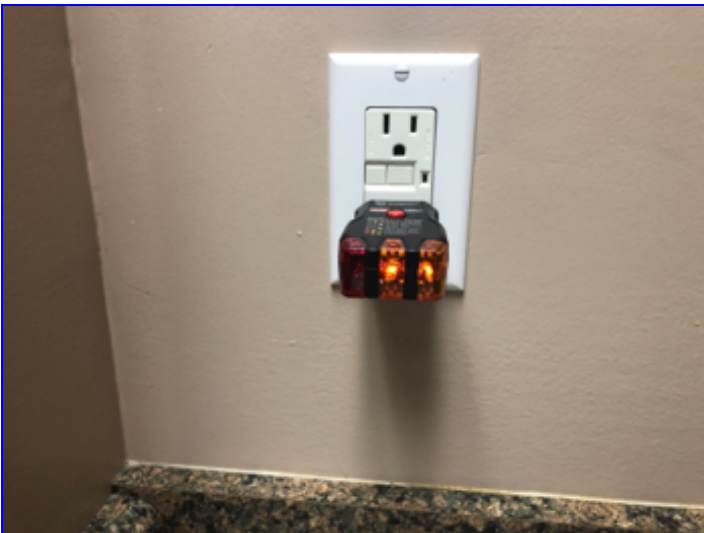
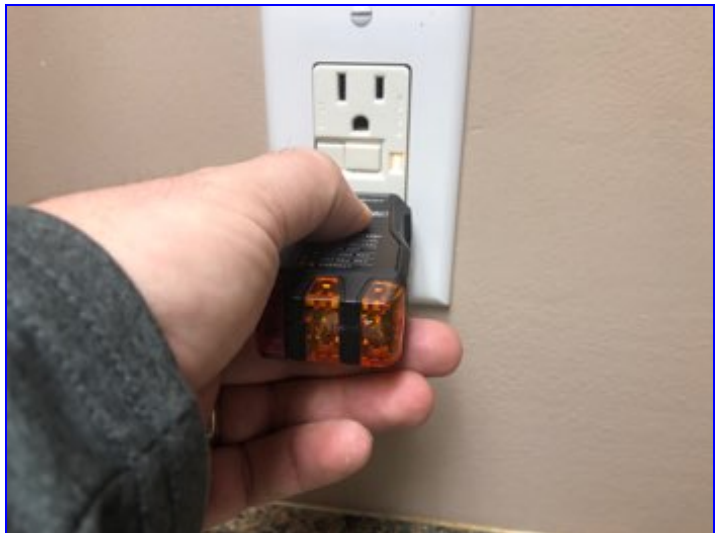
**F. GFCI**

- GFCI outlets were tested and appear operational.

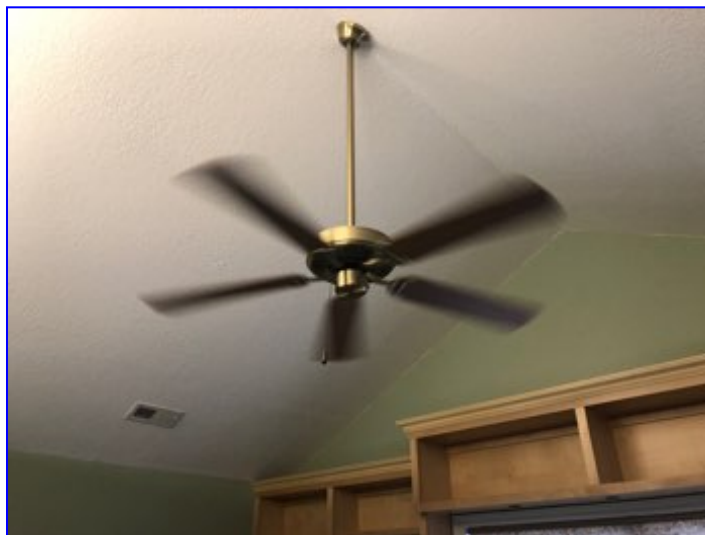
C. Ceiling Fans

- Operated normally when tested at time of inspection.

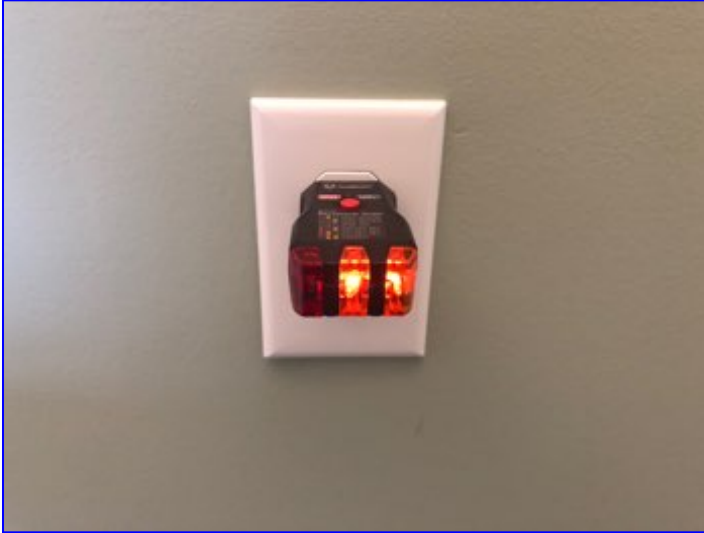
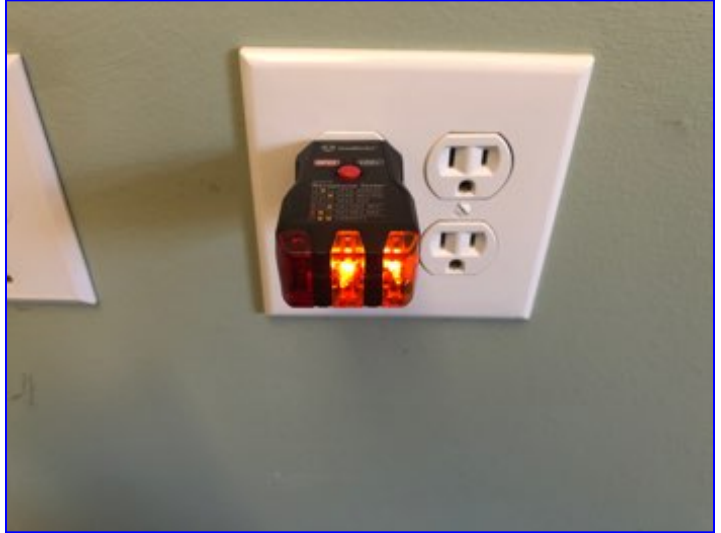
D. Electrical

- A representative number of electrical outlets were tested and wiring appears to be correct. Two amber or green lights on tester indicate correct wiring.

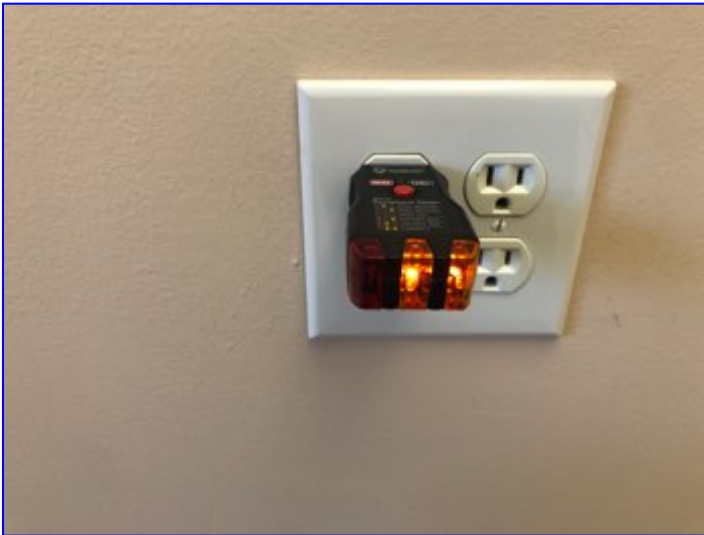
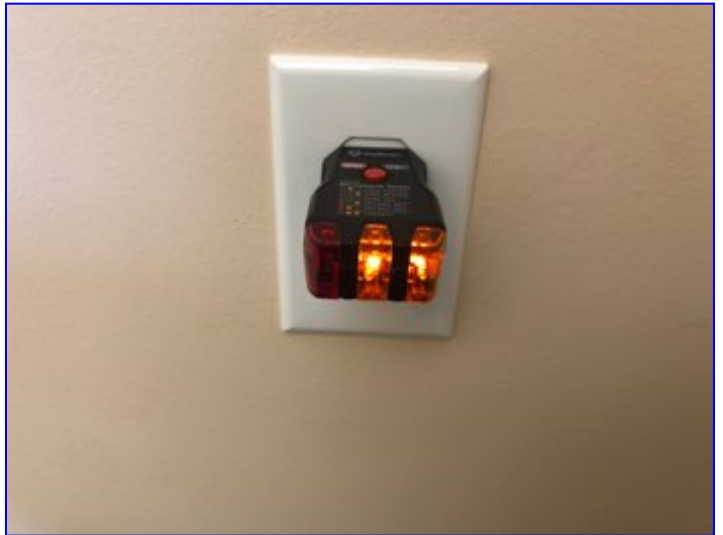
D. Electrical

- A representative number of electrical outlets were tested and wiring appears to be correct. Two amber or green lights on tester indicate correct wiring.

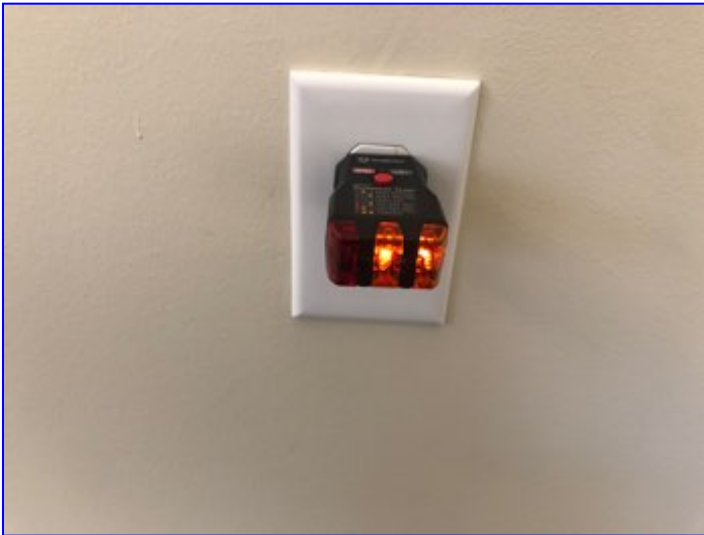
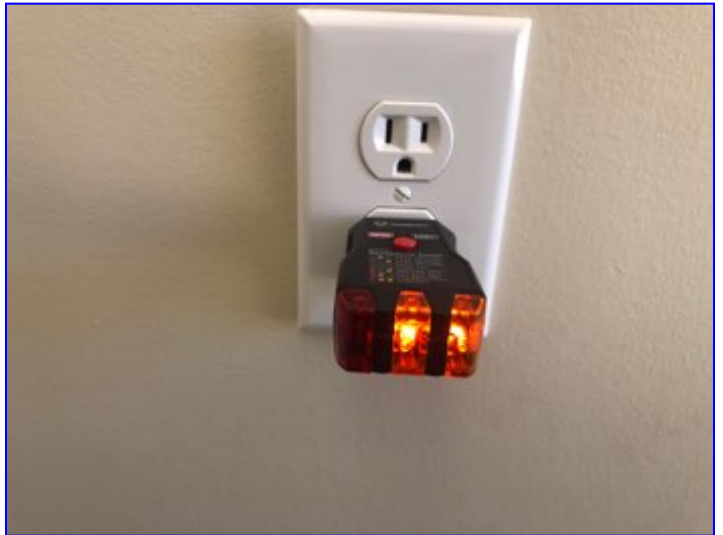
D. Electrical

- A representative number of electrical outlets were tested and wiring appears to be correct. Two amber or green lights on tester indicate correct wiring.

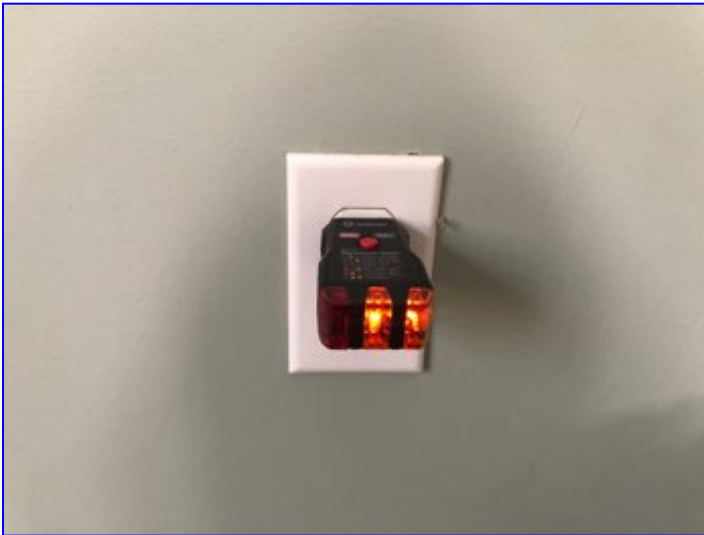
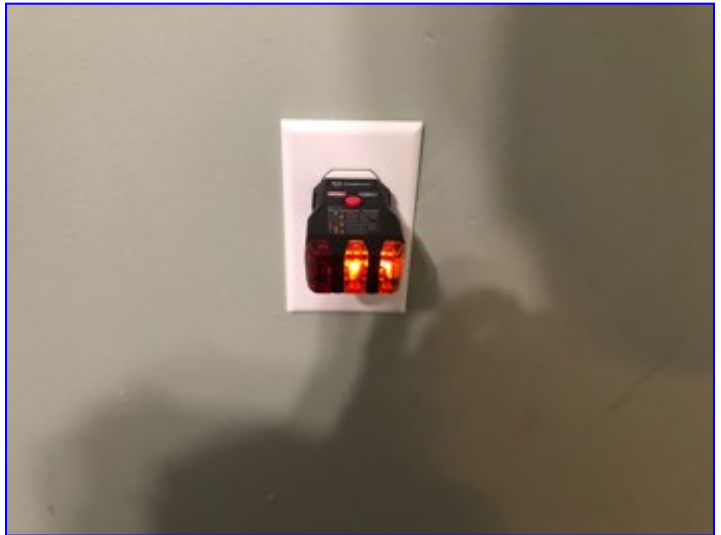
D. Electrical

- A representative number of electrical outlets were tested and wiring appears to be correct. Two amber or green lights on tester indicate correct wiring.

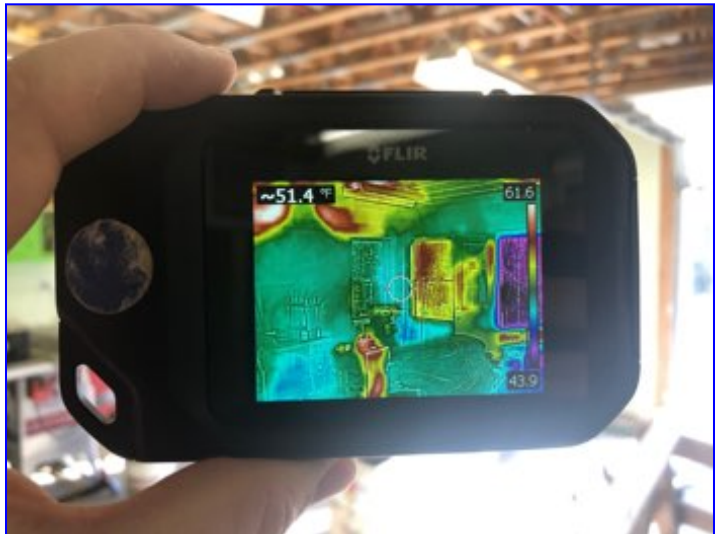
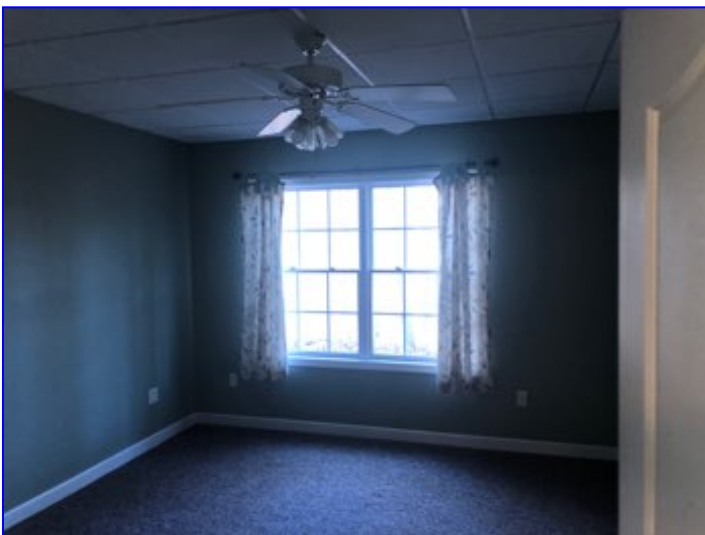
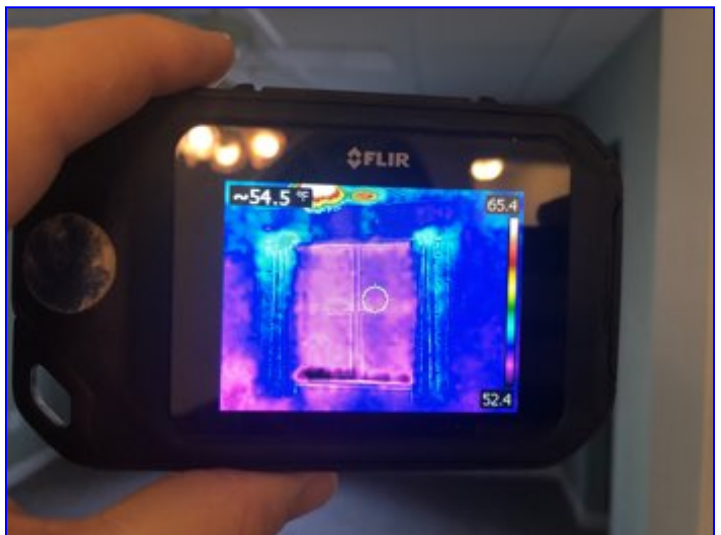
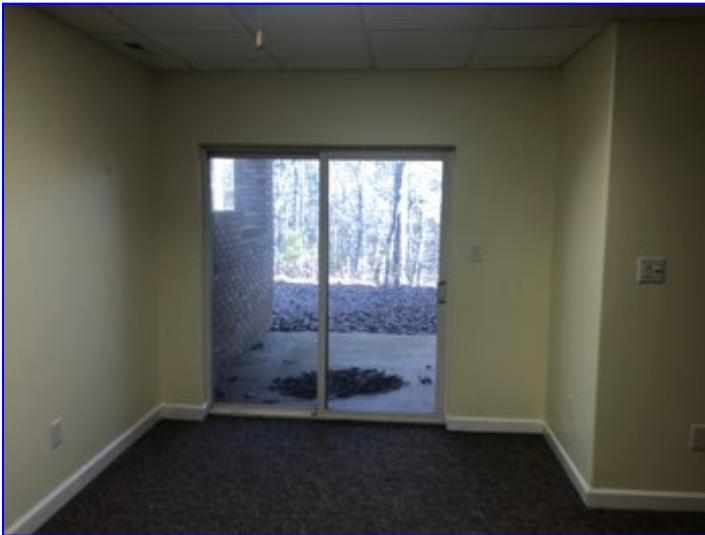
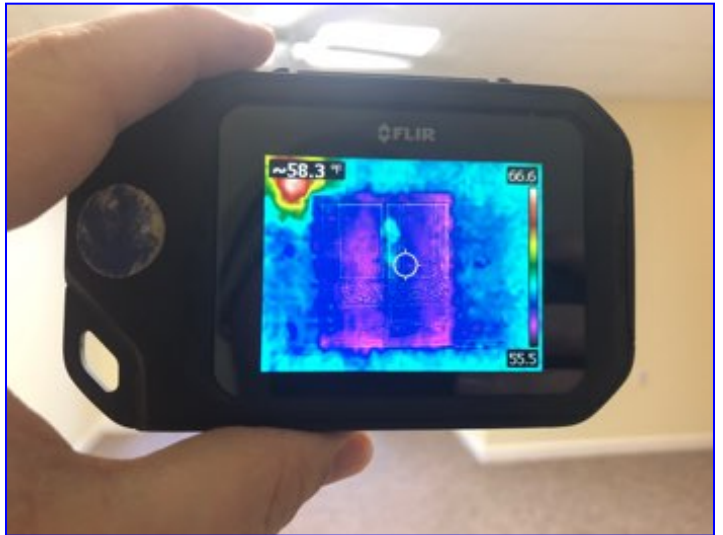
- This thermal scan is not a complete energy scan, it is simply a bonus for our clients. This test may show areas where extra insulation or upgrades to specific items could help with reducing energy costs.
